Processing Record for this file: (Make notes here unique for this file)

Loading 8/1 - 9/1/2014 Data loaded directly from DMF

TEI Model 43i-TLE Pulsed Fluorescence SO<sub>2</sub> Analyzer Housekeeping

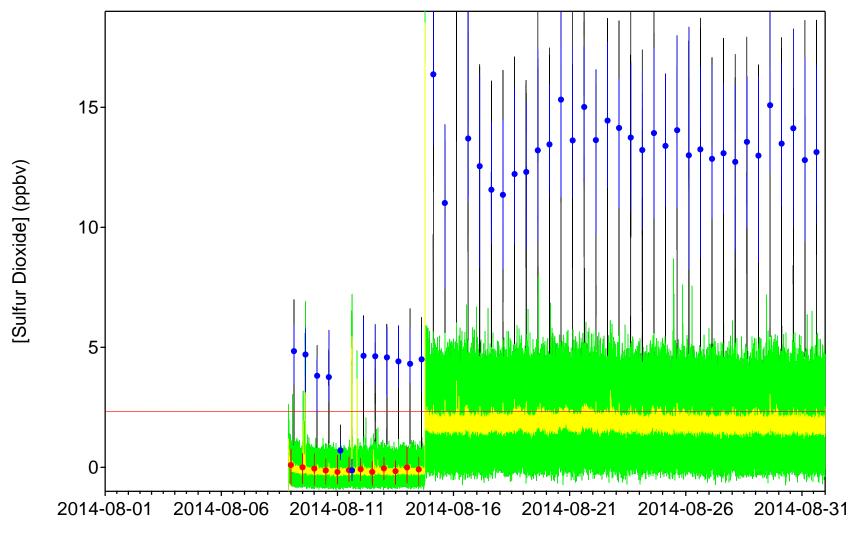
Noise is greater than expected, but appears ok. Long period (>1 min) averaging shows a slight negative bias (~0.3-5 ppbv) in the signal.

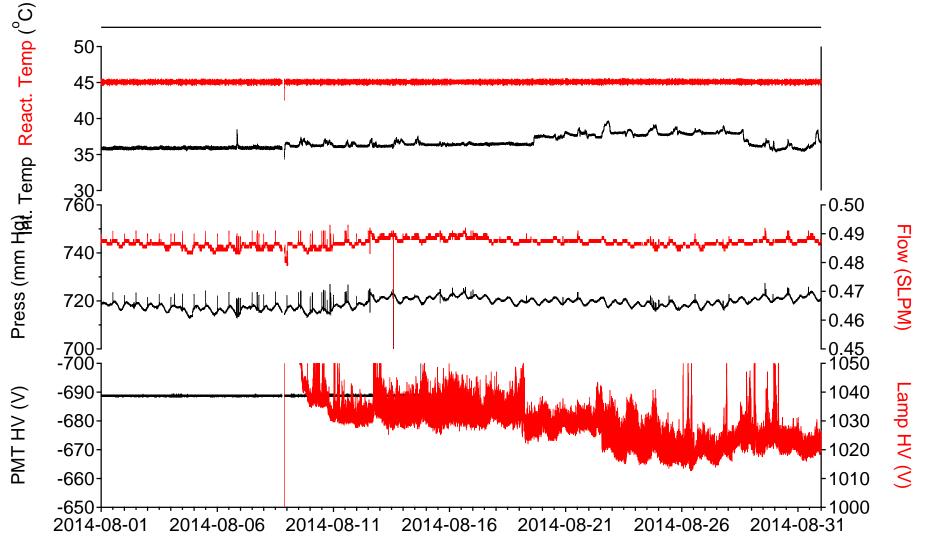
TEI Model 43i-TLE Pulsed Fluorescence  $SO_2$  Analyzer Zero/Span Checks

When the instrument was repaired and turned back on, internal parameters were adjusted. This required entering Service Mode. The instument was inadvertantly left in Service Mode and so automatic zeros were not carried out. The Average zero value (2.33124) from the operational period was used in lieu of a measured zero for the part of the month until Service Mode was turned off ~2014-09-15. i.e..
