Processing Record for this file:  
(Make notes here unique for this file)

Loading 1/1/2014 - 2/1/2014

# TEI Model 49i UV Photometric Ozone Analyzer

Project/Platform/Site: maomaoscs1  
ARM Climate Research Facility  
Contact: S.R. Springston (631) 344-4477, srs@bnl.gov

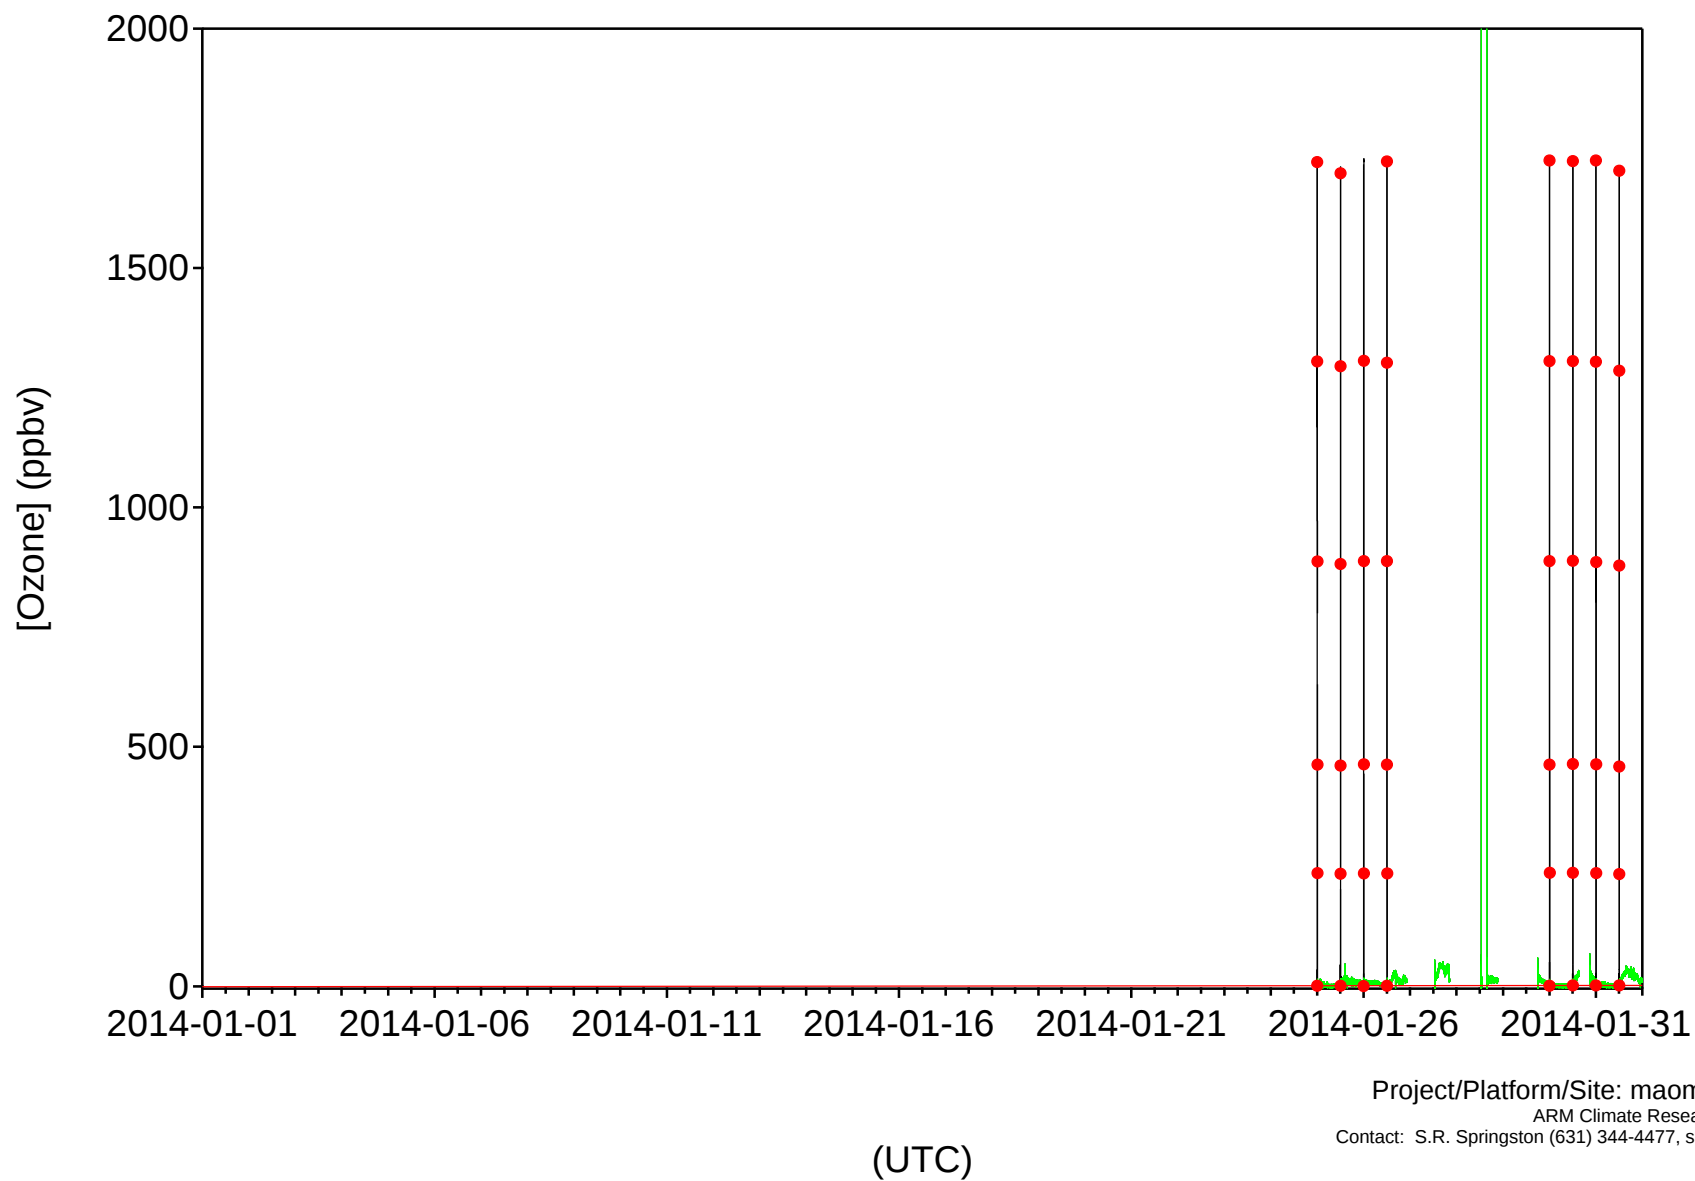
Data appear normal and reliable. Internal calibrations consistent and very stable.

The instrument commenced GoAmazon operations on 2014-01-24 23:00 Data stability and valid ambient data commenced on 2014-01-29 18:39

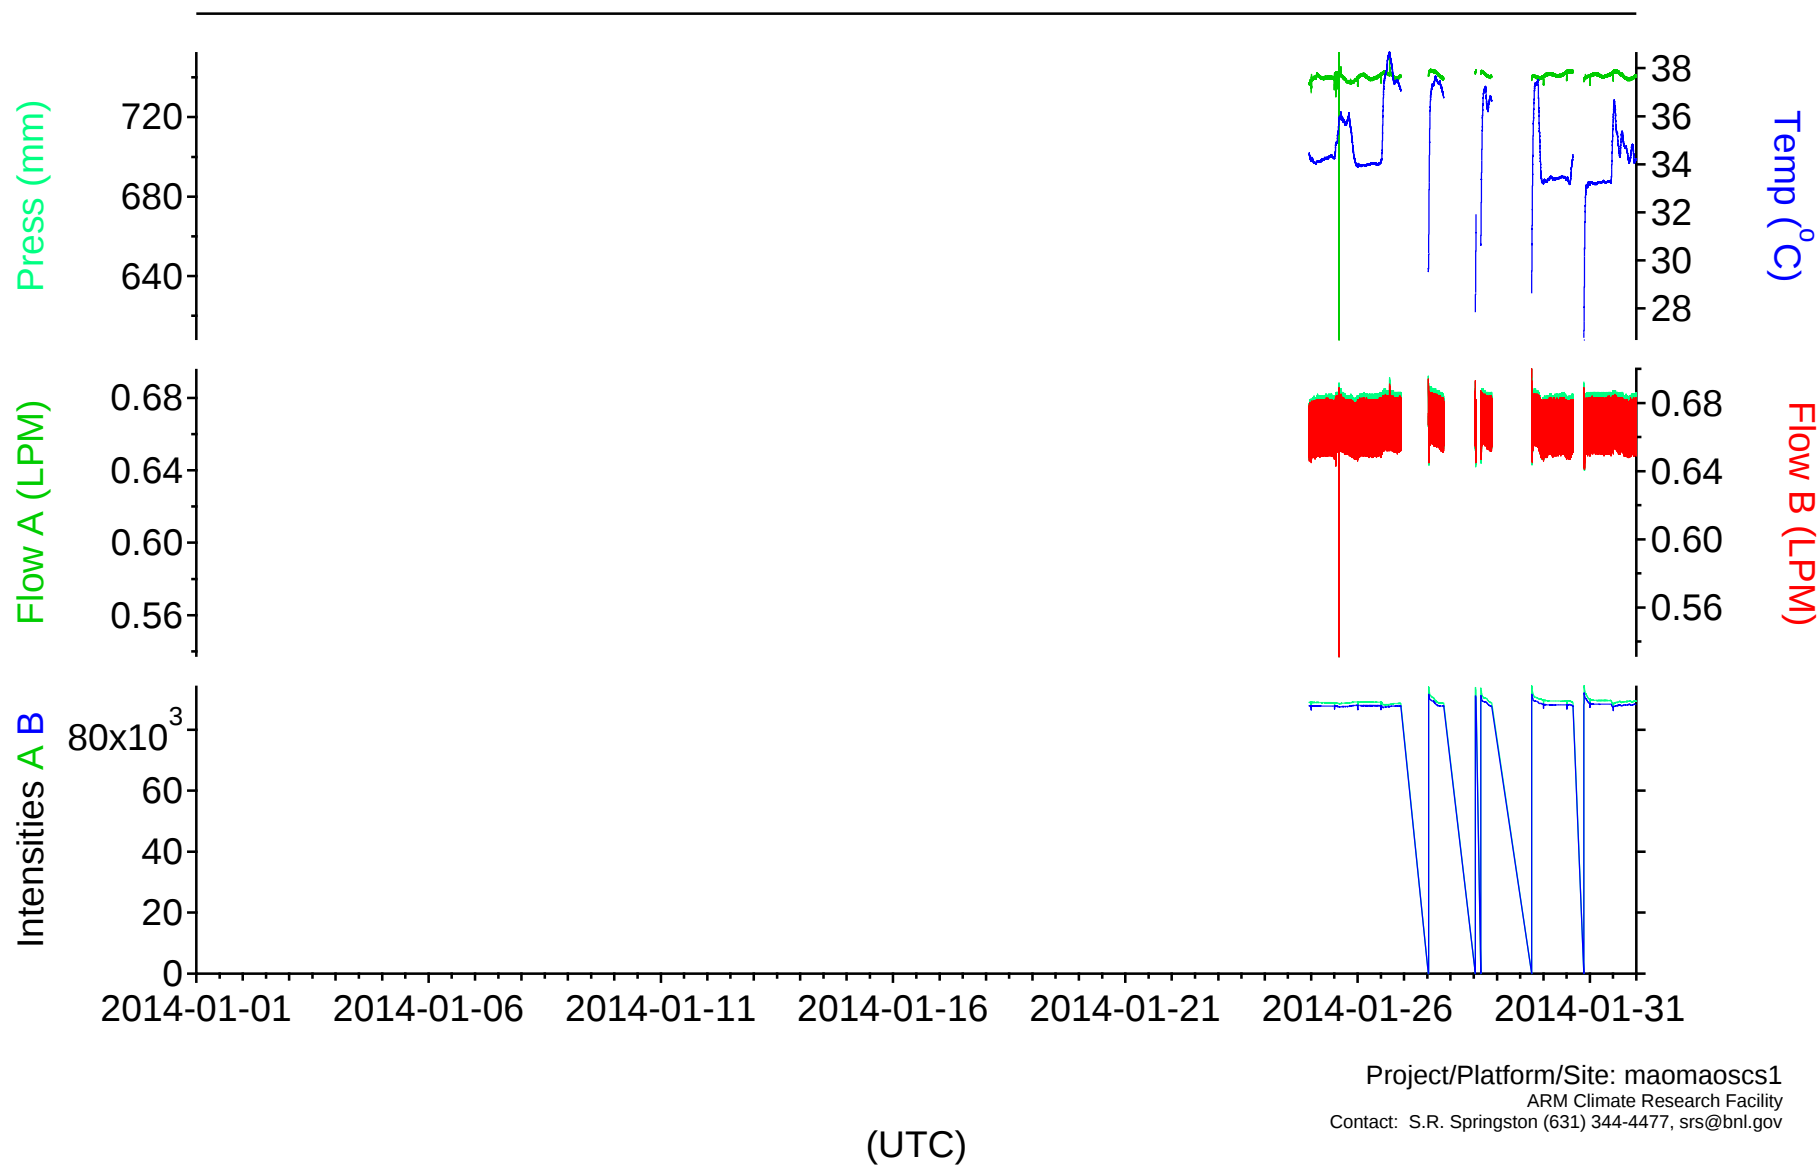
TEI Model 49i UV Photometric Ozone Analyzer  
Housekeeping

Consult Operator logs for power outage periods. After power outages, the instrument 'rings' for ~5 minutes during warm up. These periods were edited out by Mentor.

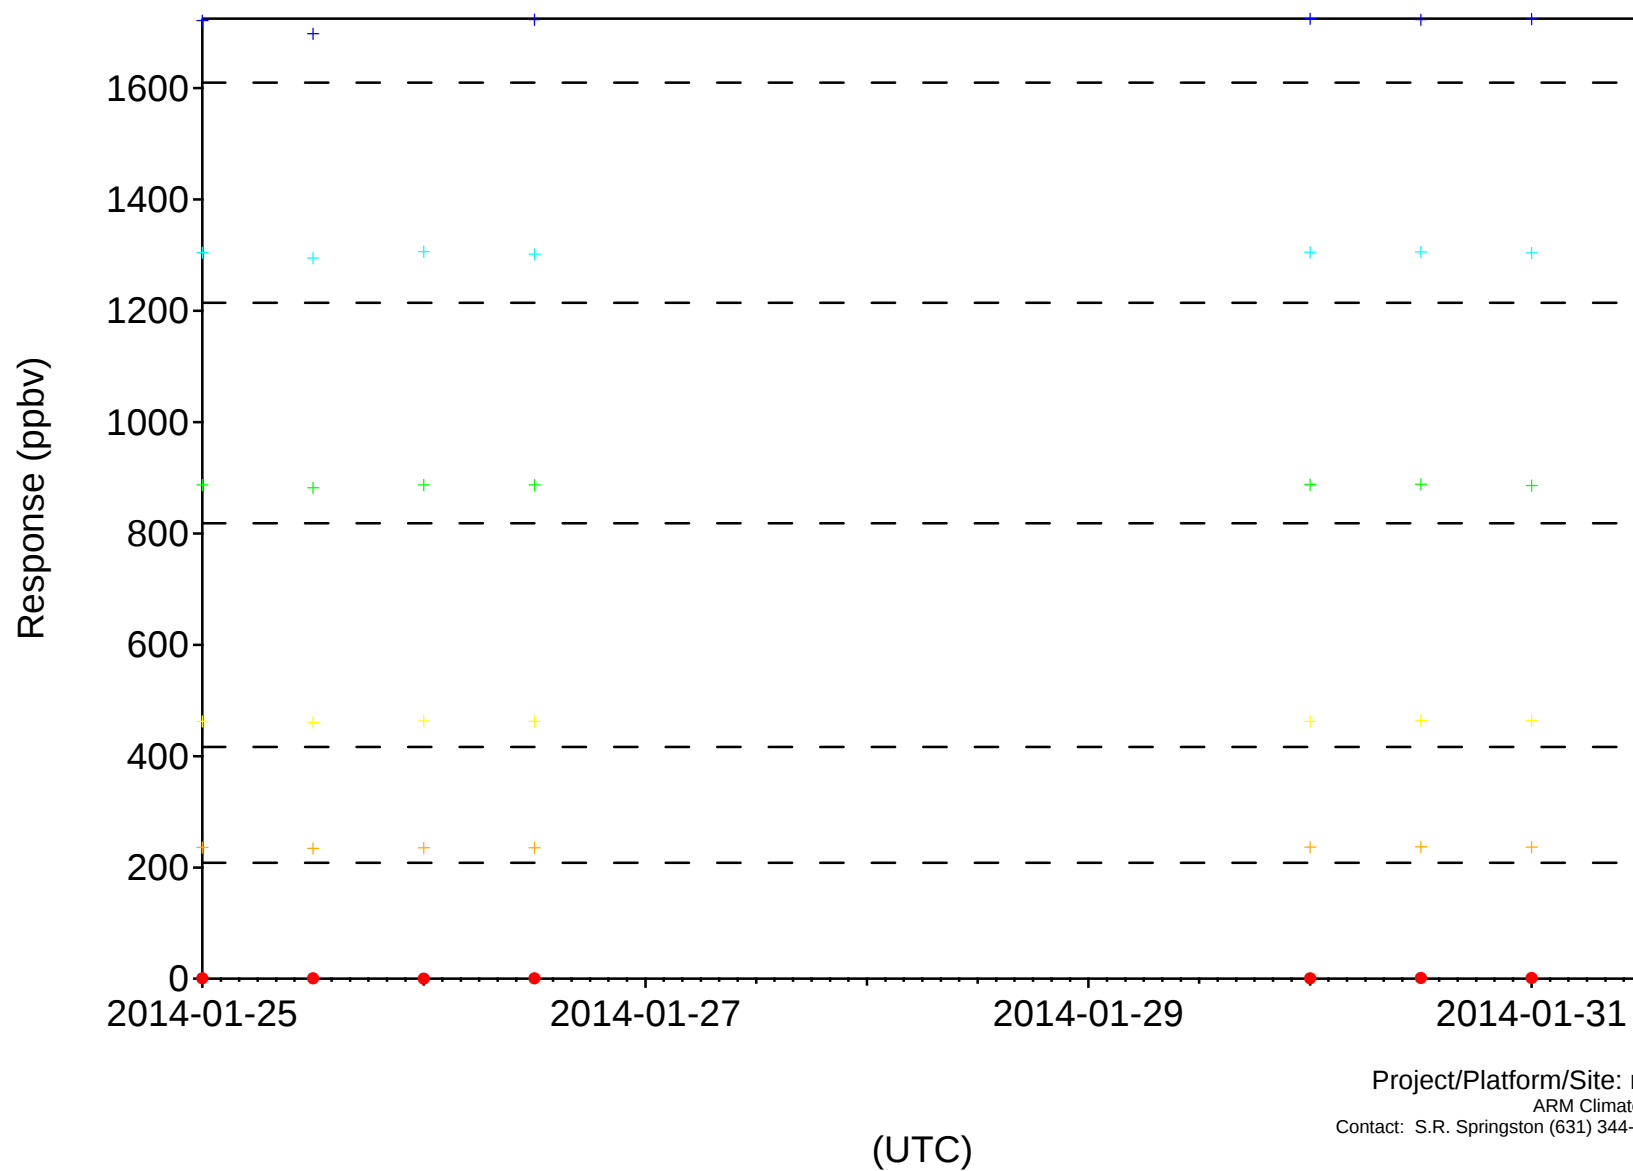
TEI Model 49i UV Photometric Ozone Analyzer  
Zero/Span Checks

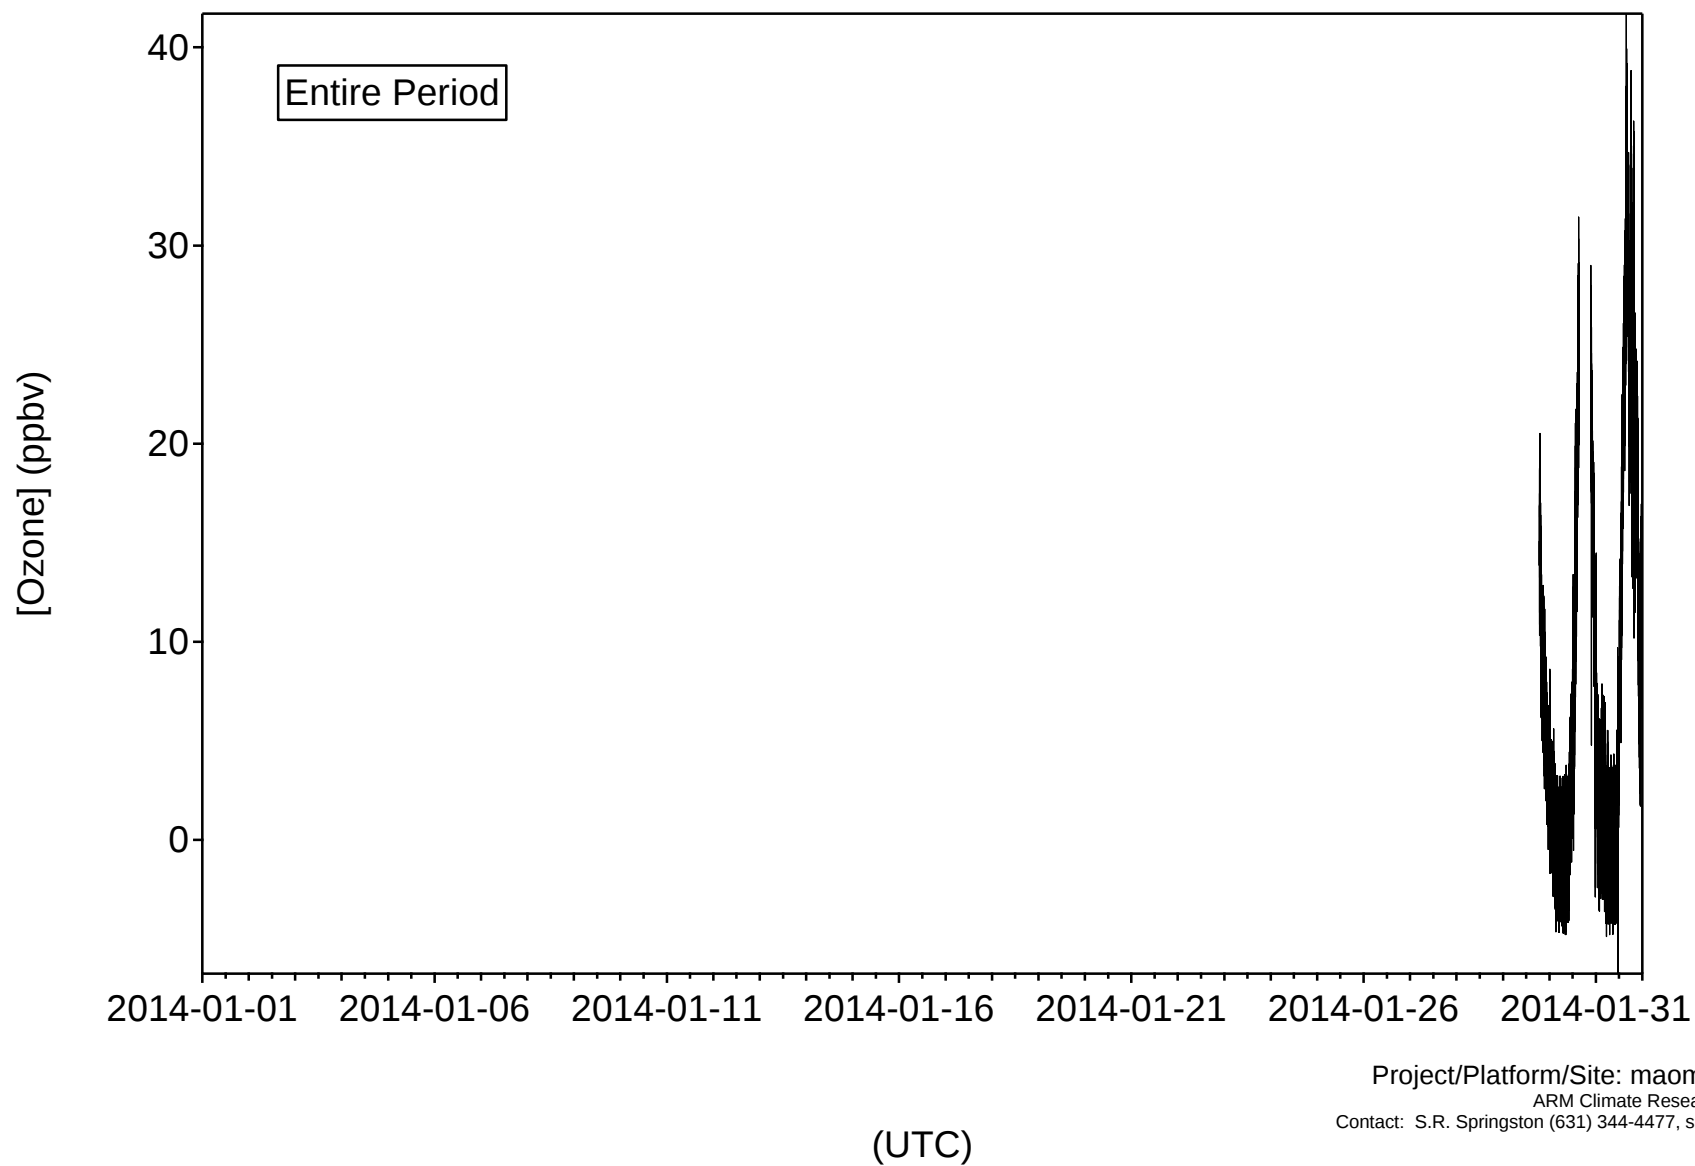
TEI Model 49i UV Photometric Ozone Analyzer  
Baseline Corrected

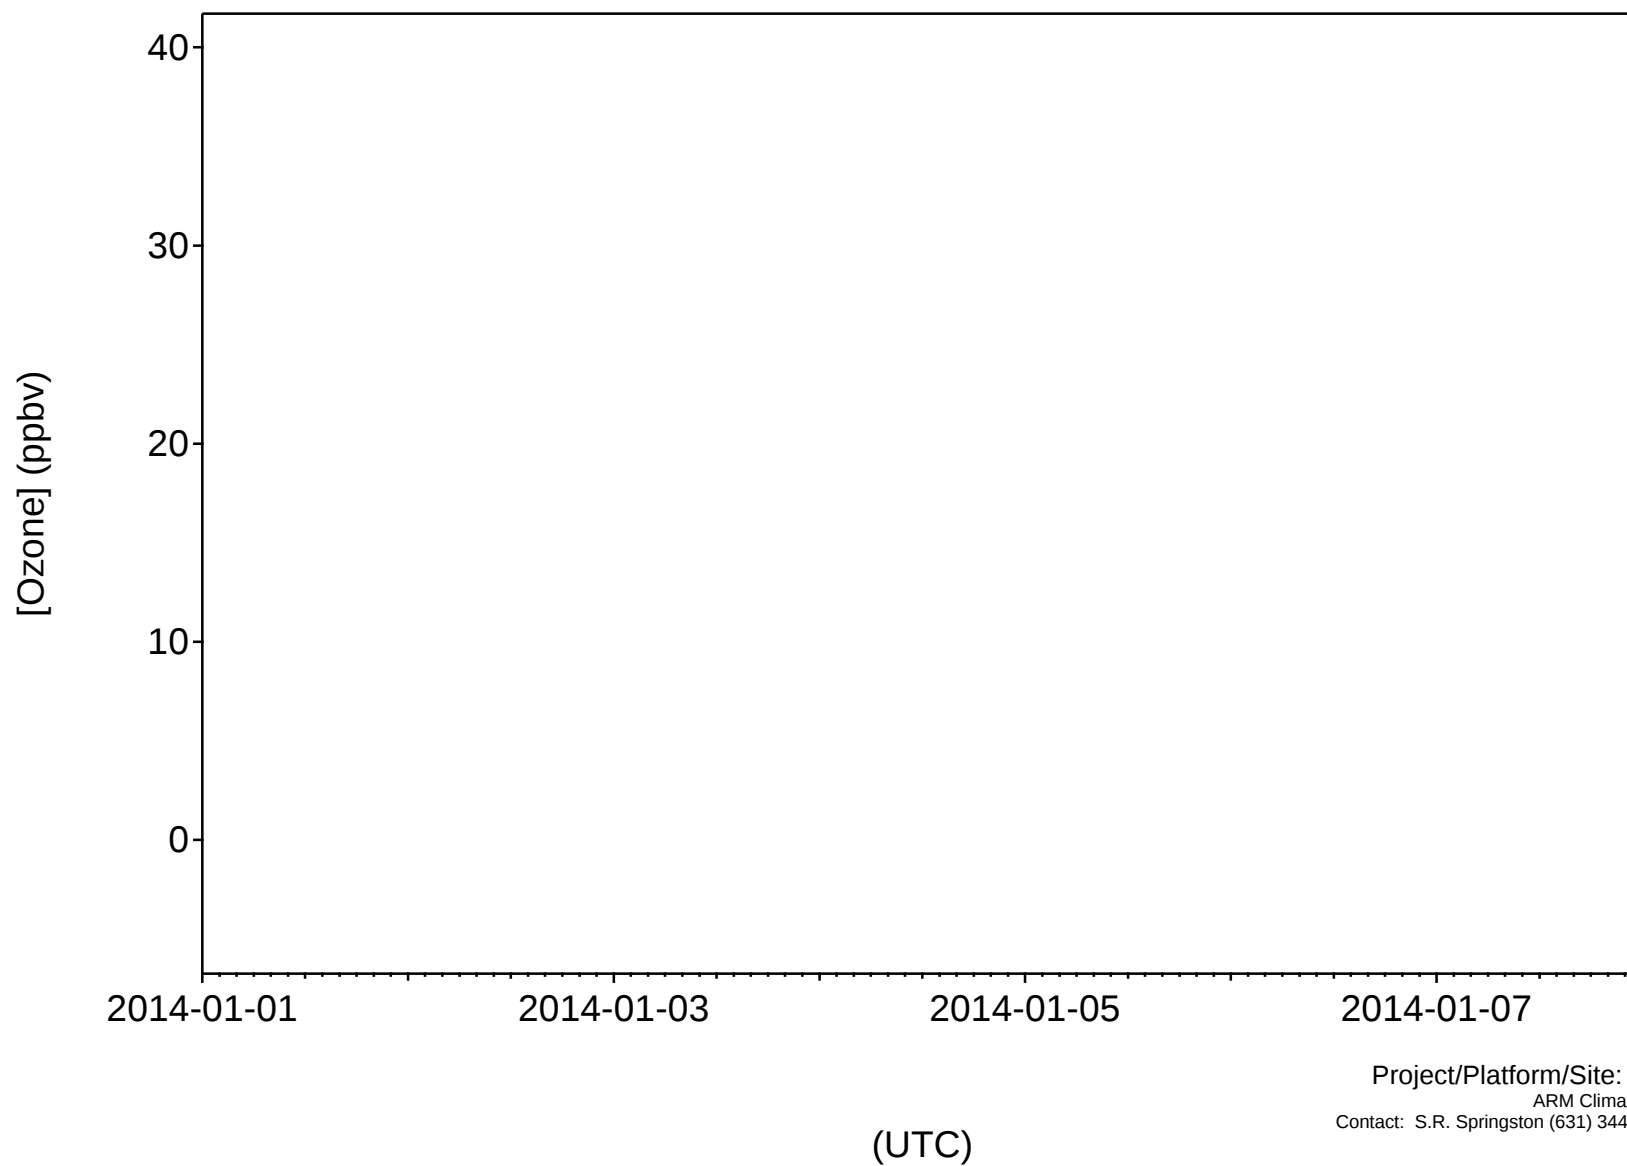
TEI Model 49i UV Photometric Ozone Analyzer  
Baseline Corrected

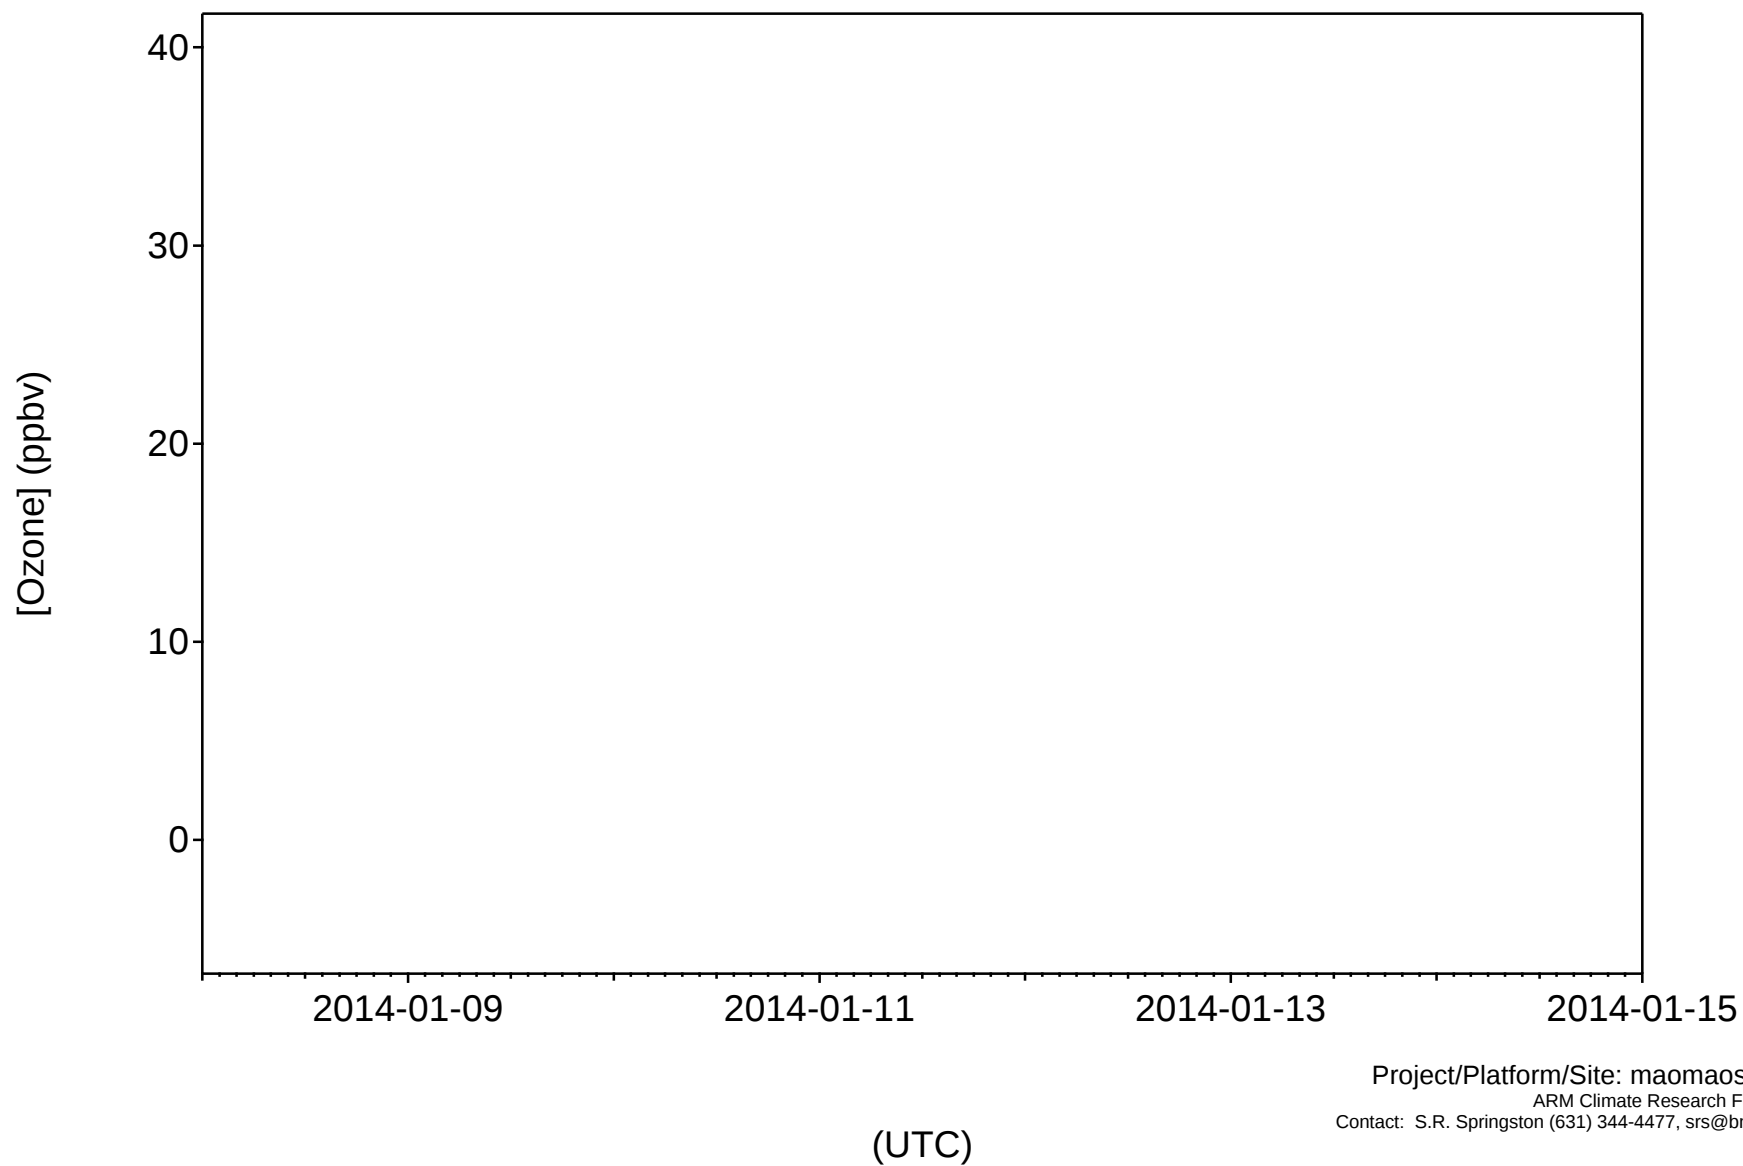
TEI Model 49i UV Photometric Ozone Analyzer  
Baseline Corrected

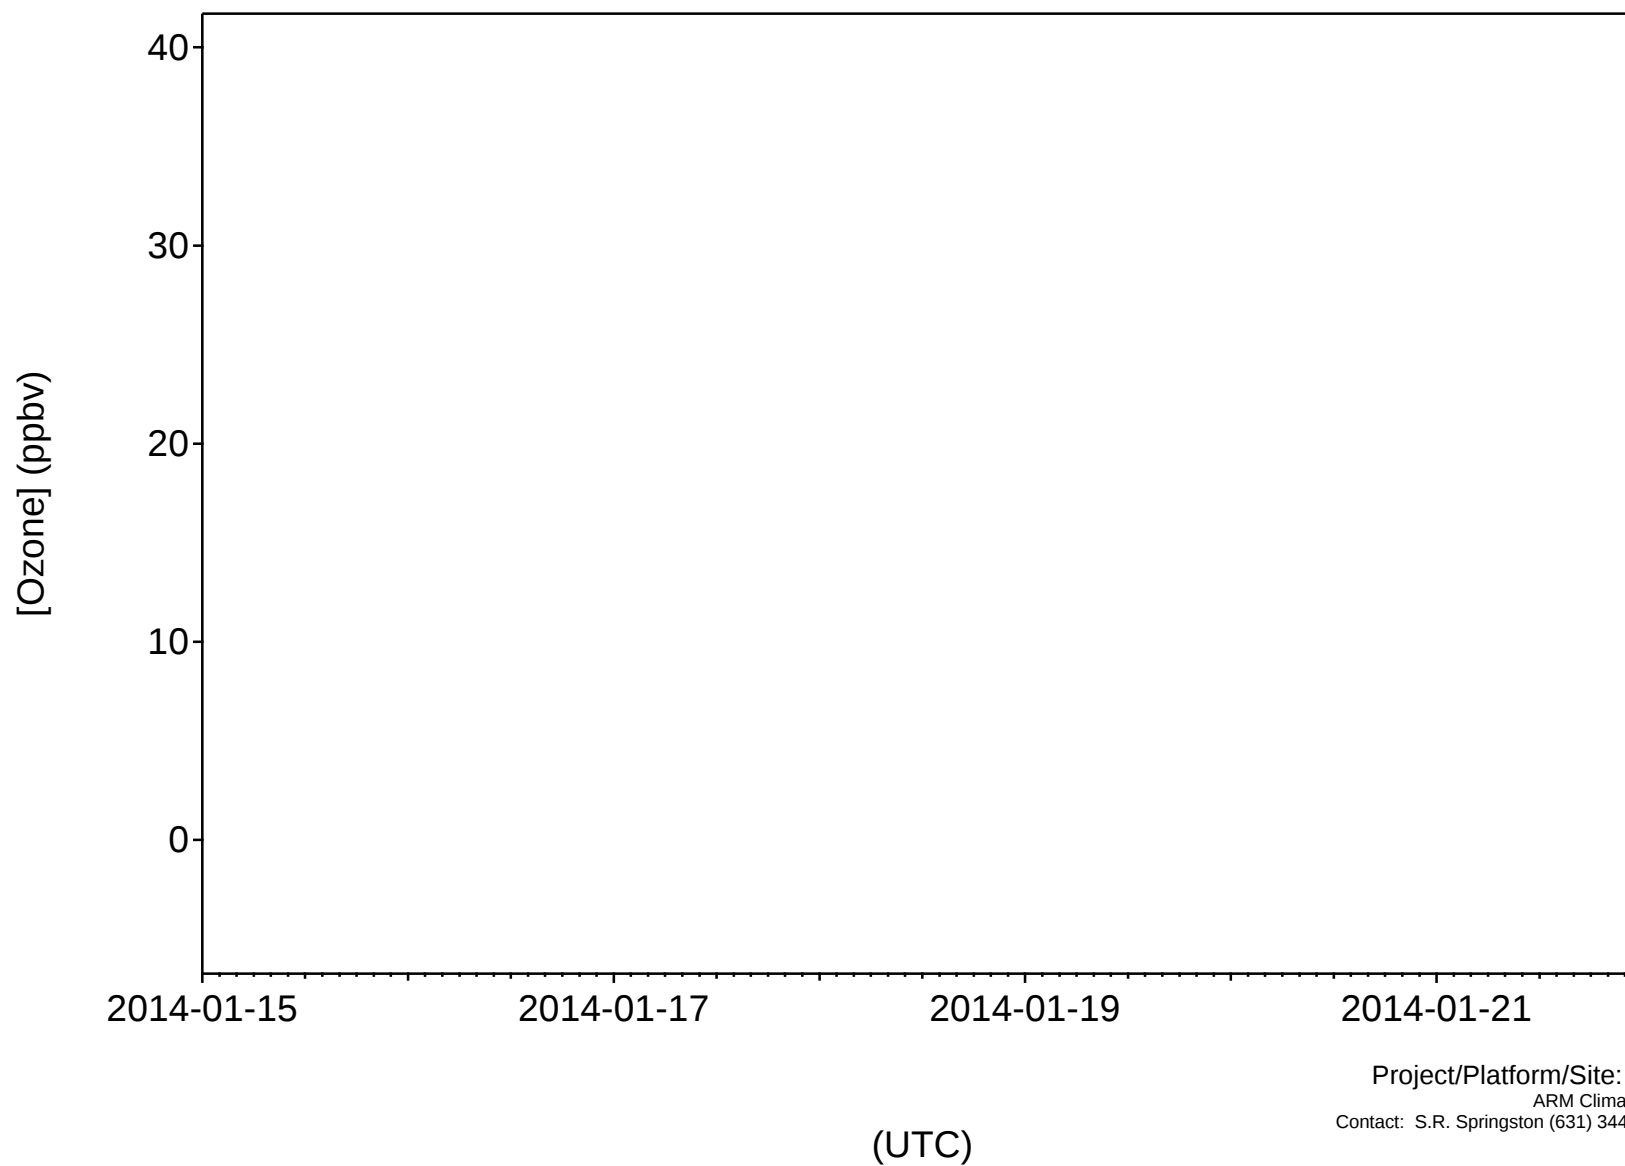
TEI Model 49i UV Photometric Ozone Analyzer  
Baseline Corrected

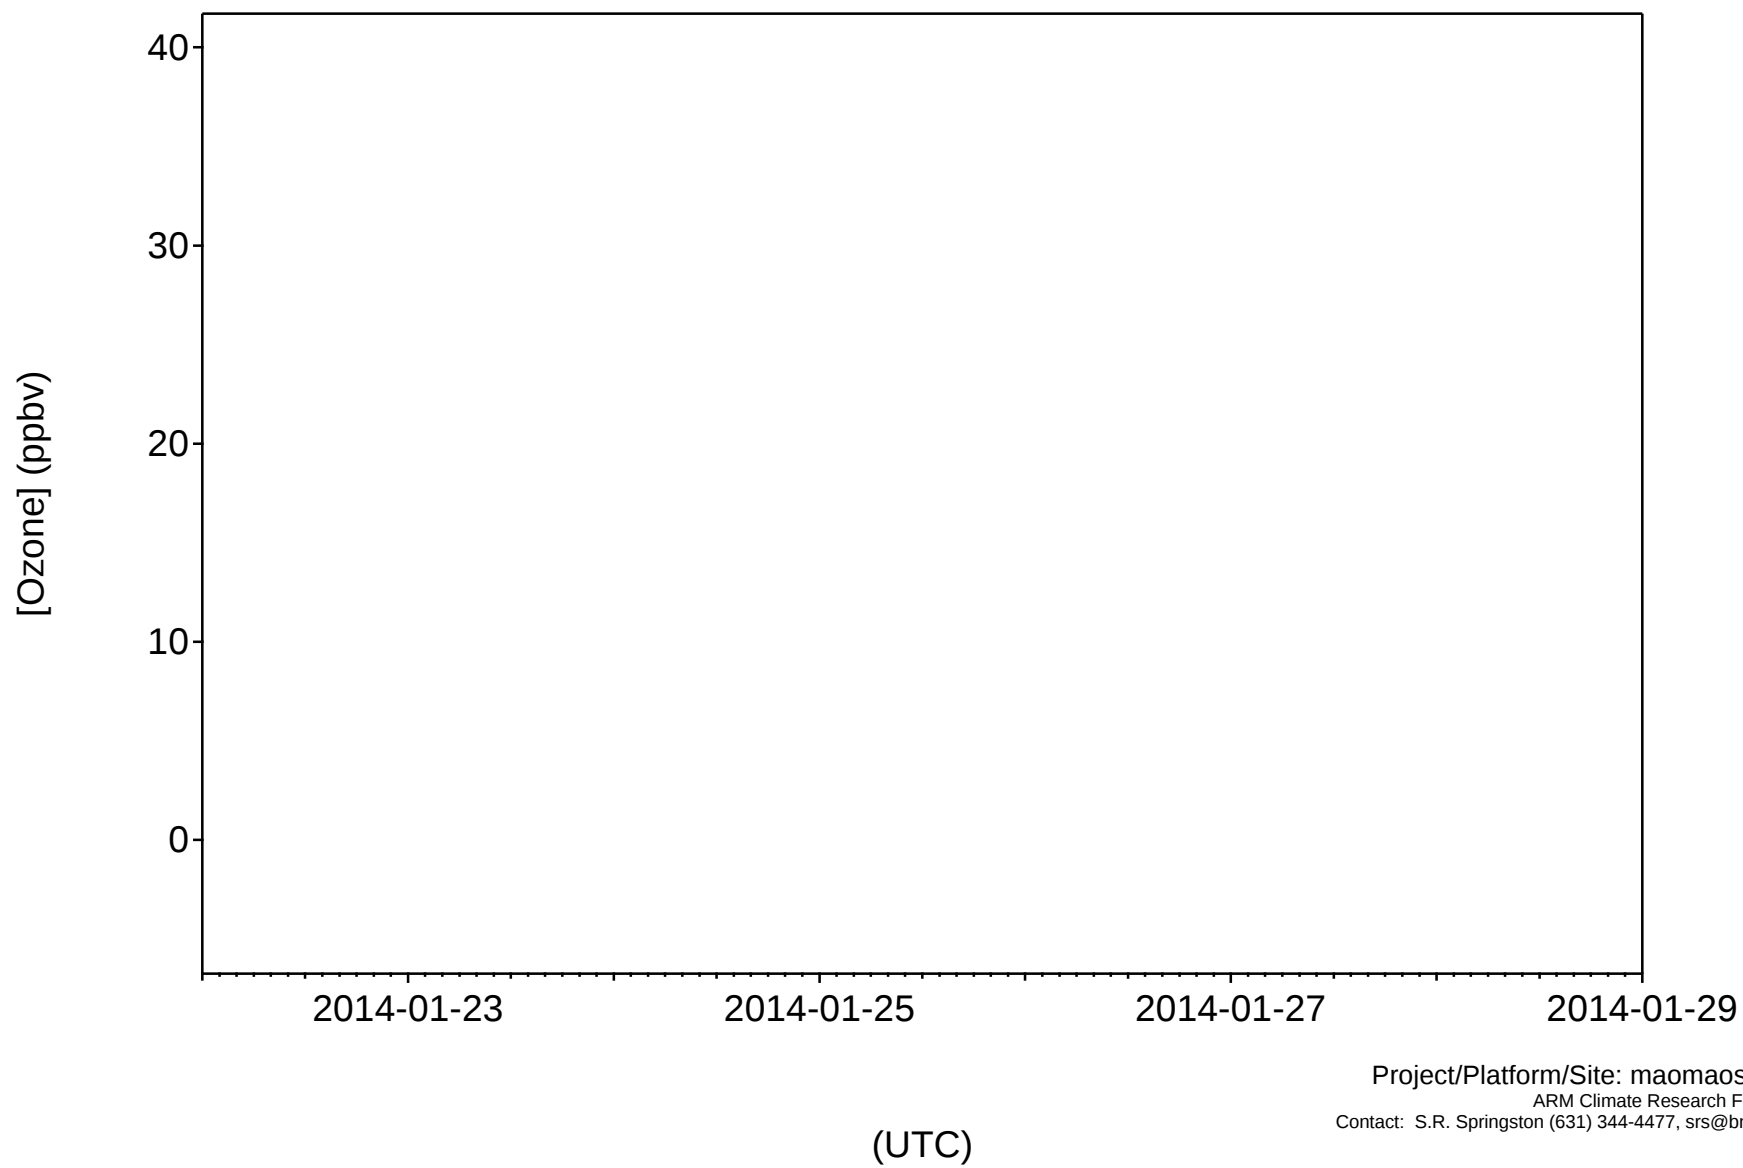
TEI Model 49i UV Photometric Ozone Analyzer  
Baseline Corrected

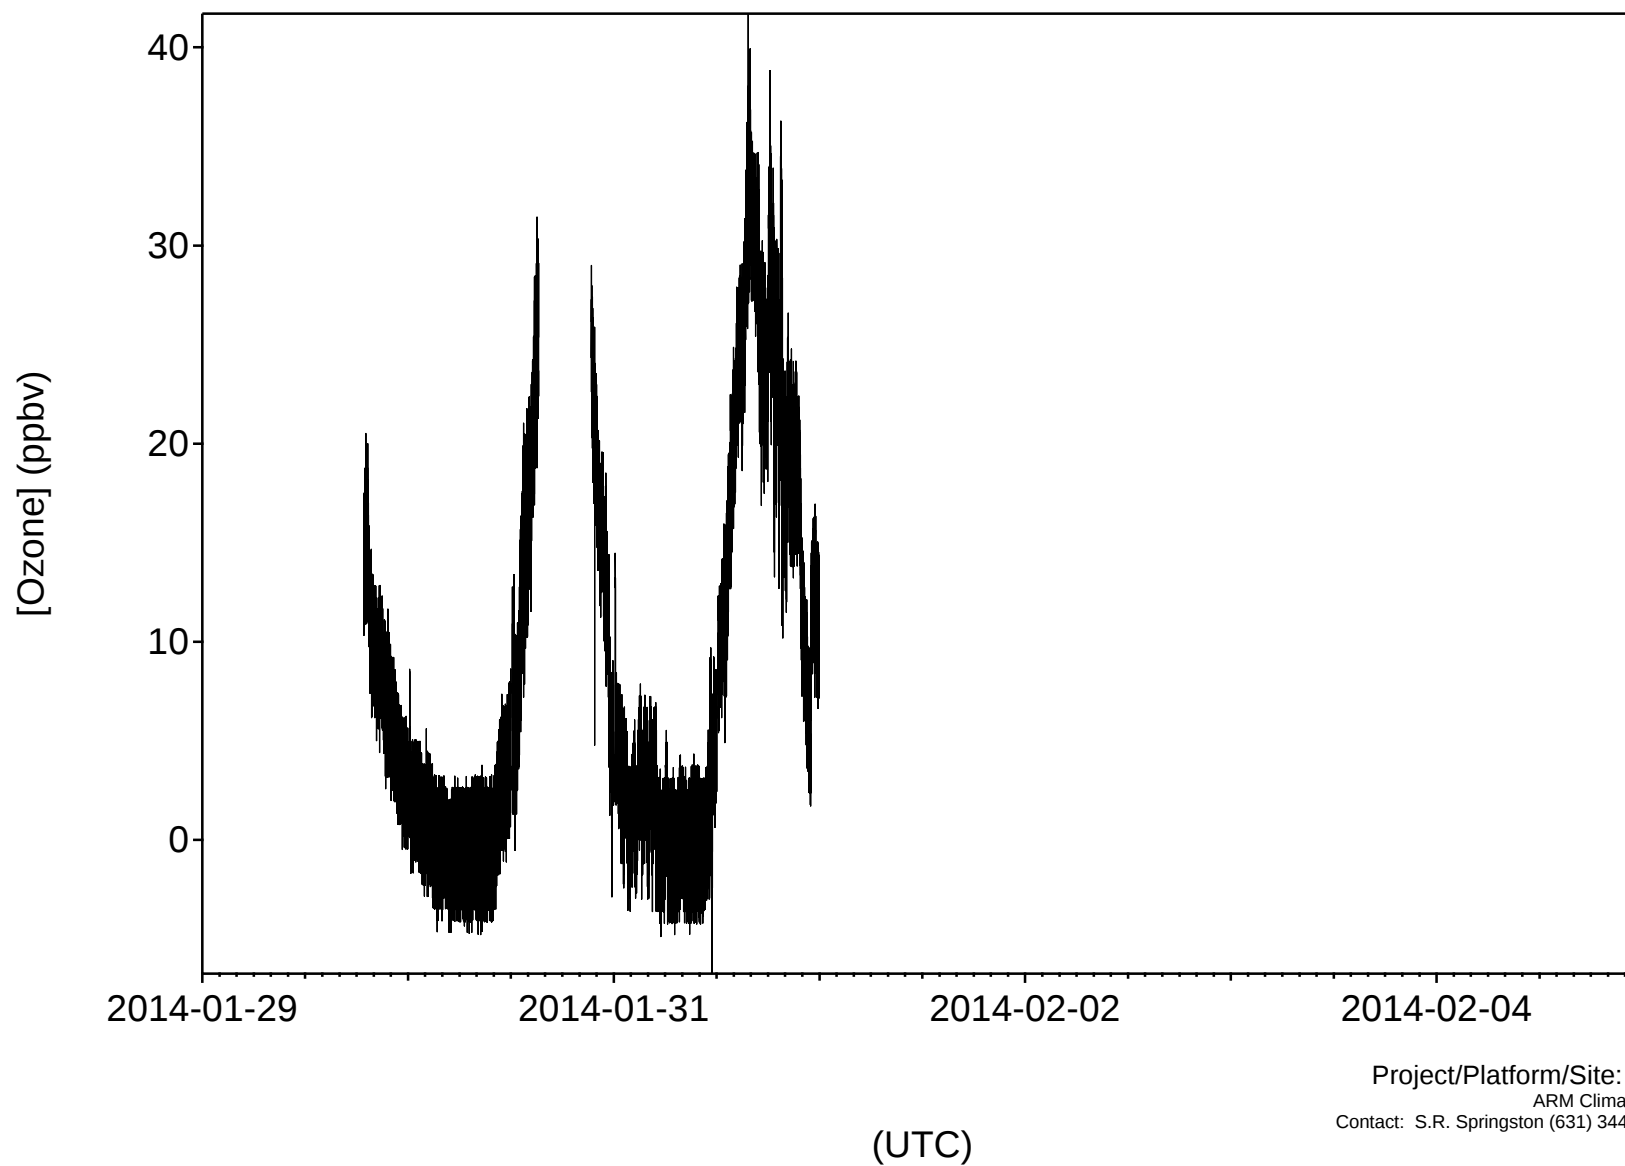
TEI Model 49i UV Photometric Ozone Analyzer  
Baseline Corrected
