Processing Record for this file:  
(Make notes here unique for this file)

Loading 2/1/2014 - 3/1/2014

# TEI Model 49i UV Photometric Ozone Analyzer

Project/Platform/Site: maomaoscs1  
ARM Climate Research Facility  
Contact: S.R. Springston (631) 344-4477, srs@bnl.gov

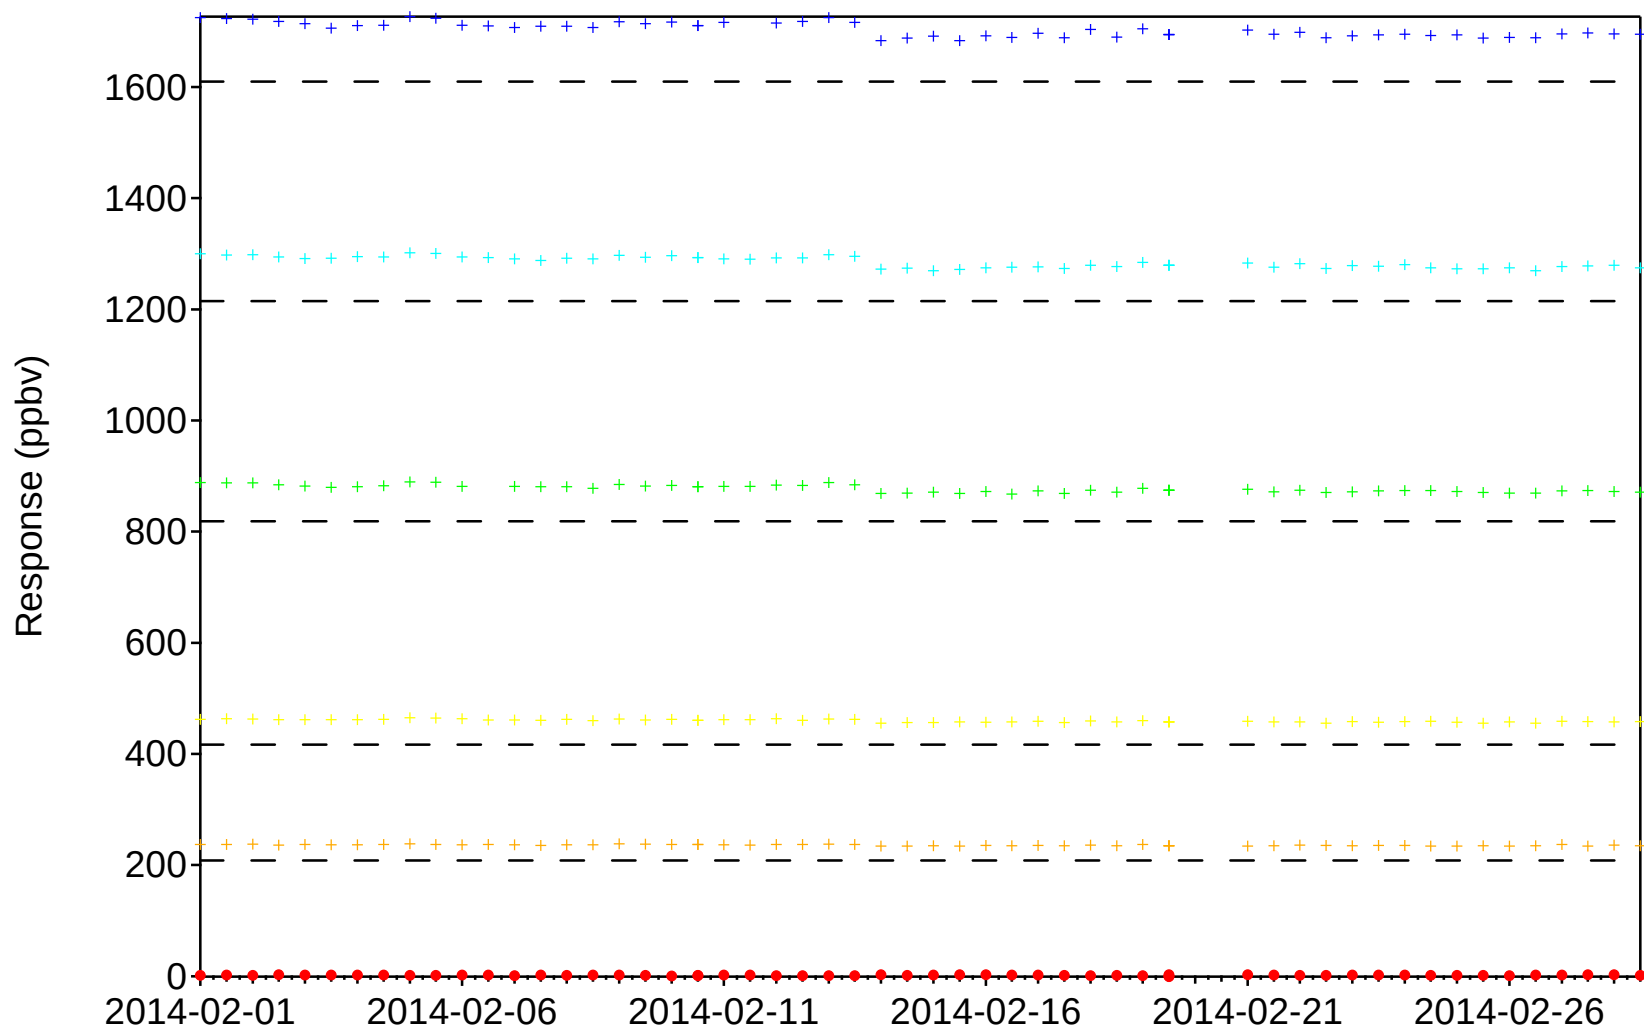
# TEI Model 49i UV Photometric Ozone Analyzer Zero/Span Checks

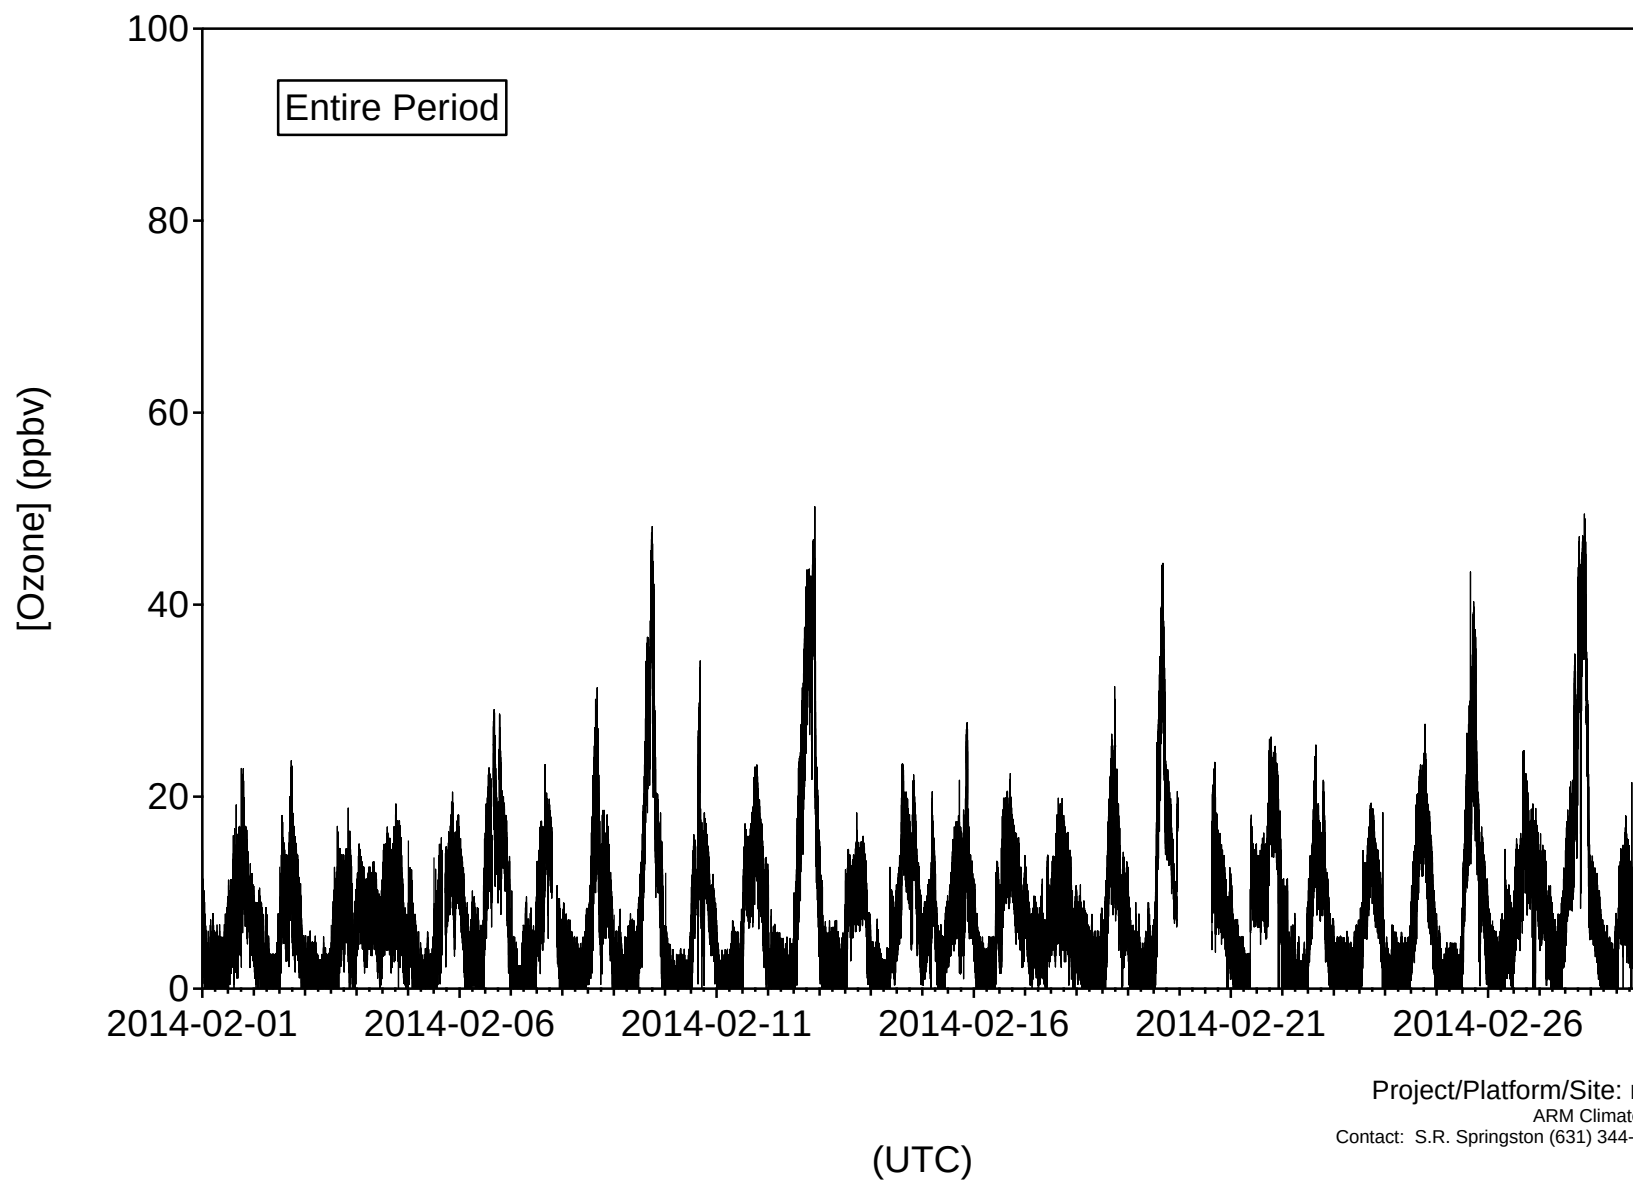
TEI Model 49i UV Photometric Ozone Analyzer  
Baseline Corrected

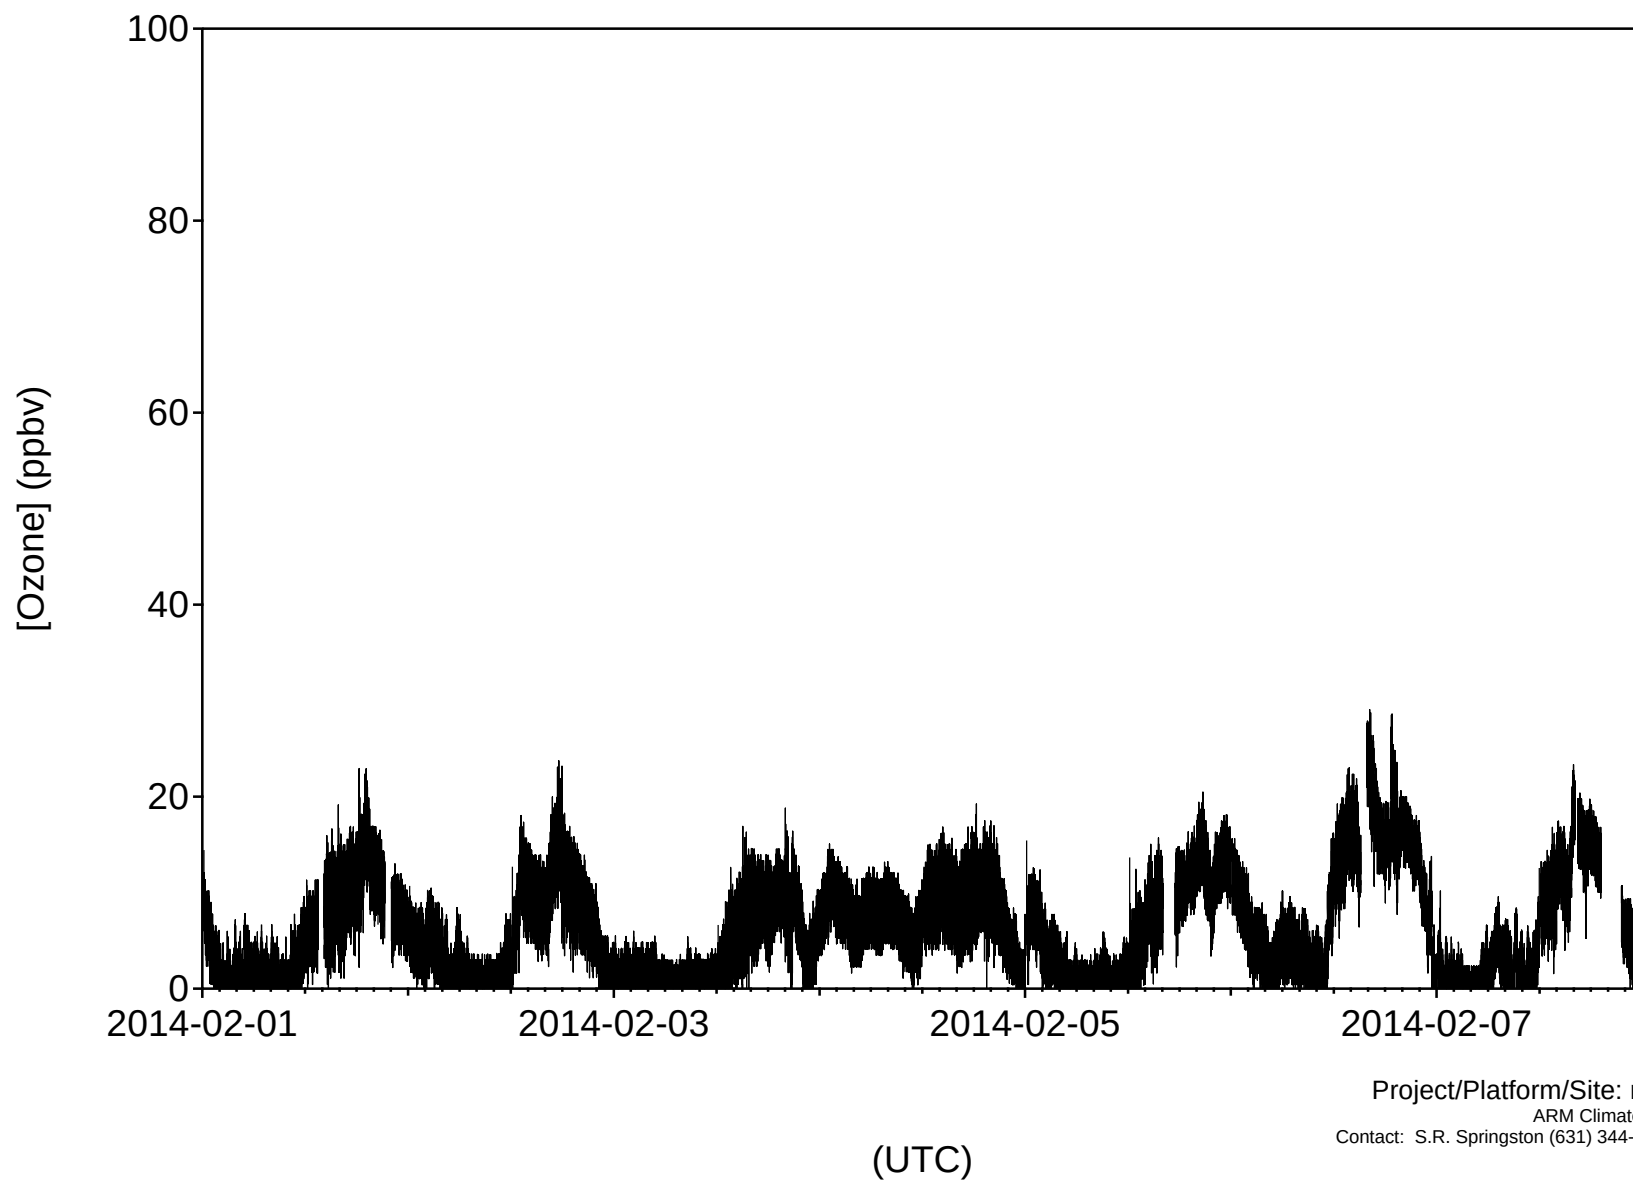
TEI Model 49i UV Photometric Ozone Analyzer  
Baseline Corrected

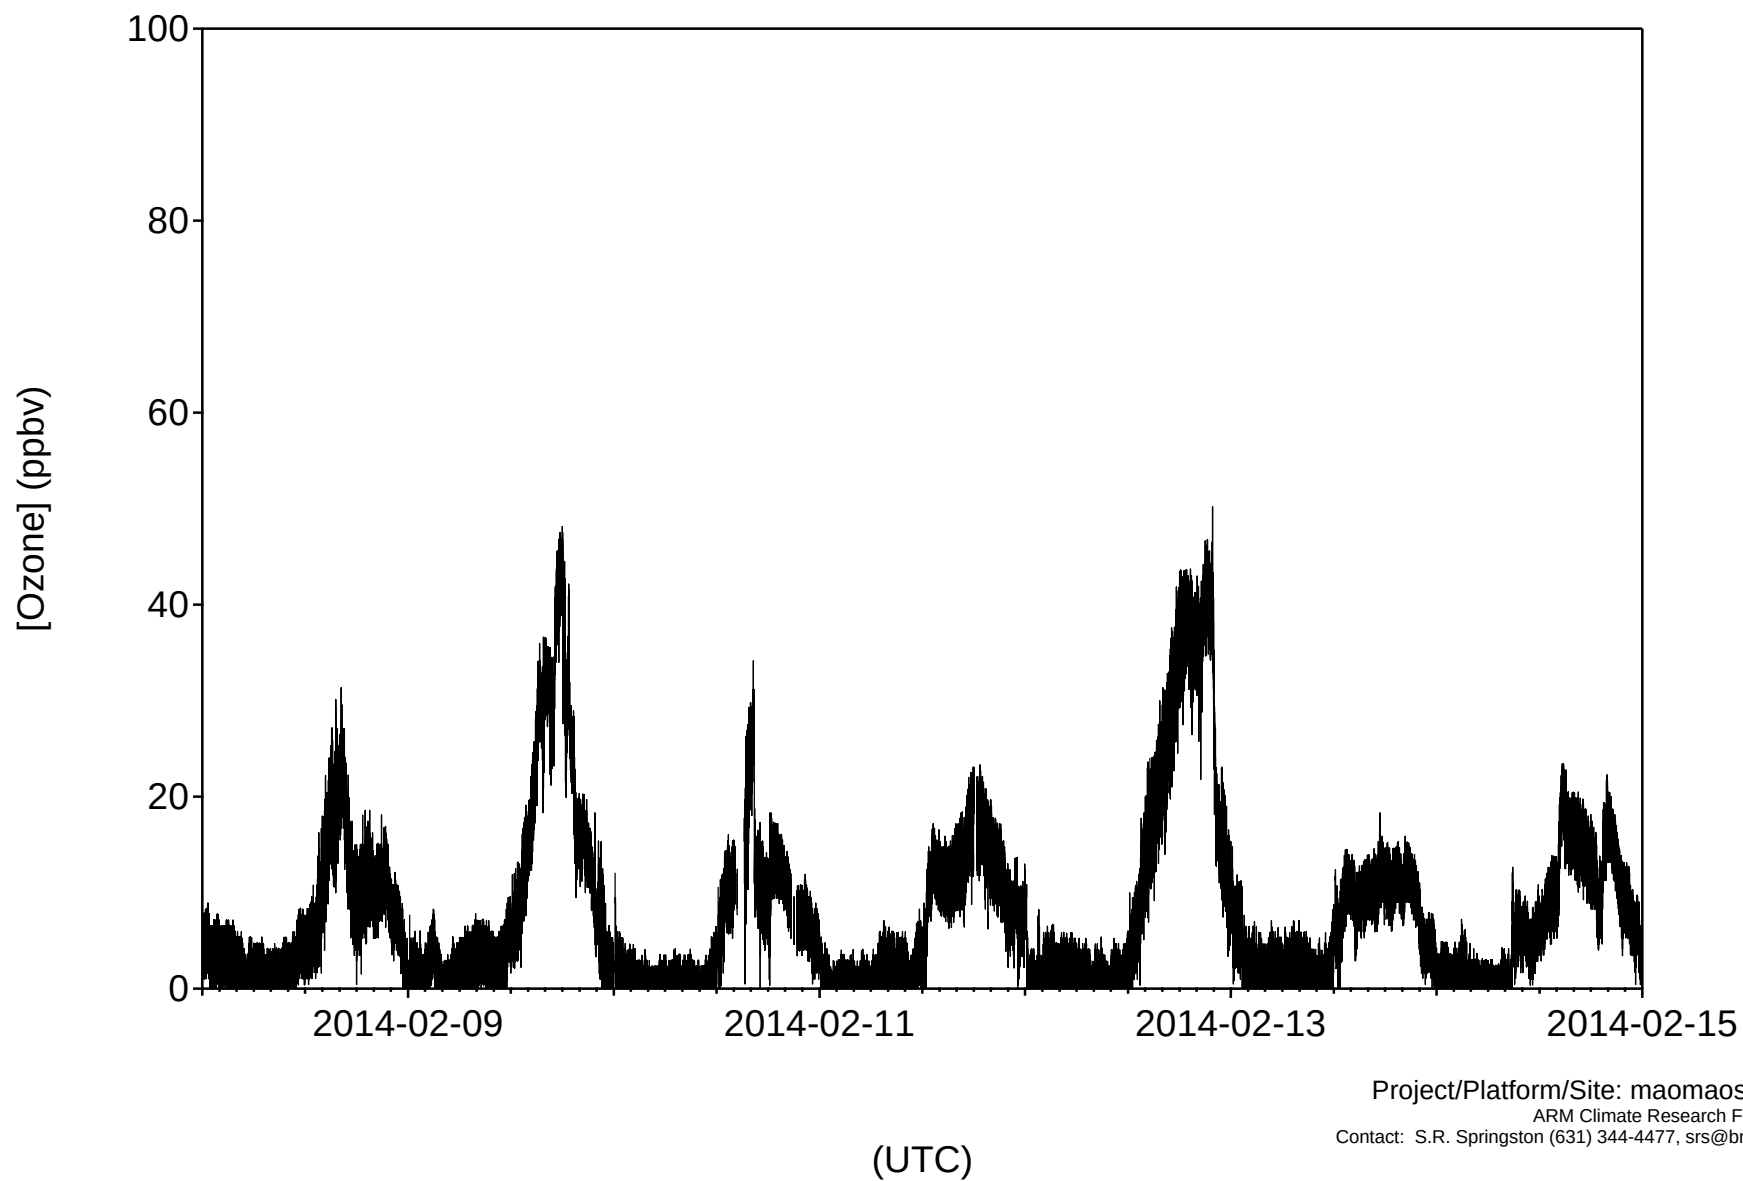
TEI Model 49i UV Photometric Ozone Analyzer  
Baseline Corrected

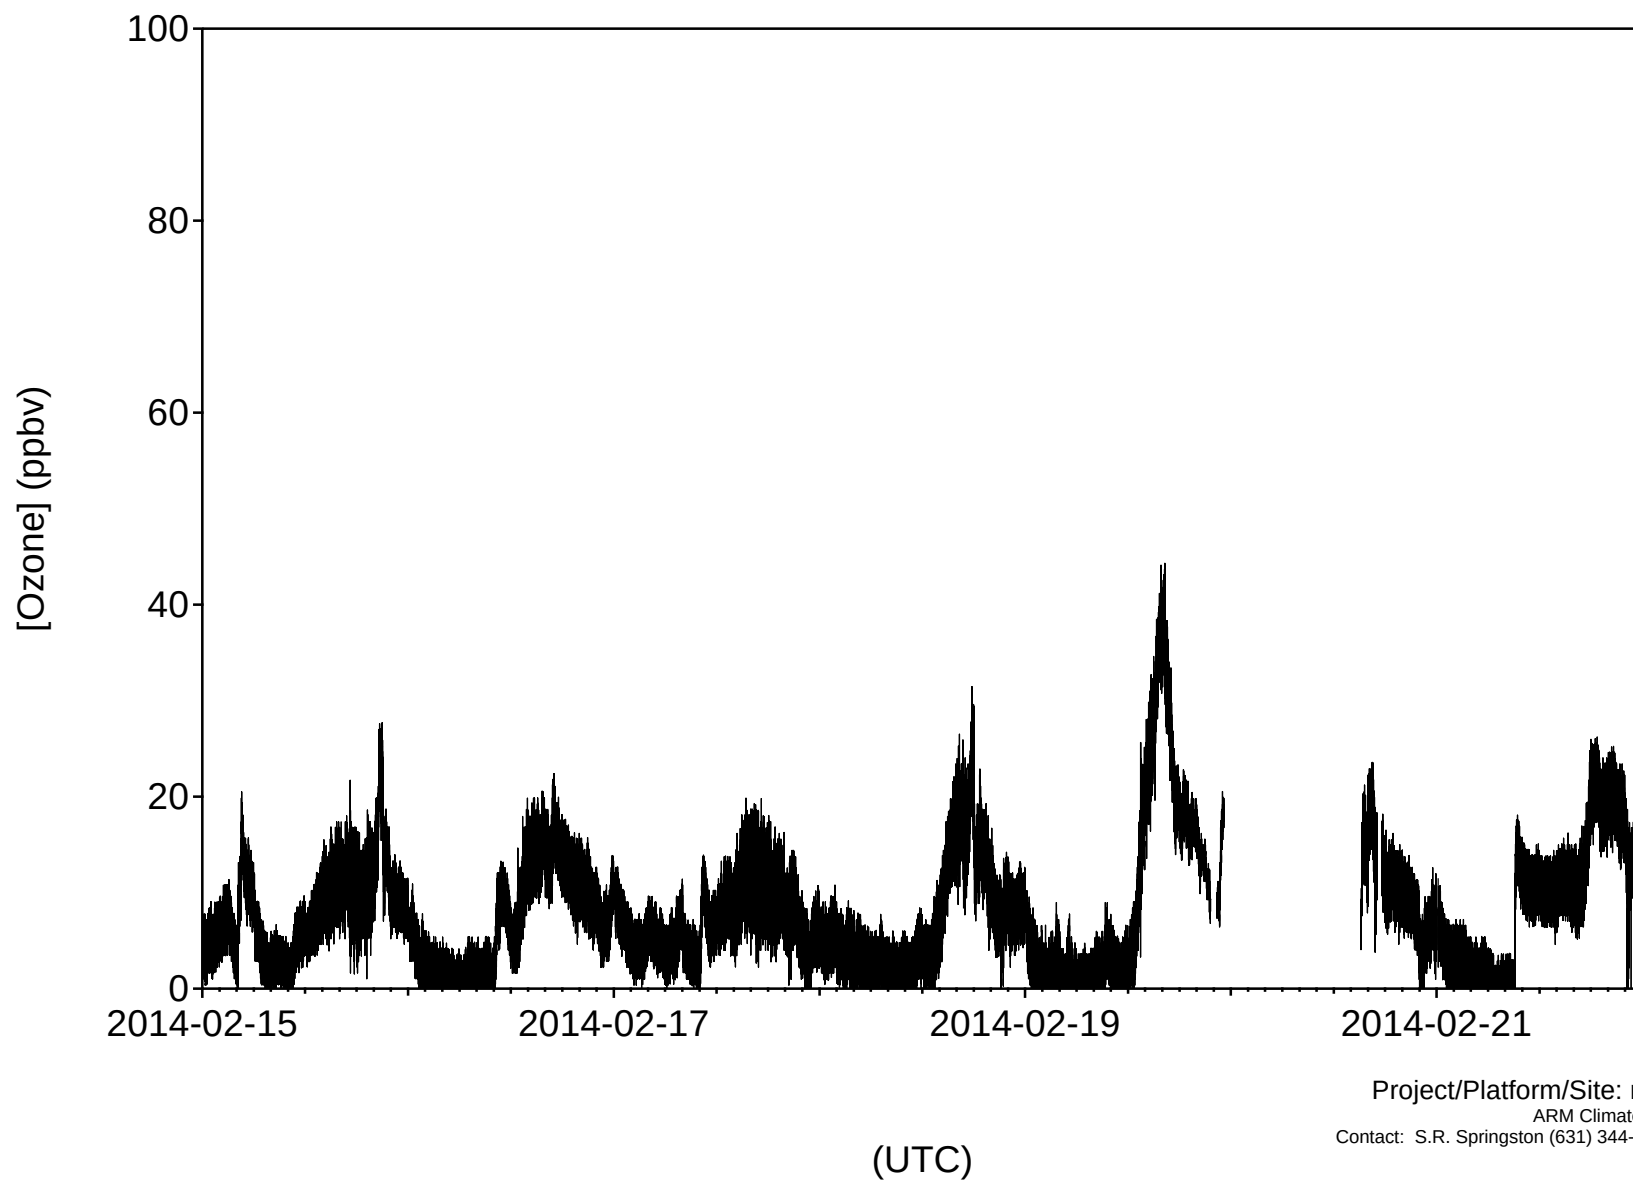
TEI Model 49i UV Photometric Ozone Analyzer  
Baseline Corrected

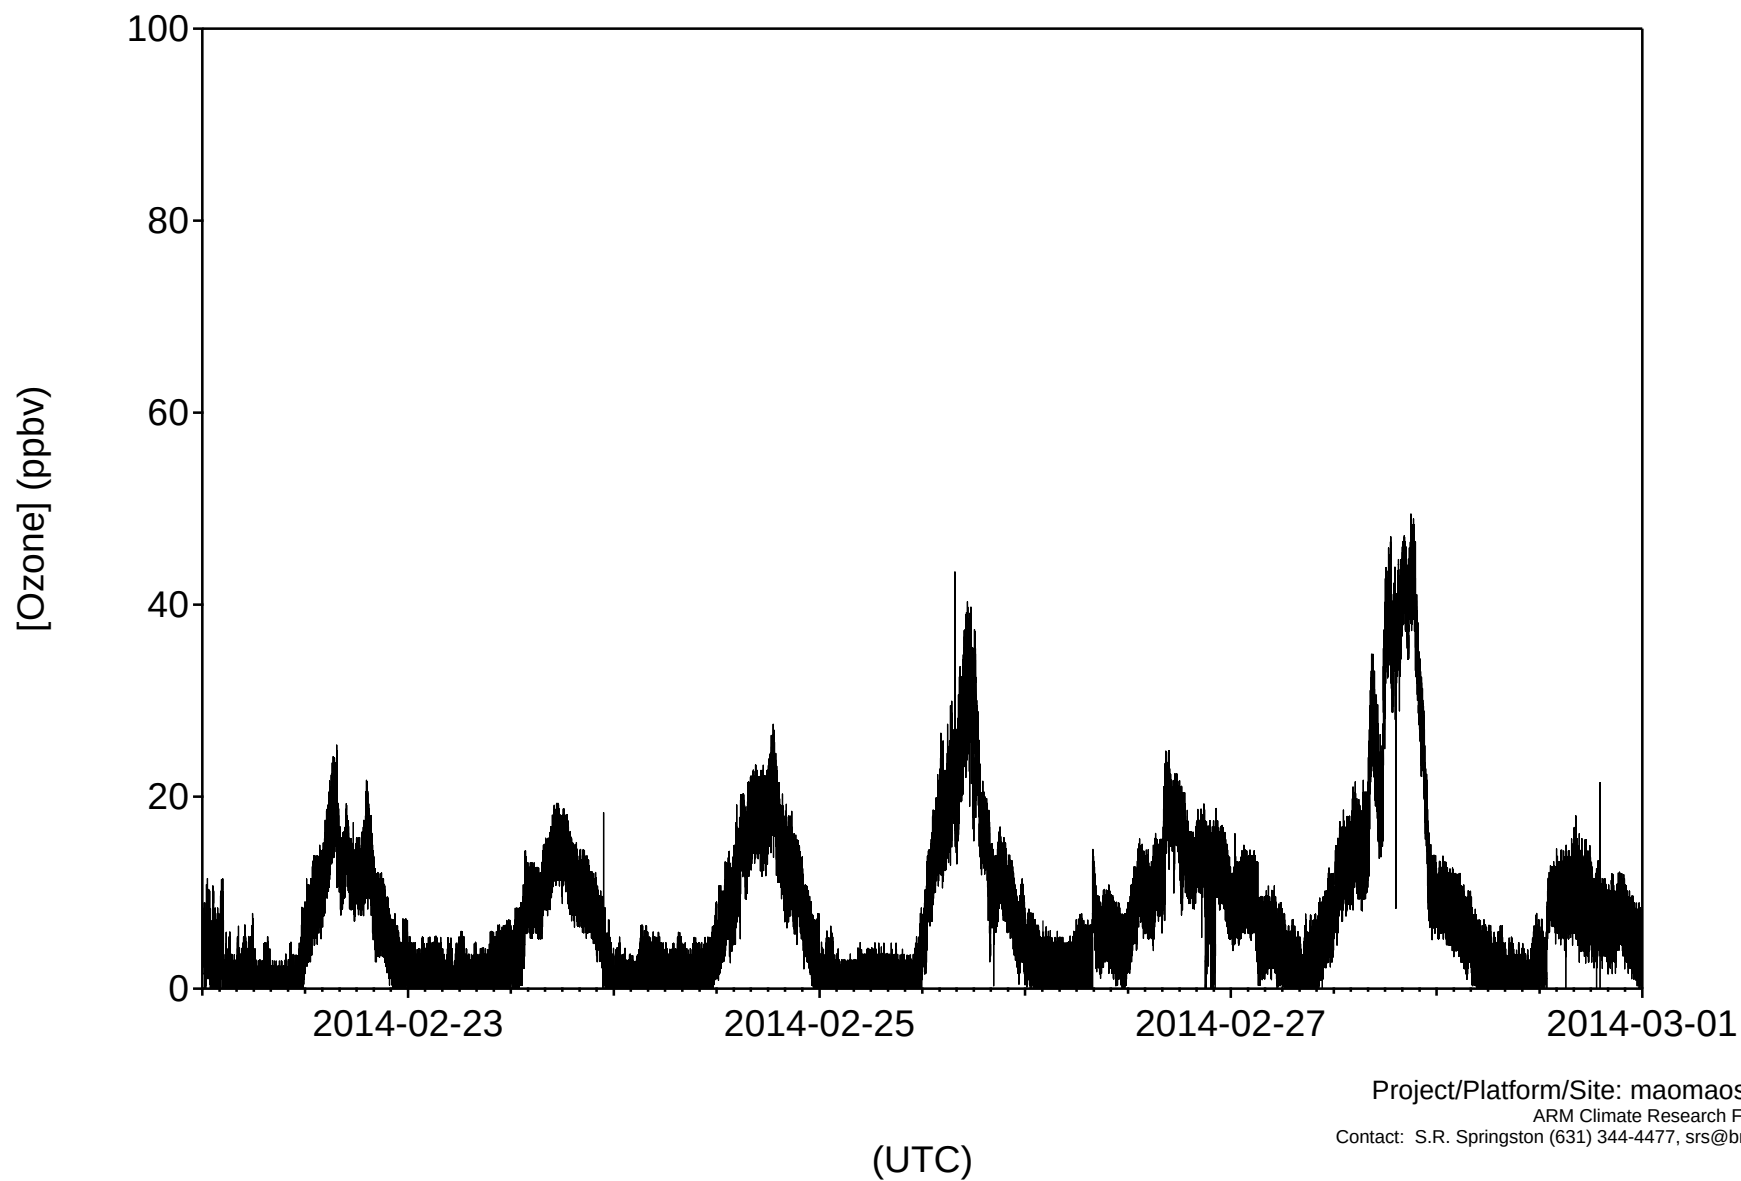
TEI Model 49i UV Photometric Ozone Analyzer  
Baseline Corrected
