Loading 9/1/2014 - 10/1/2014

# TEI Model 49i UV Photometric Ozone Analyzer

Project/Platform/Site: maomaoscs1  
ARM Climate Research Facility  
Contact: S.R. Springston (631) 344-4477, srs@bnl.gov

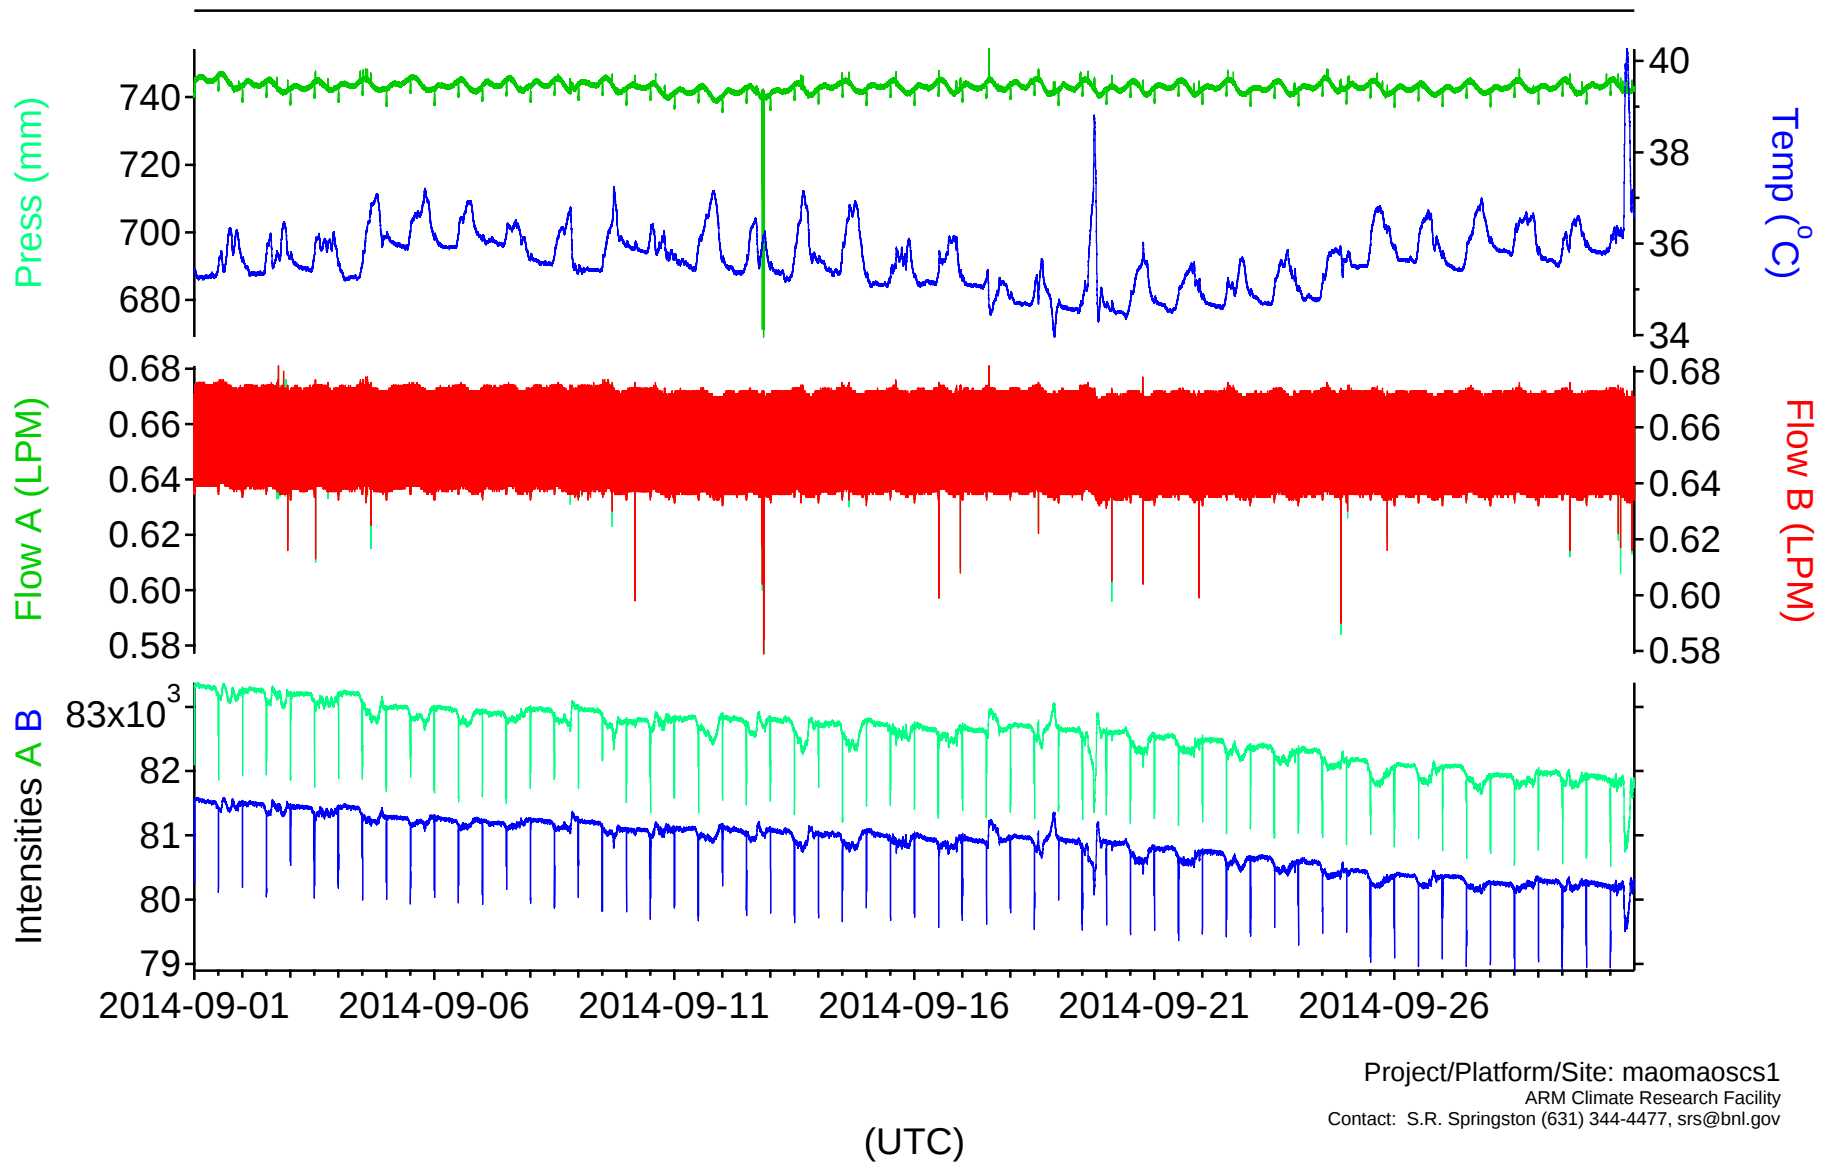
TEI Model 49i UV Photometric Ozone Analyzer  
Housekeeping

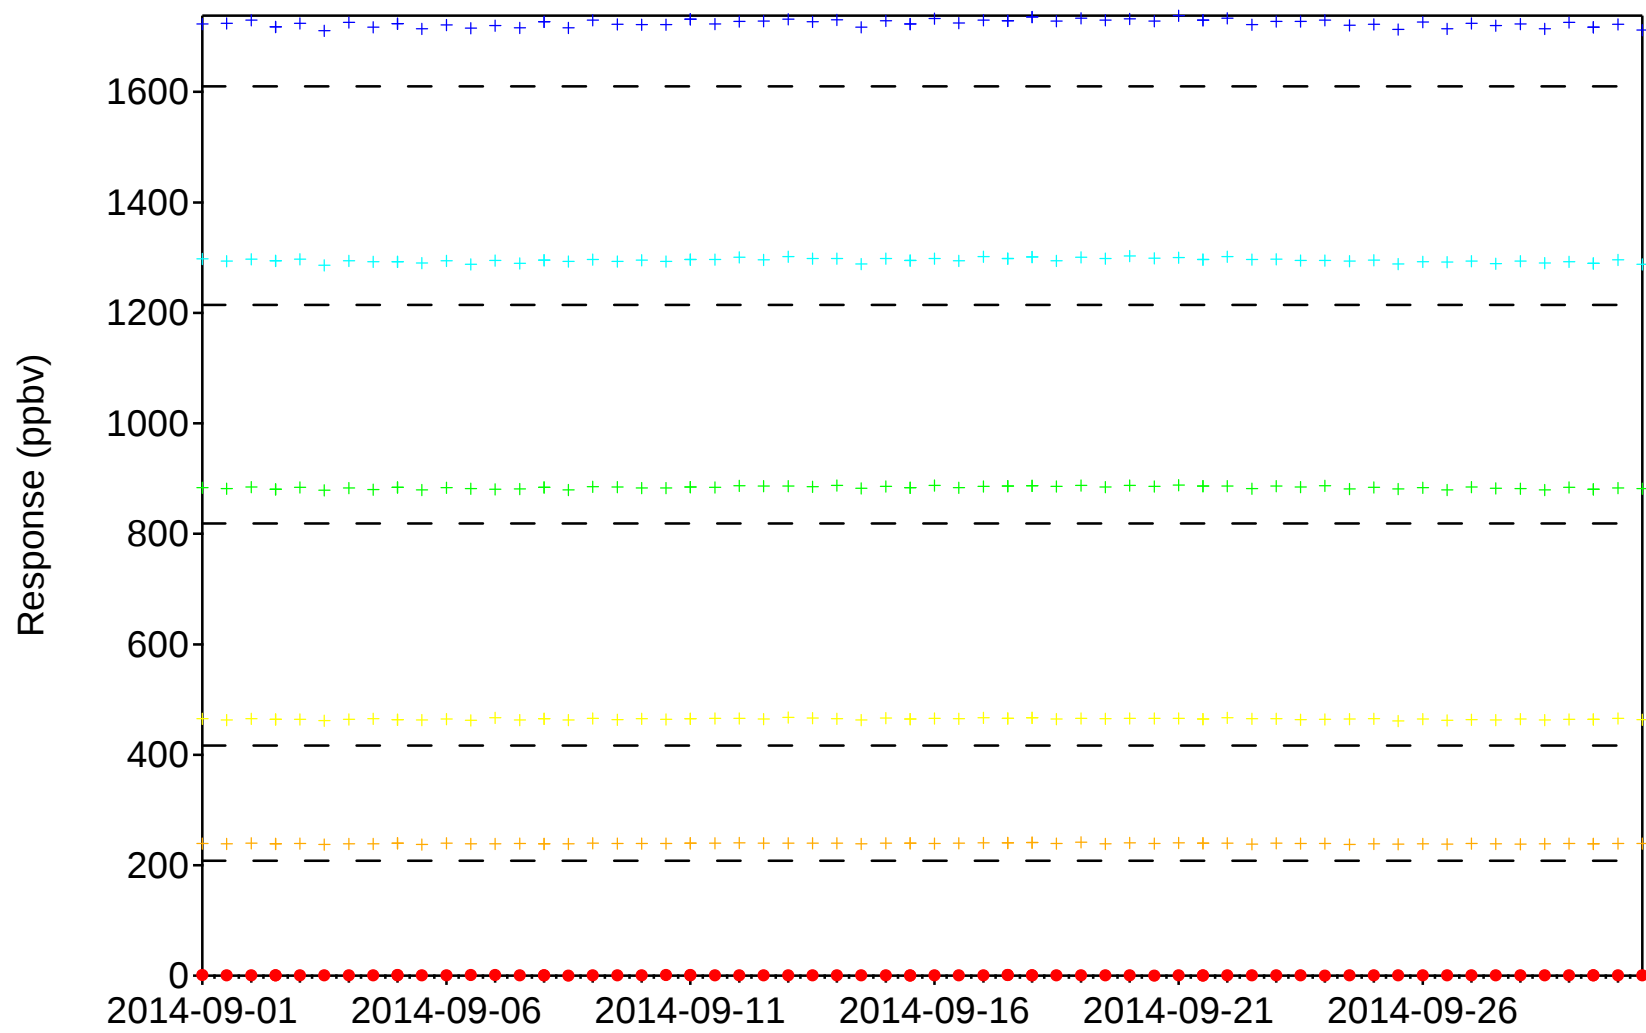
# TEI Model 49i UV Photometric Ozone Analyzer Zero/Span Checks

Data appear normal and reliable. Internal calibrations consistent and very stable.

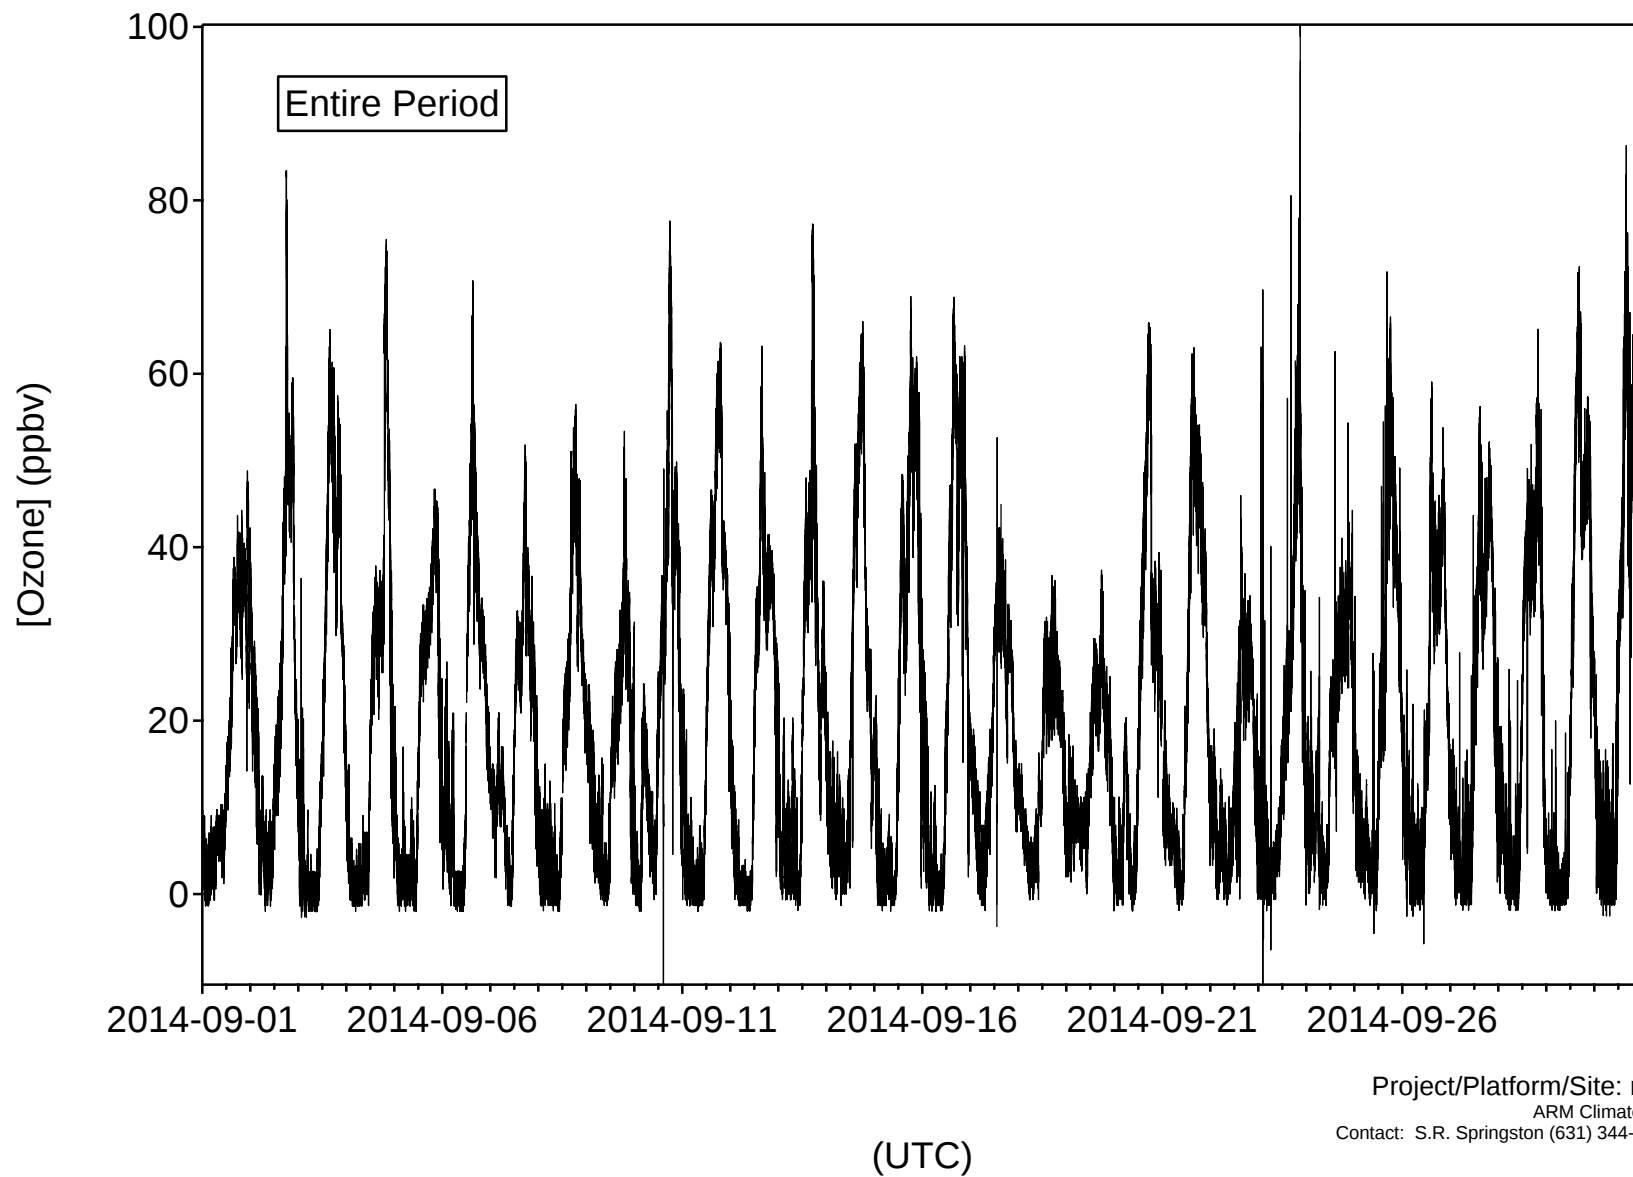
TEI Model 49i UV Photometric Ozone Analyzer  
Baseline Corrected

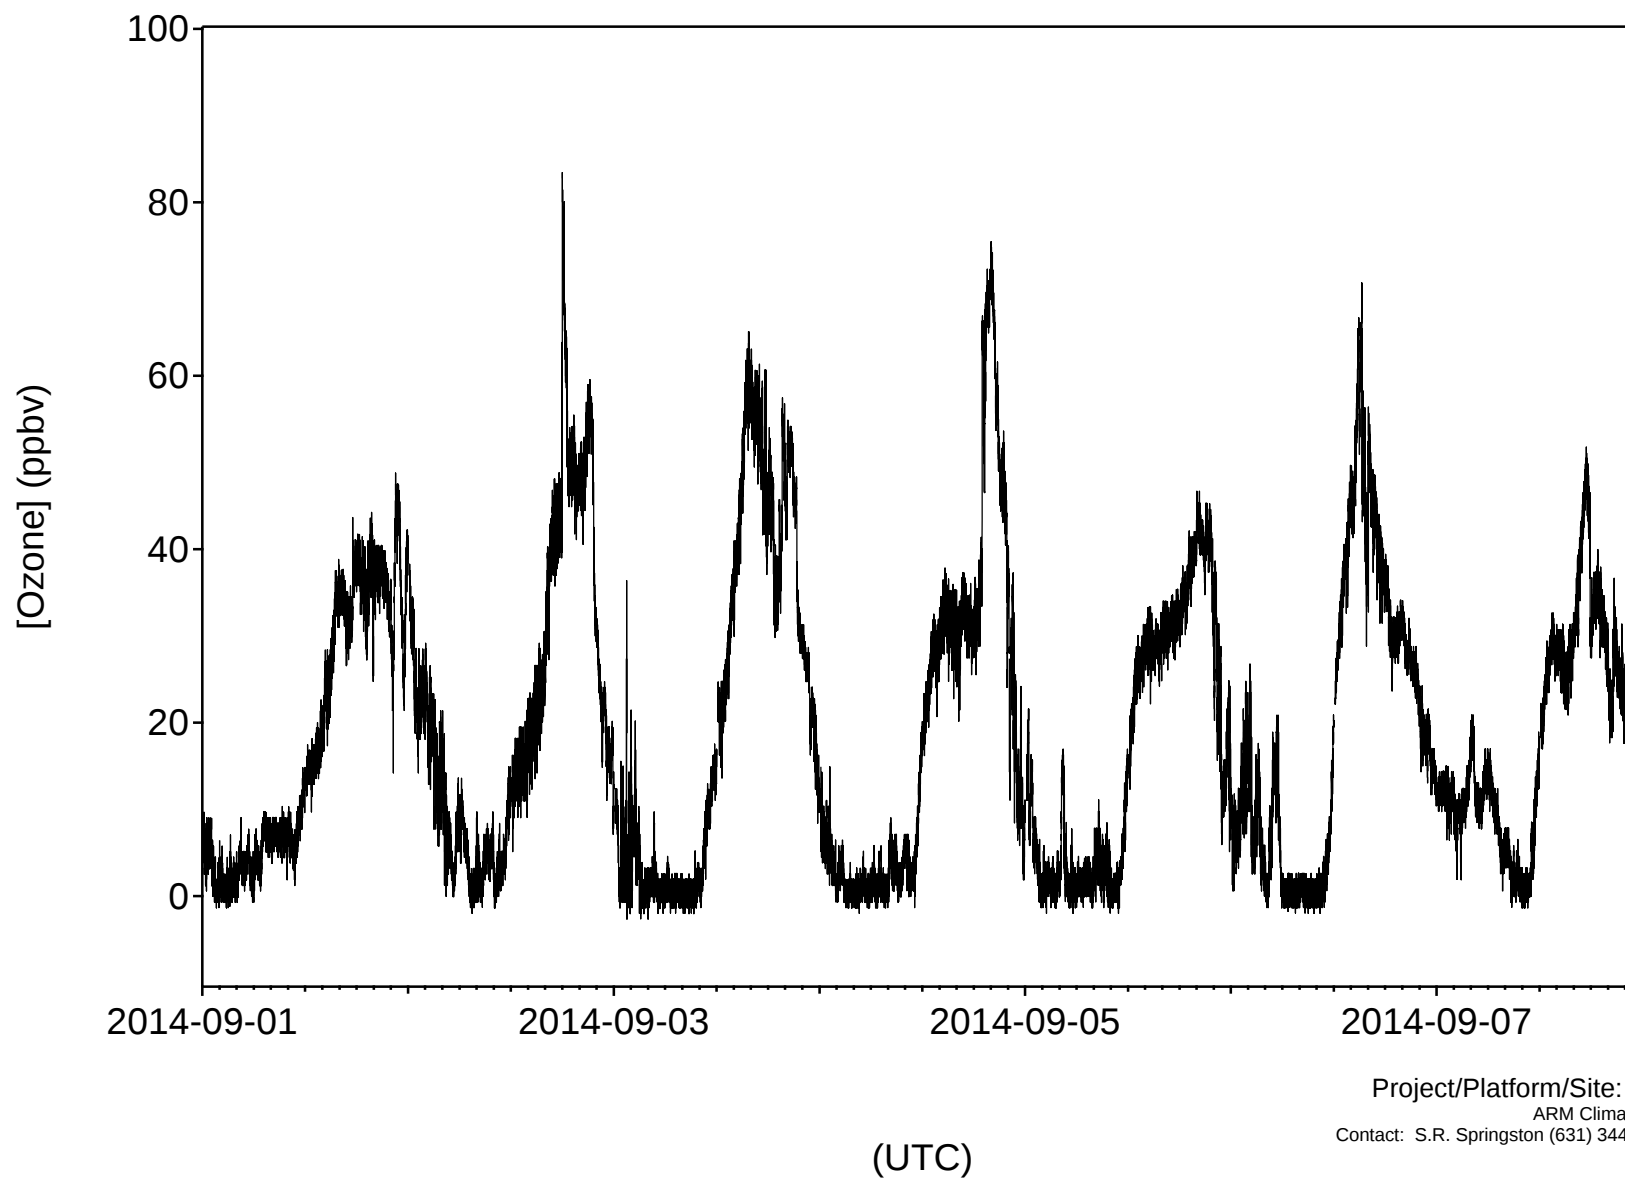
TEI Model 49i UV Photometric Ozone Analyzer  
Baseline Corrected

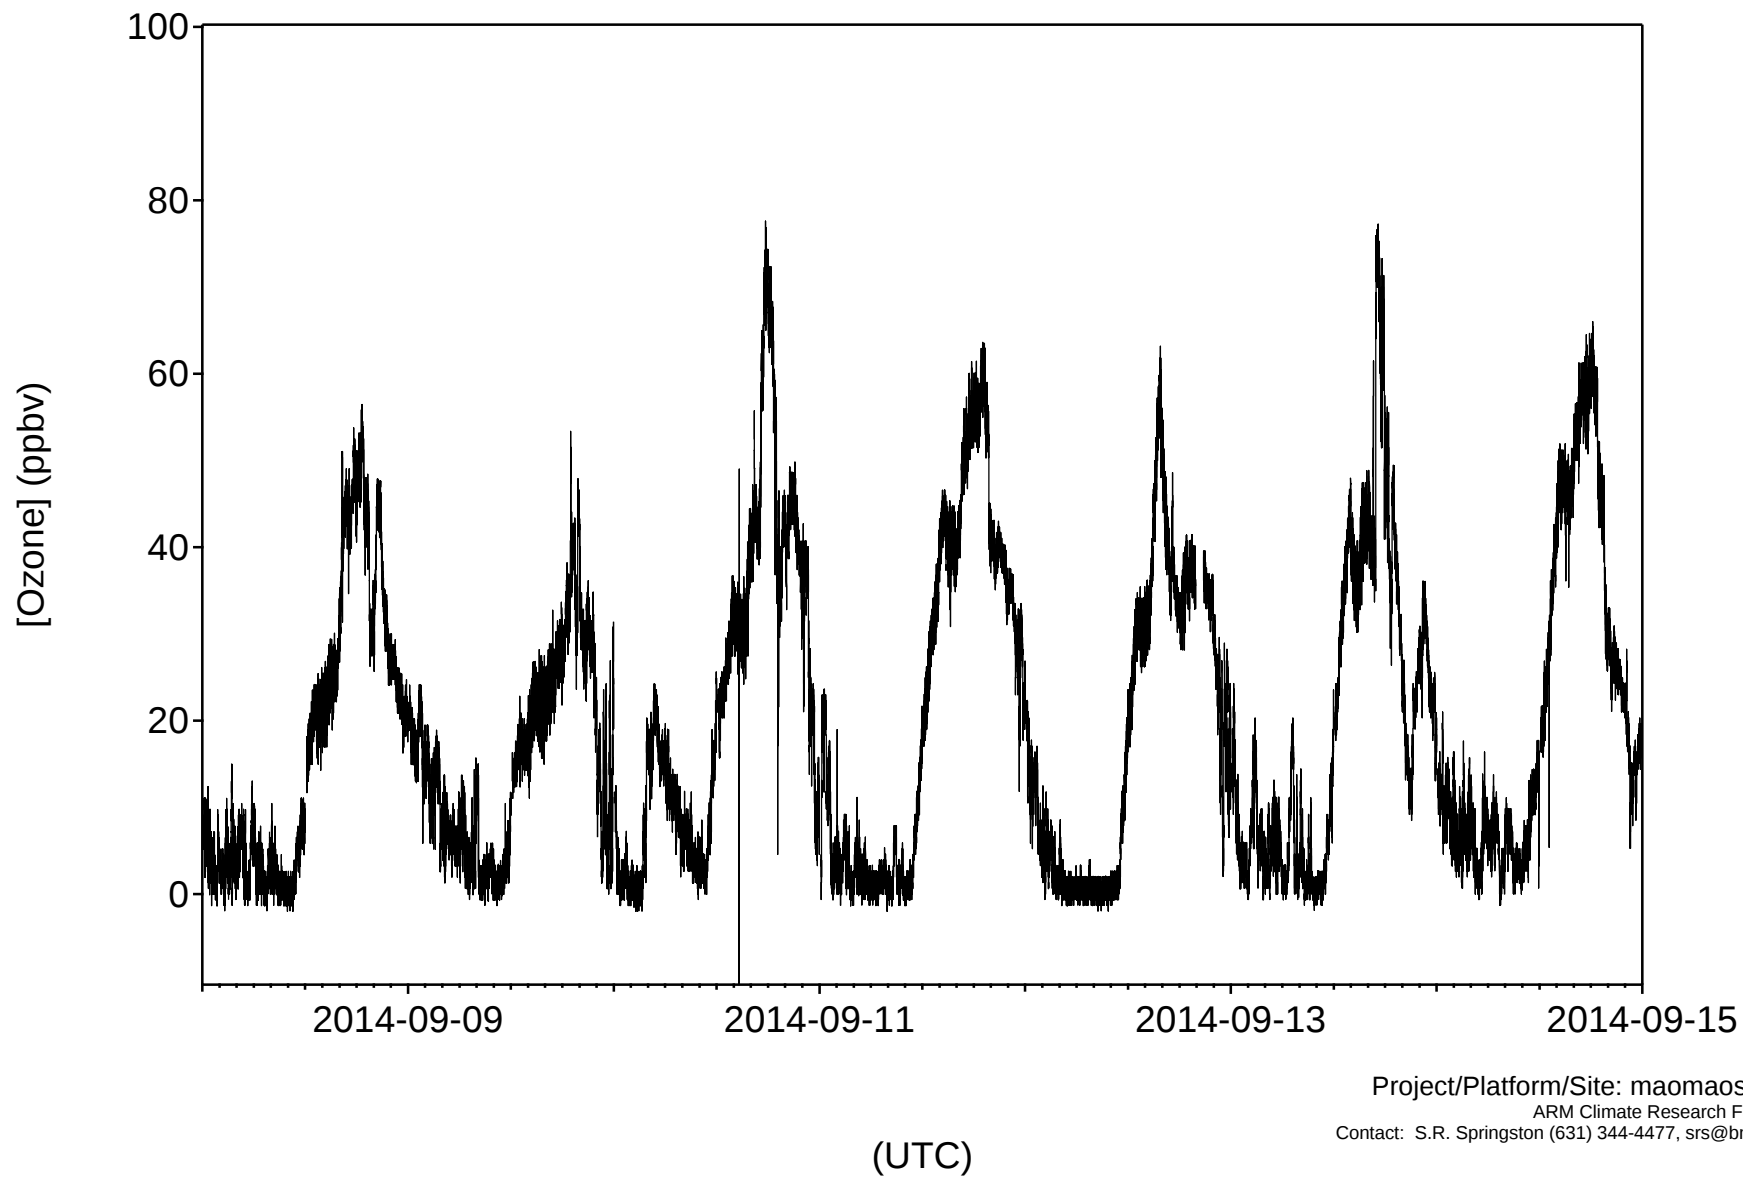
TEI Model 49i UV Photometric Ozone Analyzer  
Baseline Corrected

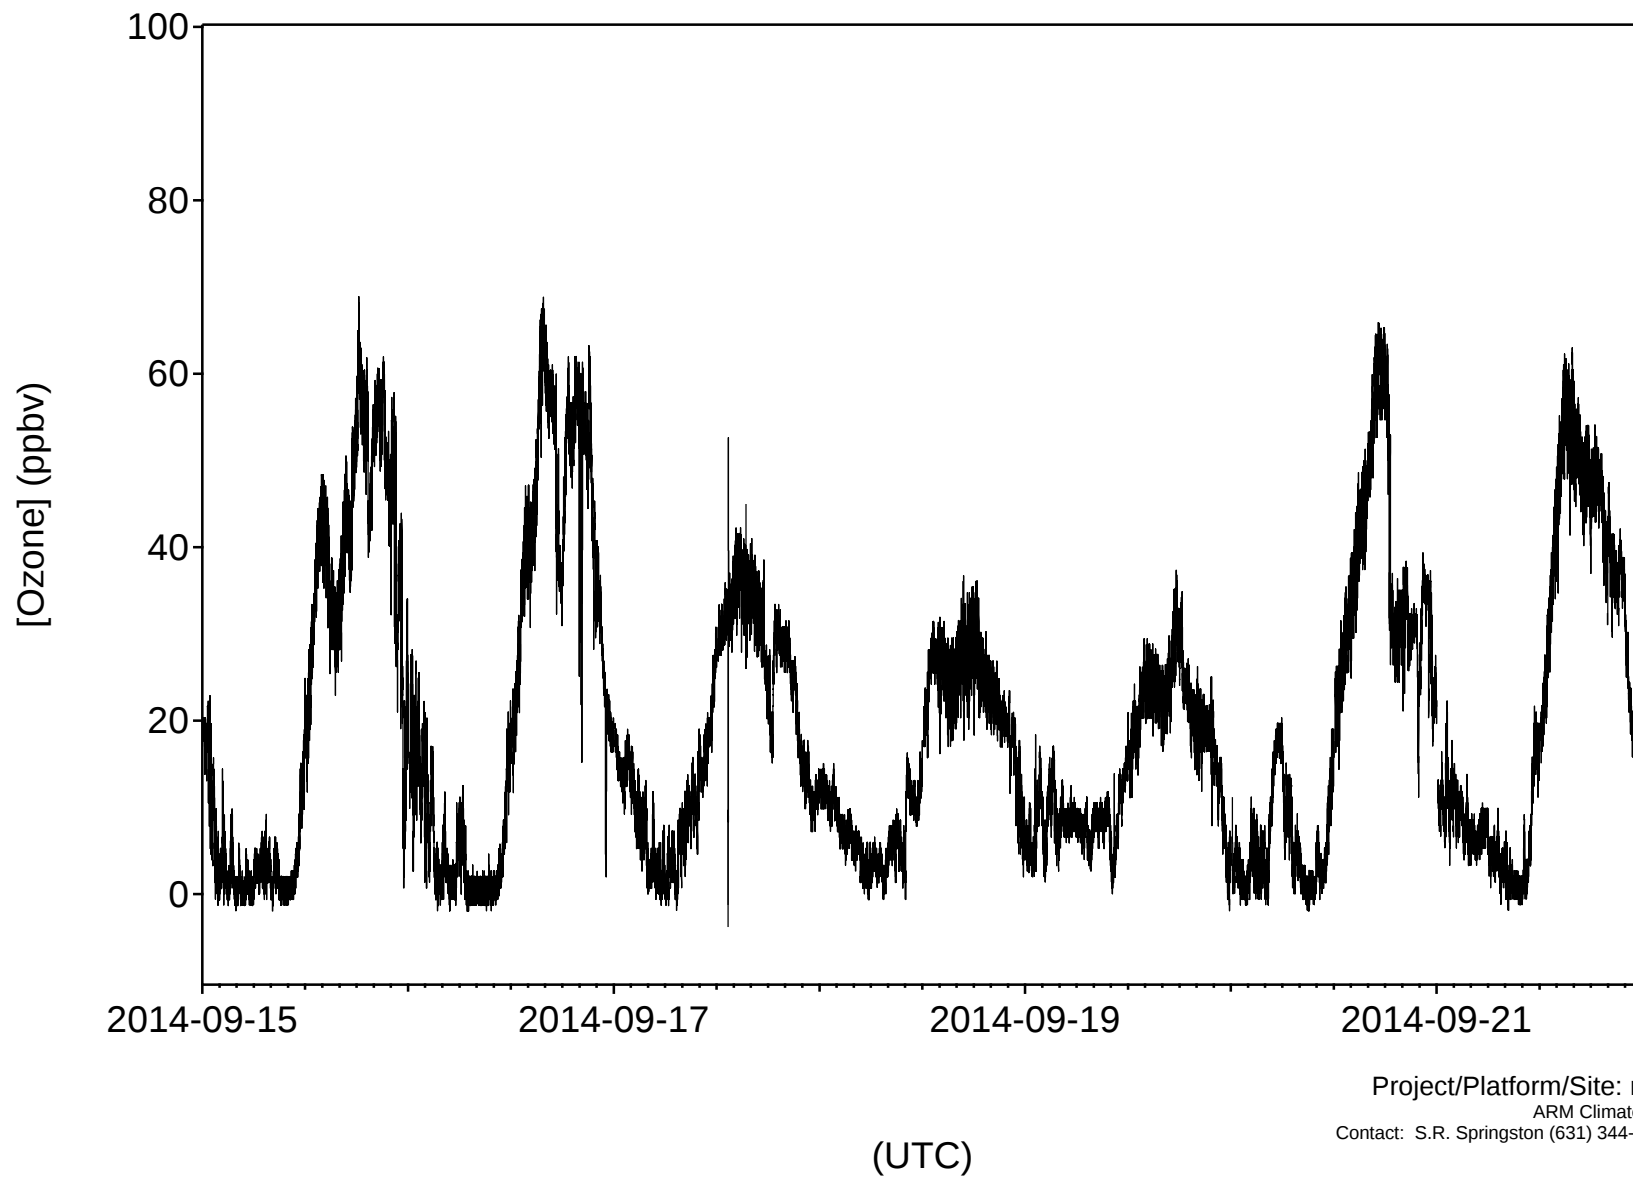
TEI Model 49i UV Photometric Ozone Analyzer  
Baseline Corrected

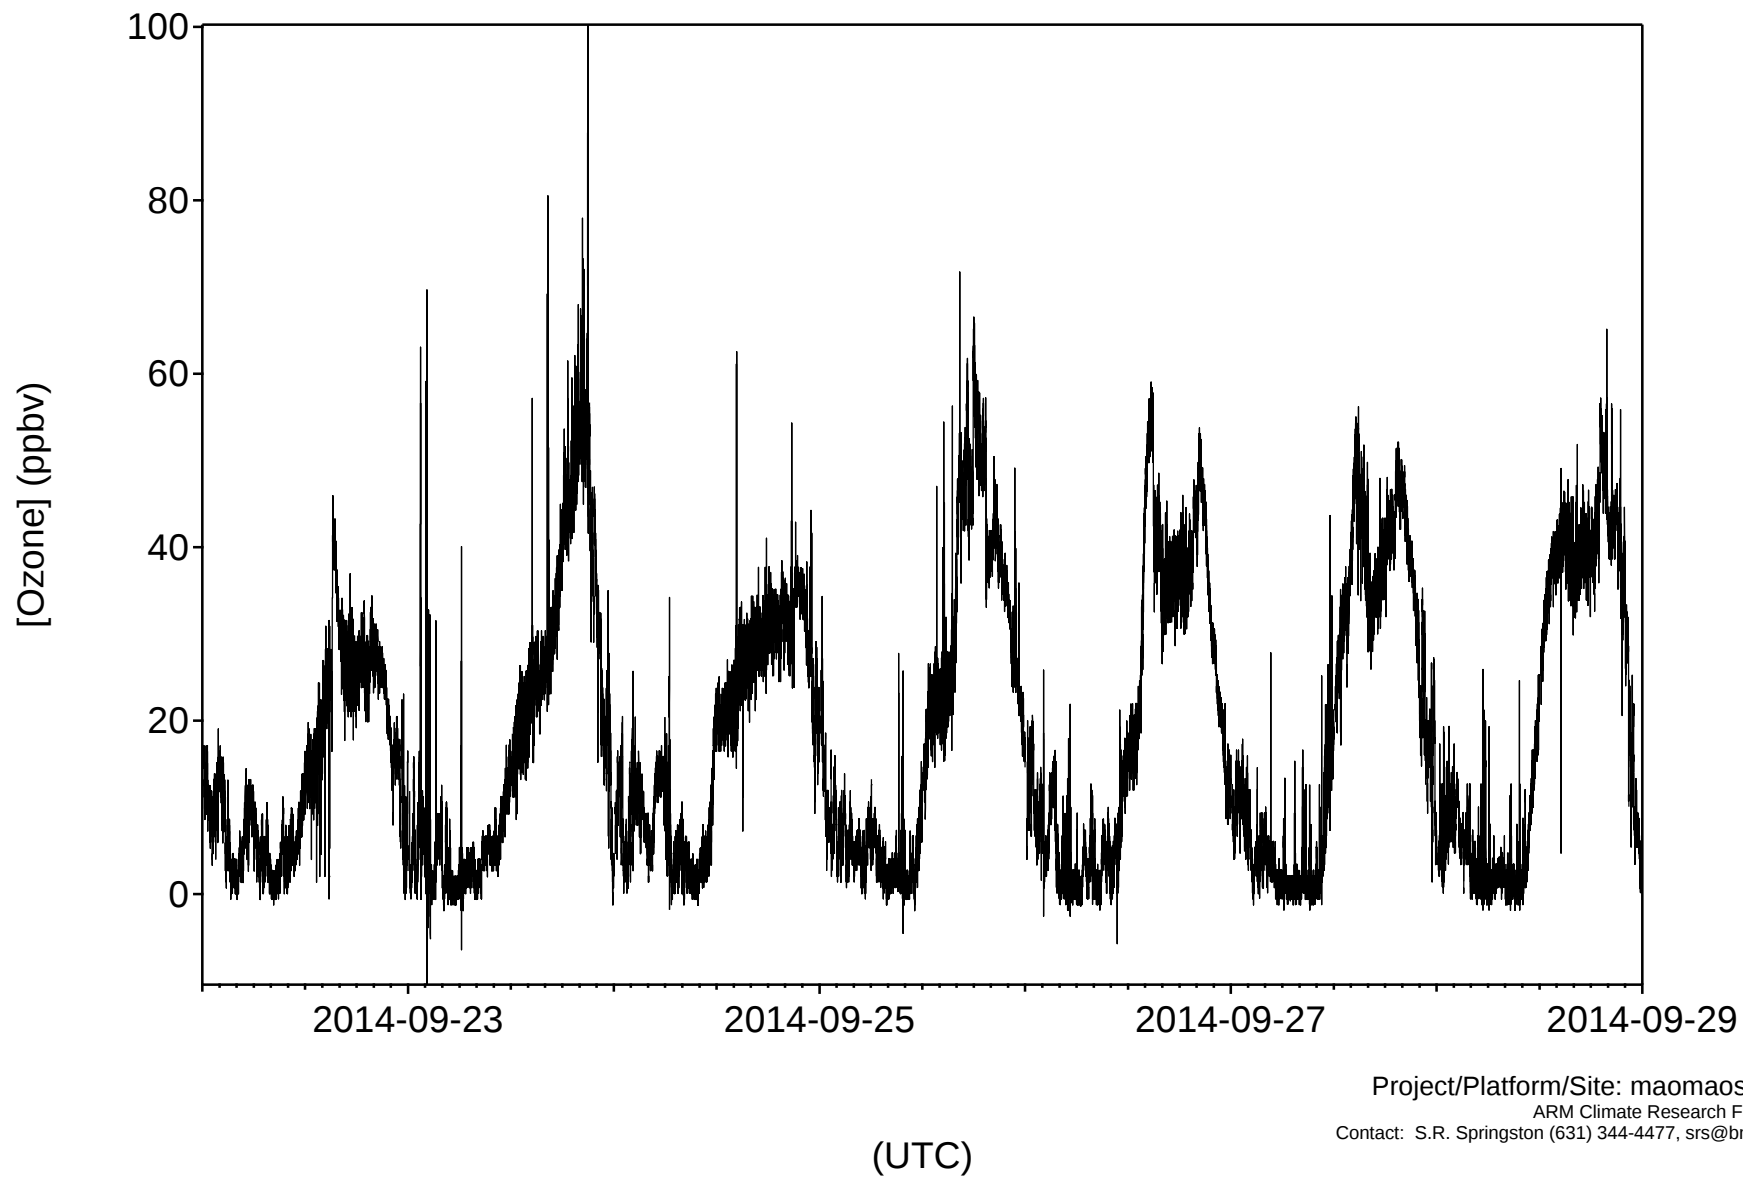
TEI Model 49i UV Photometric Ozone Analyzer  
Baseline Corrected

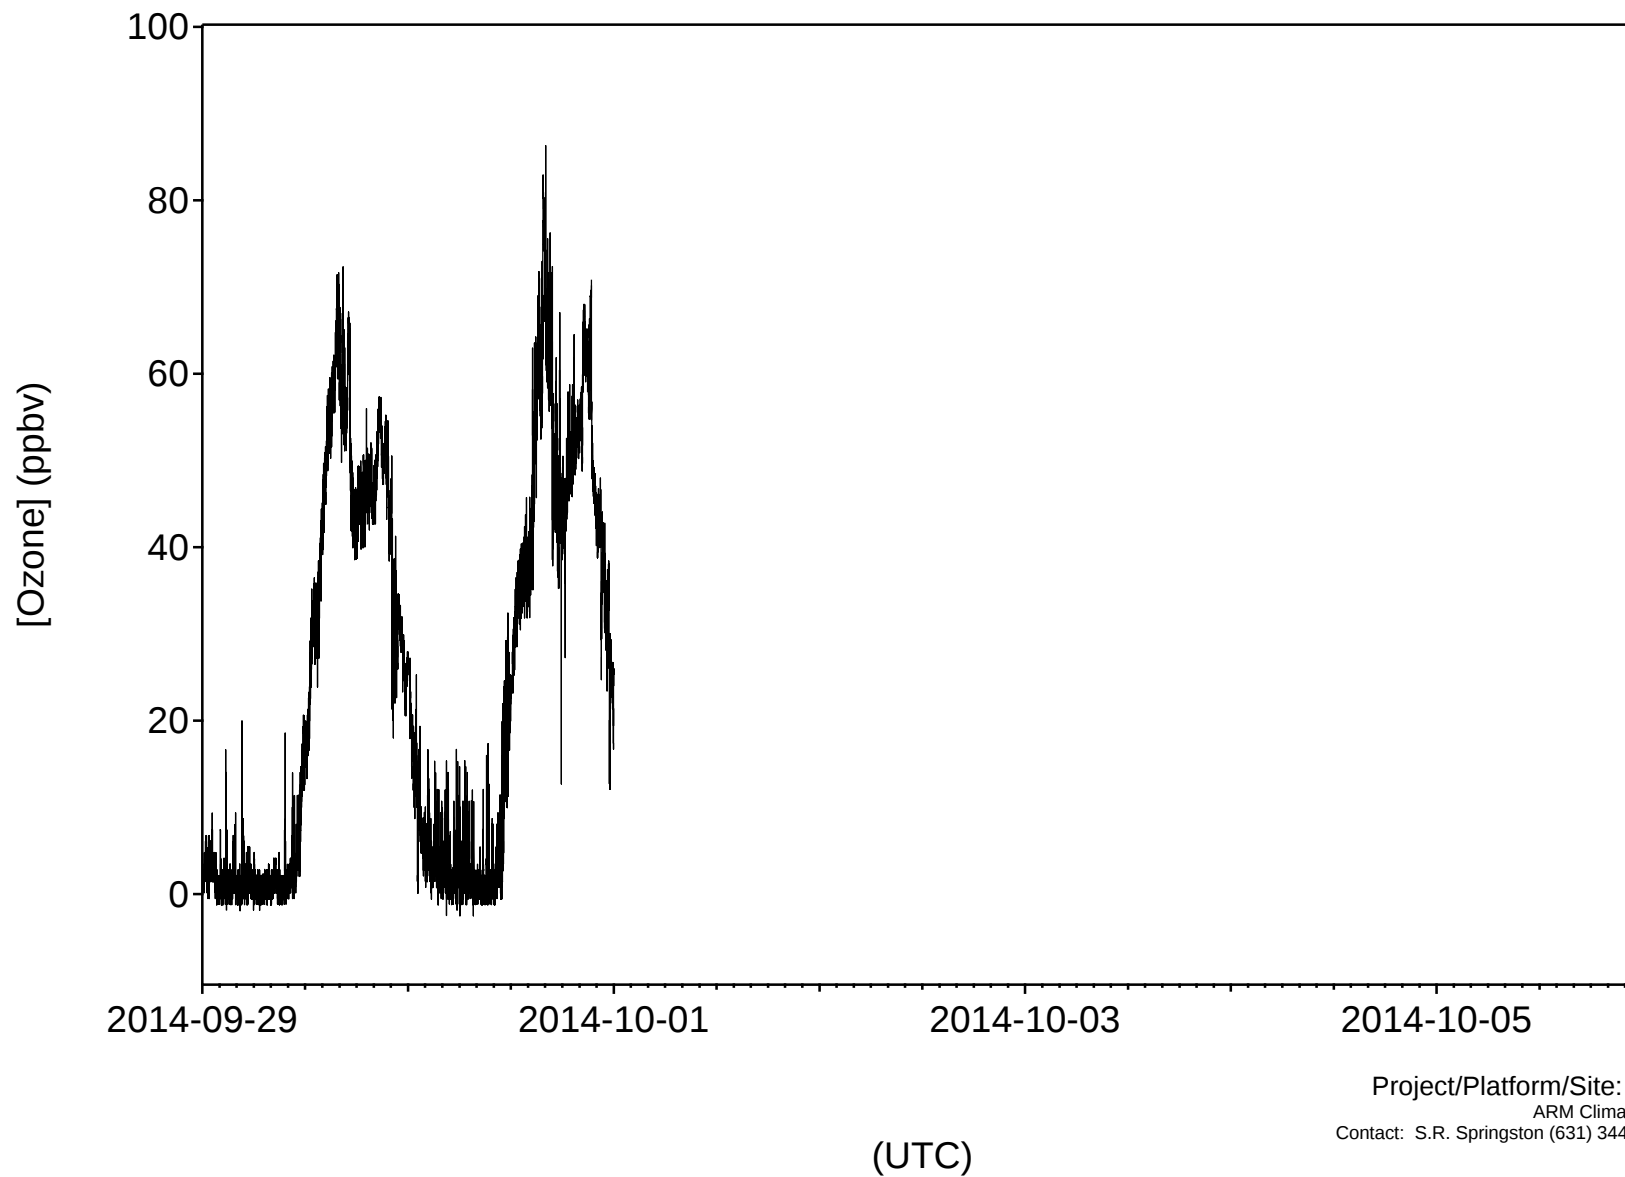
TEI Model 49i UV Photometric Ozone Analyzer  
Baseline Corrected
