Loading 10/1/2014 - 11/1/2014

# TEI Model 49i UV Photometric Ozone Analyzer

Project/Platform/Site: maomaoscs1  
ARM Climate Research Facility  
Contact: S.R. Springston (631) 344-4477, srs@bnl.gov

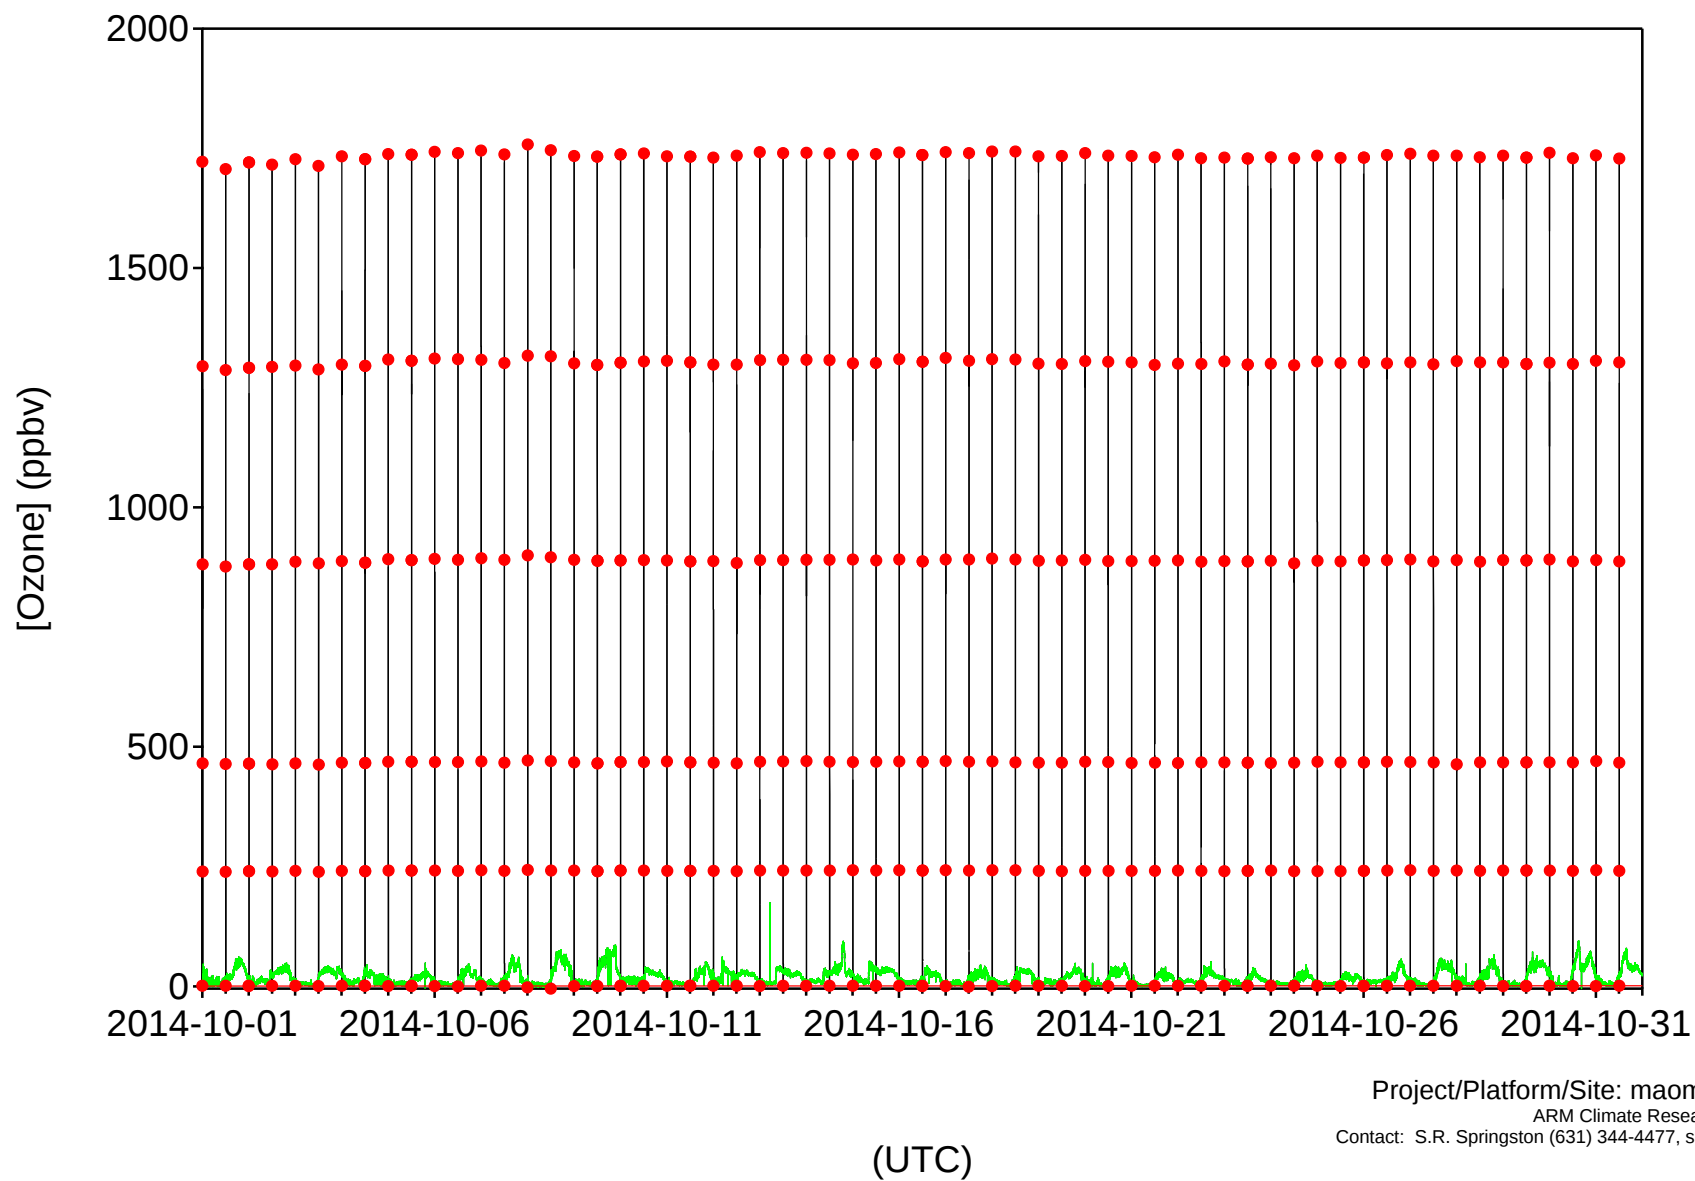
Data appear normal and reliable. Internal calibrations consistent and very stable.

Several short (4-s) data spikes of unknown origin.
