Loading 2015-04-01 - 2015-05-01  
Data loaded from DMF (detarred, unzipped and names restored)

# TEI Model 49i UV Photometric Ozone Analyzer

Project/Platform/Site: maomaoscs1  
ARM Climate Research Facility  
Contact: S.R. Springston (631) 344-4477, srs@bnl.gov

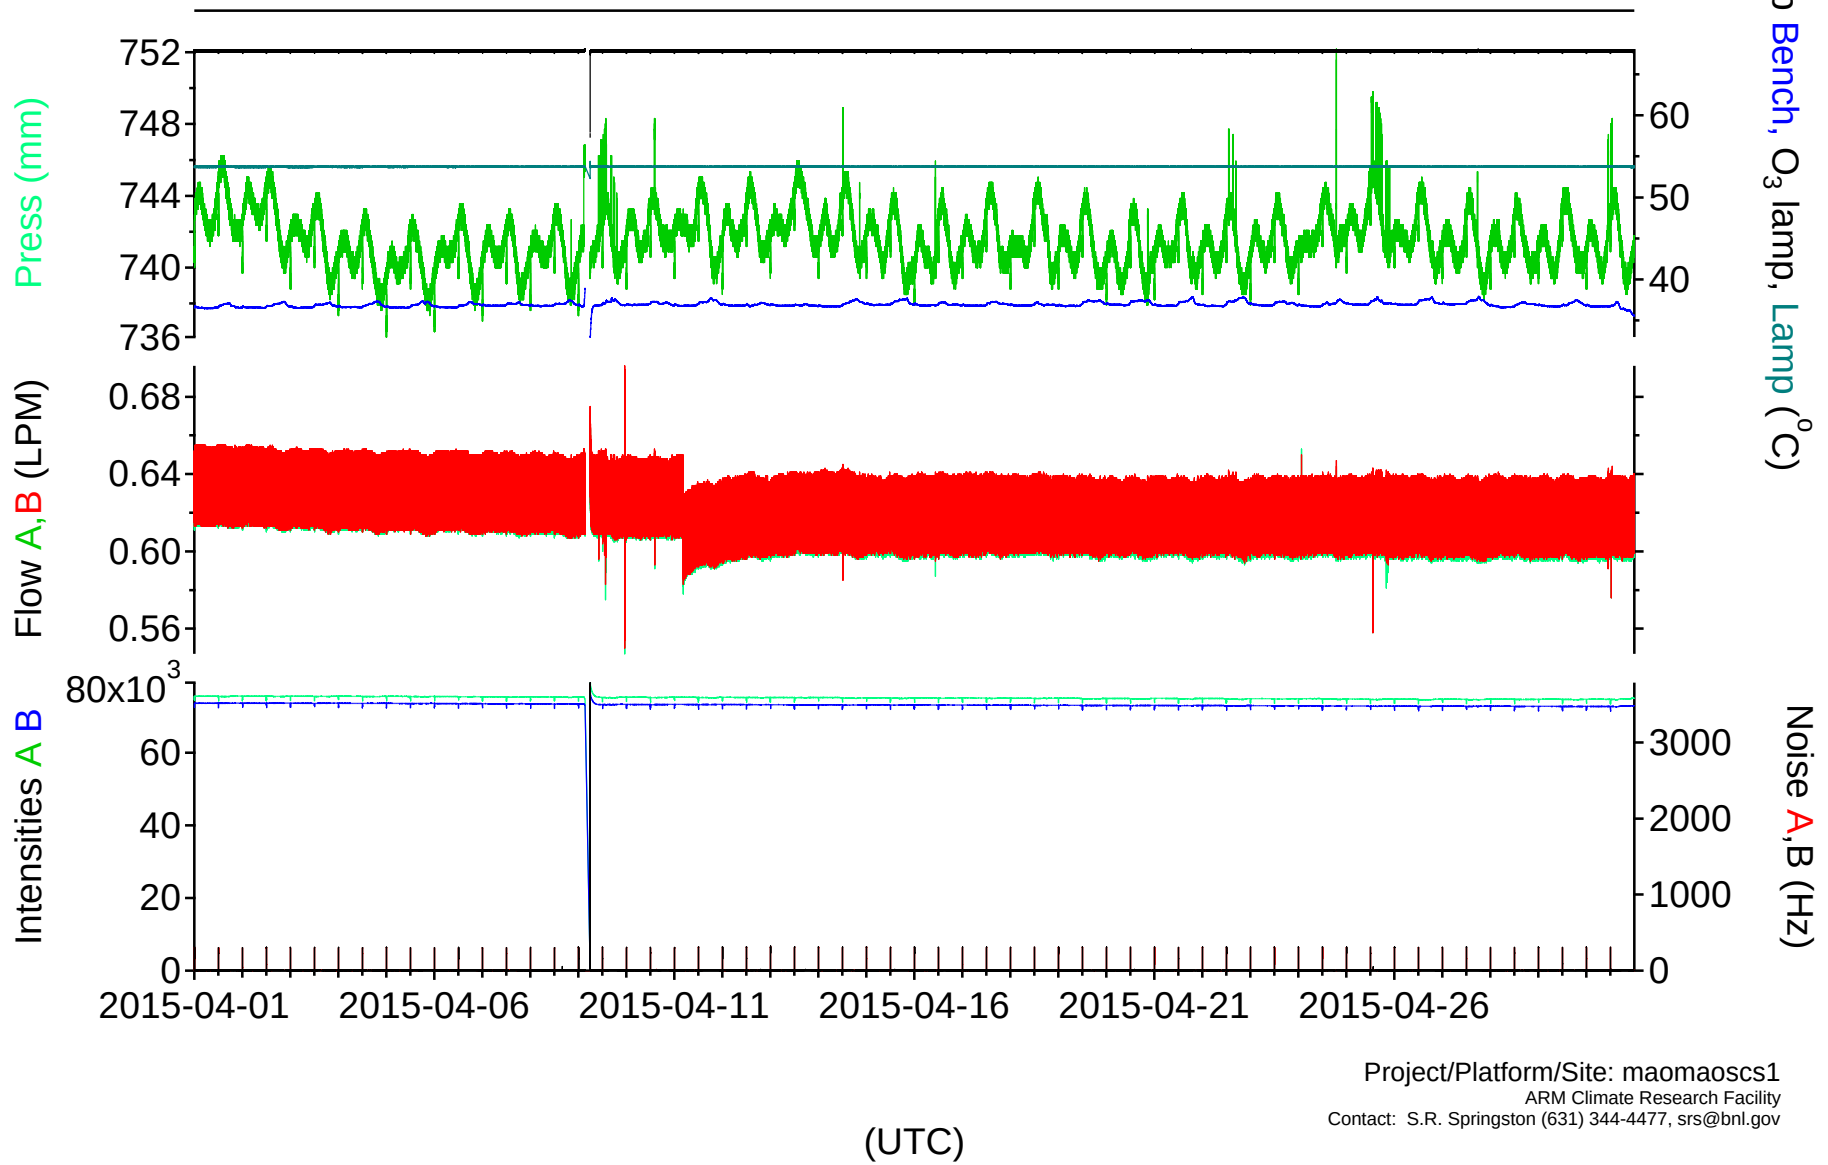
TEI Model 49i UV Photometric Ozone Analyzer  
Housekeeping

Data appear normal and reliable. Internal calibrations consistent and very stable.

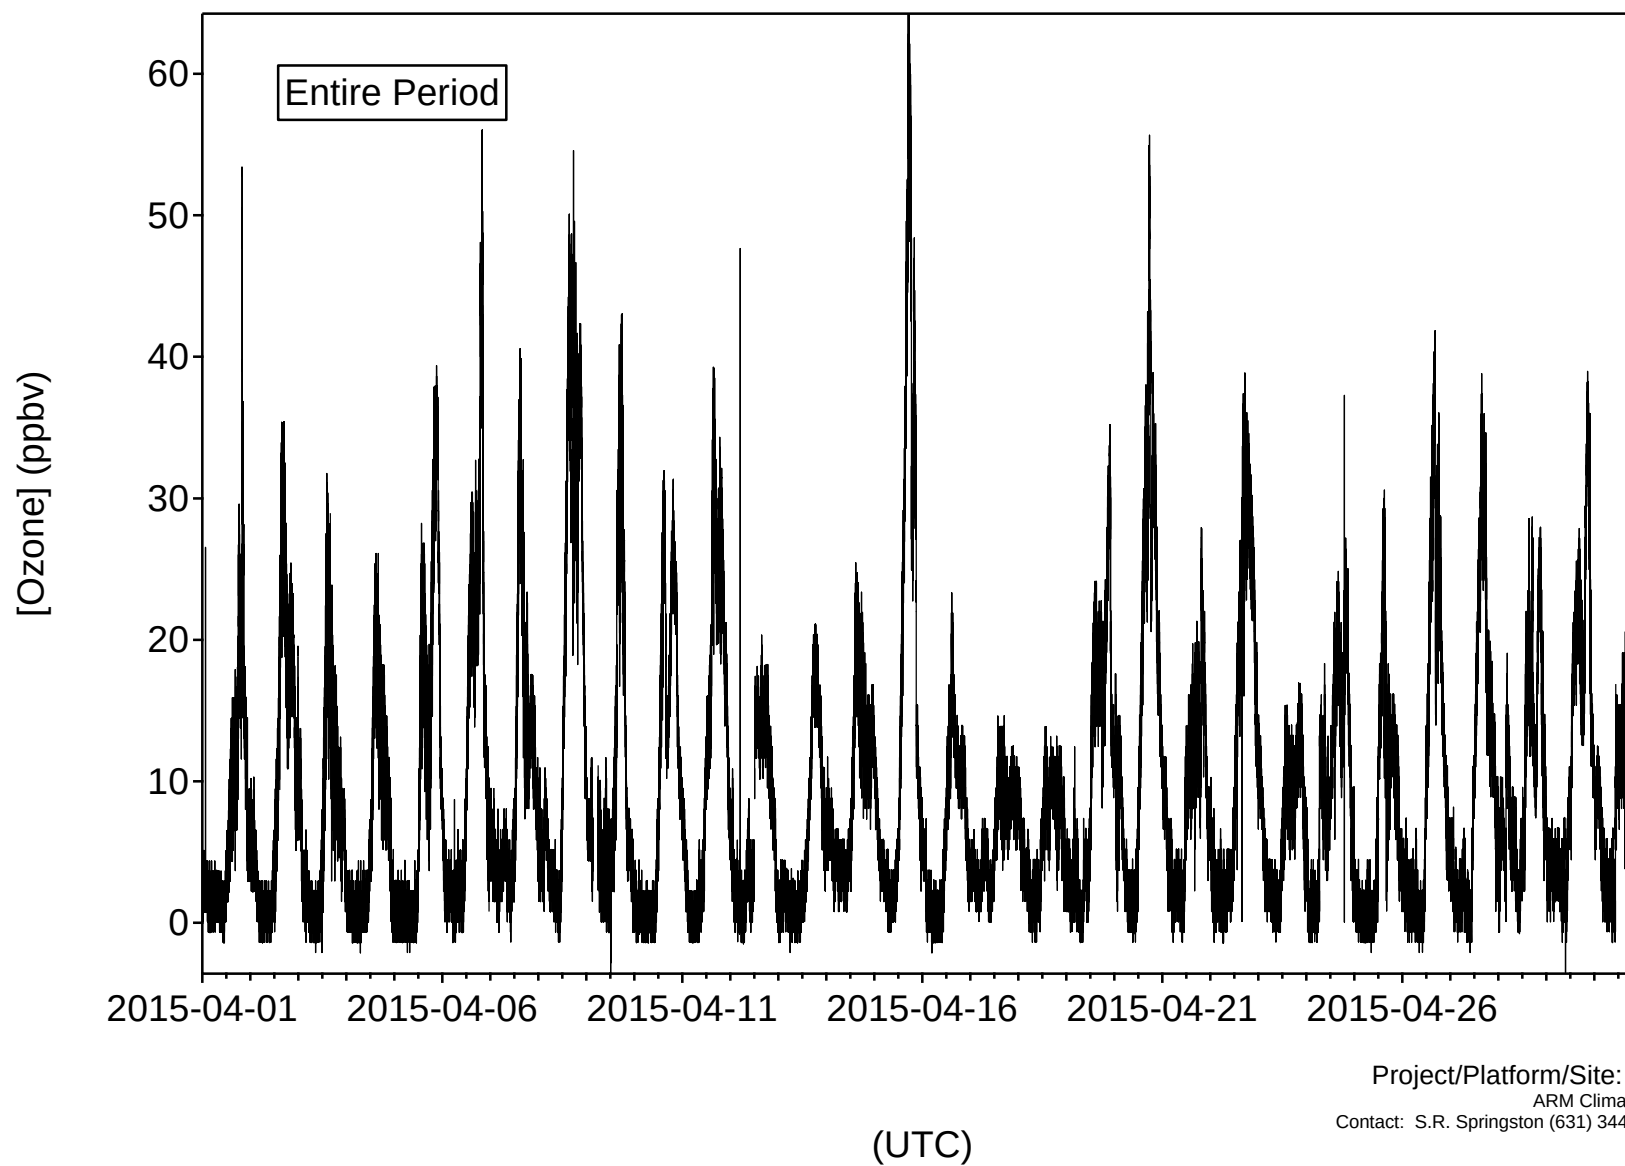
TEI Model 49i UV Photometric Ozone Analyzer  
Baseline Corrected

One short (4-s) data spike of unknown origin.
