Processing Record for this file:  
(Make notes here unique for this file)

Loading from flight 140911a  
Data taken from NOx CPU c:\data\NOx

AAF 3-Channel NO<sub>x</sub> Analyzer  
Parsed NO<sub>y</sub> Channel Data

Project/Platform/Site: maoaafa1  
ARM Climate Research Facility  
Contact: S.R. Springston (631) 344-4477, srs@bnl.gov

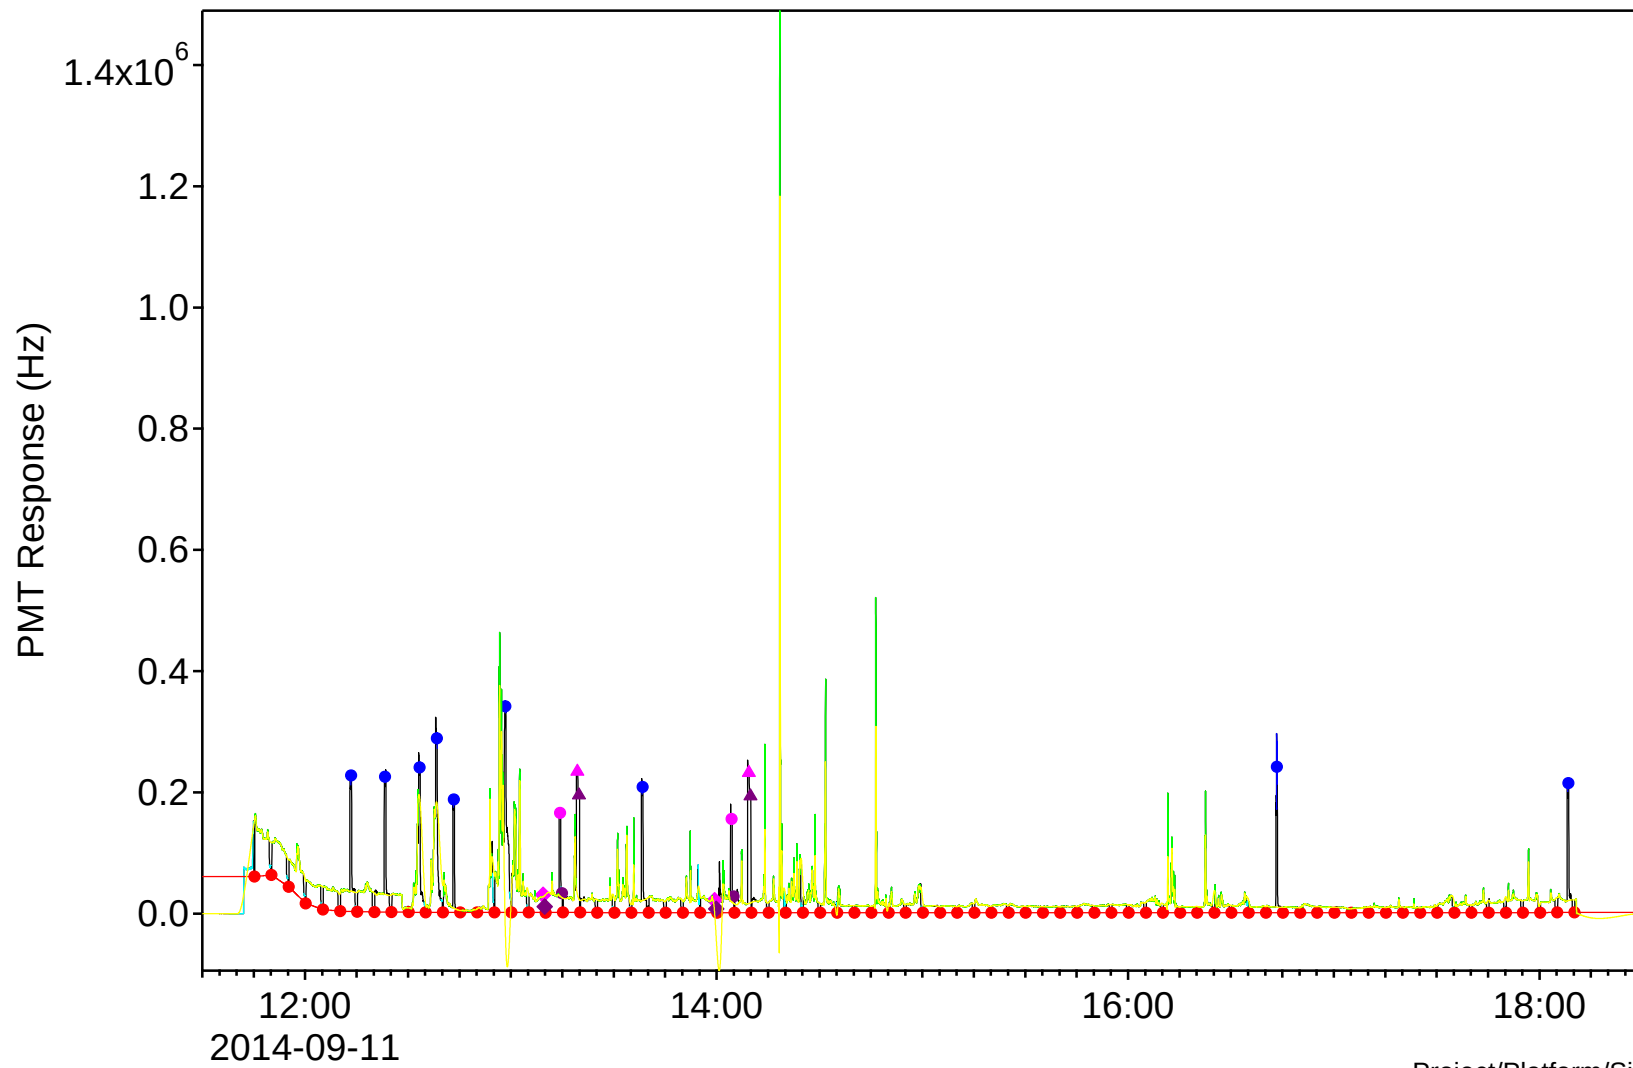
AAF 3-Channel NO<sub>x</sub> Analyzer  
Parsed NO<sub>x</sub> Channel Data

It has been observed that the NO/NO<sub>2</sub> ratios do not appear reasonable at low levels (<500 pptv). There seems to be a constant artifact in the NOx channel. This makes the NO<sub>2</sub> reported high and should not be used directly. These data are only preliminary.

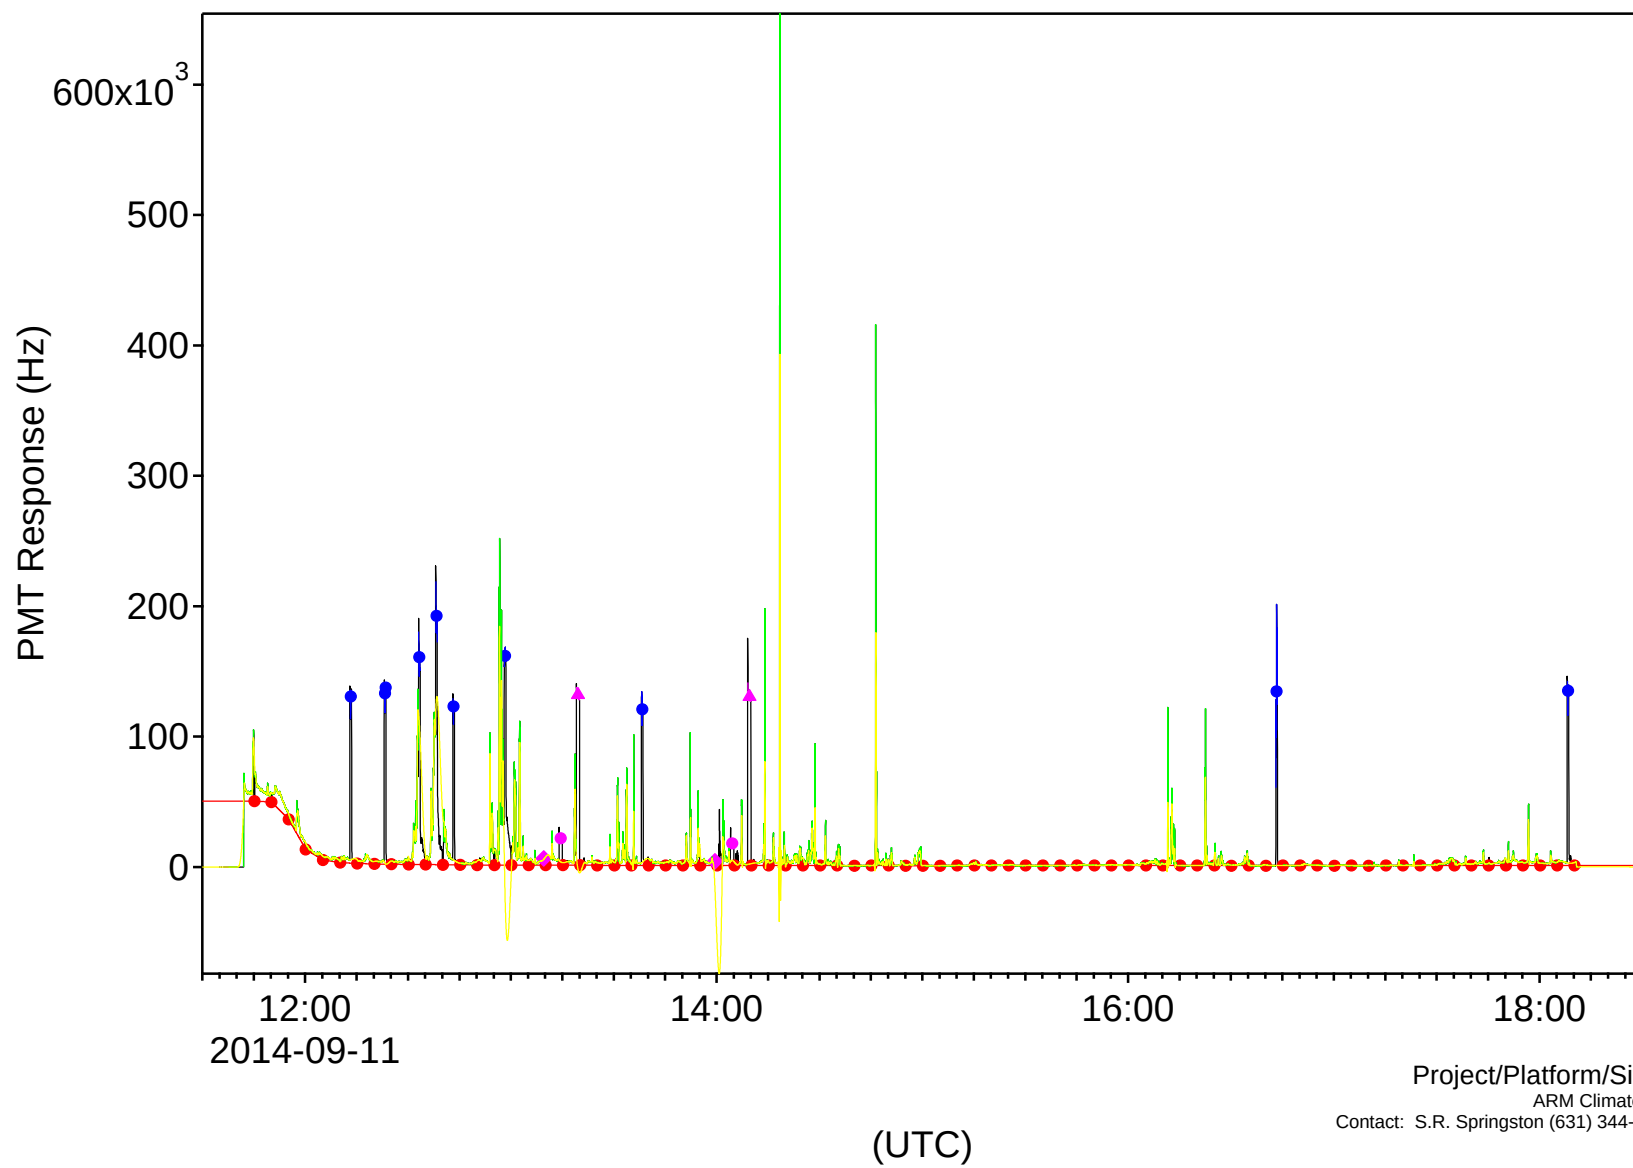
AAF 3-Channel NO<sub>x</sub> Analyzer  
Parsed NO Channel Data

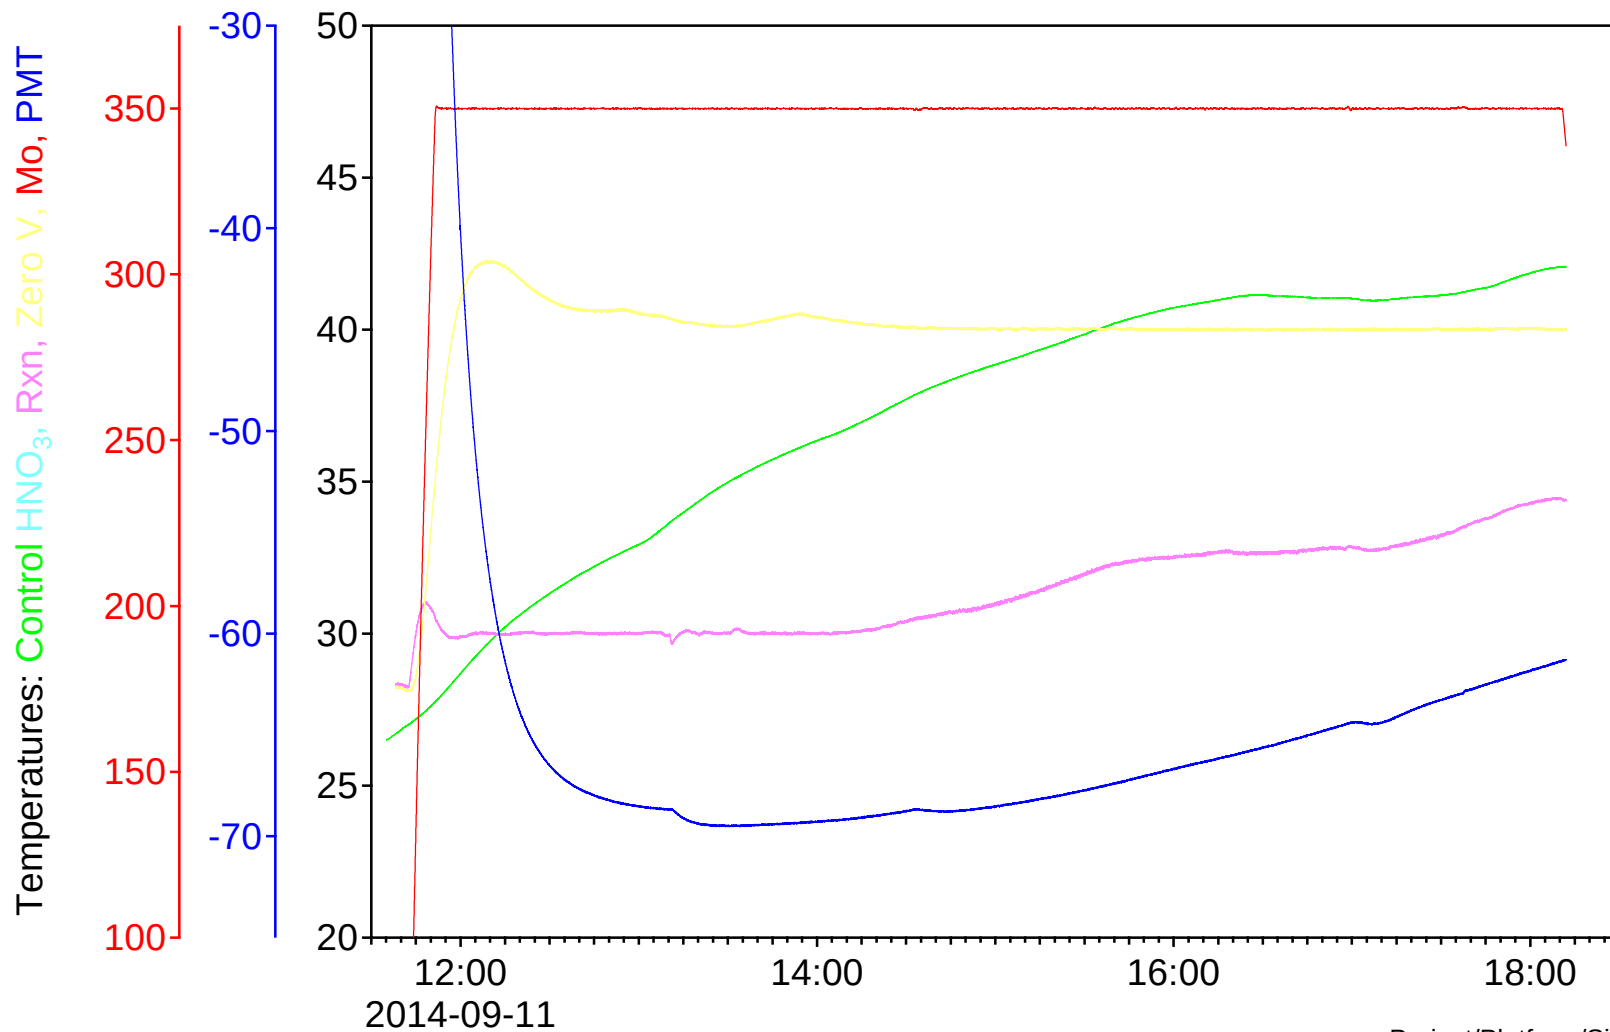
AAF 3-Channel NO<sub>x</sub> Analyzer  
Housekeeping T  
Temperatures

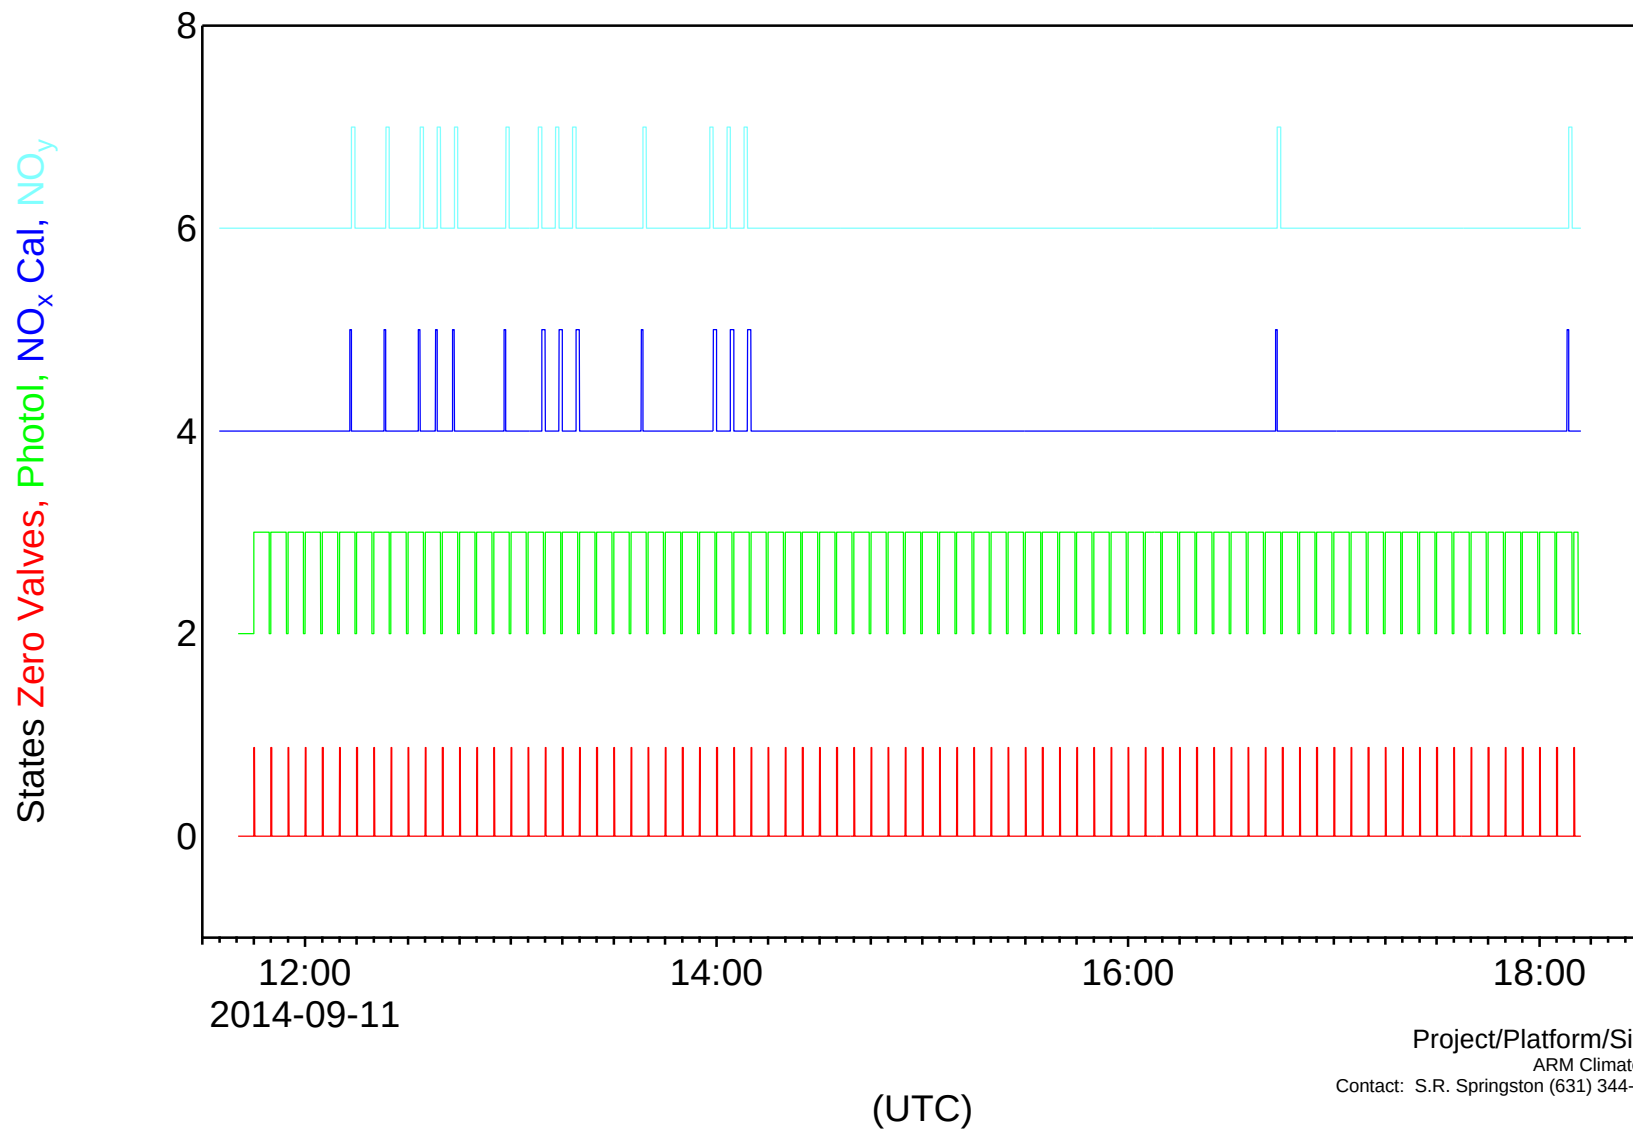
AAF 3-Channel NO<sub>x</sub> Analyzer  
Housekeeping 5  
Zeros/Photol/SAs

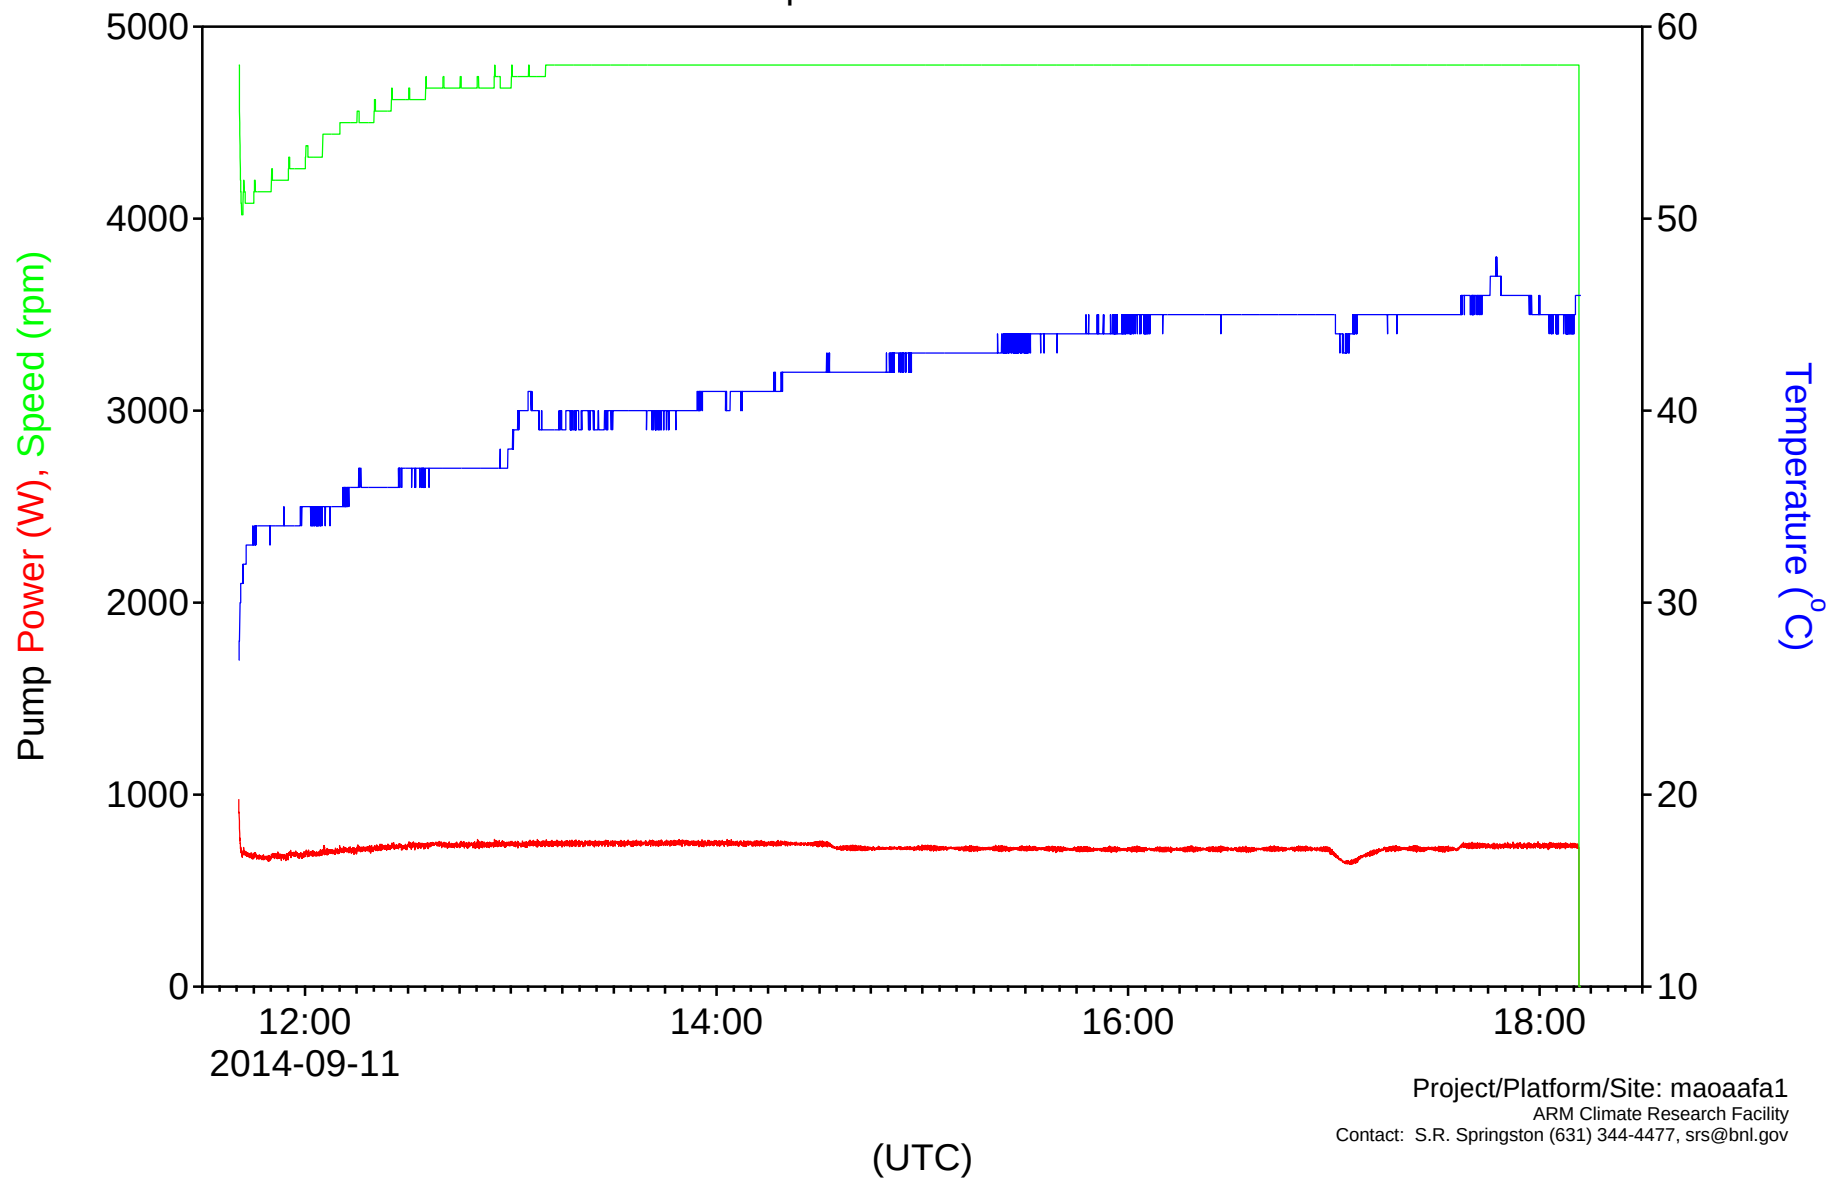
AAF 3-Channel NO<sub>x</sub> Analyzer  
Housekeeping 4  
Pump

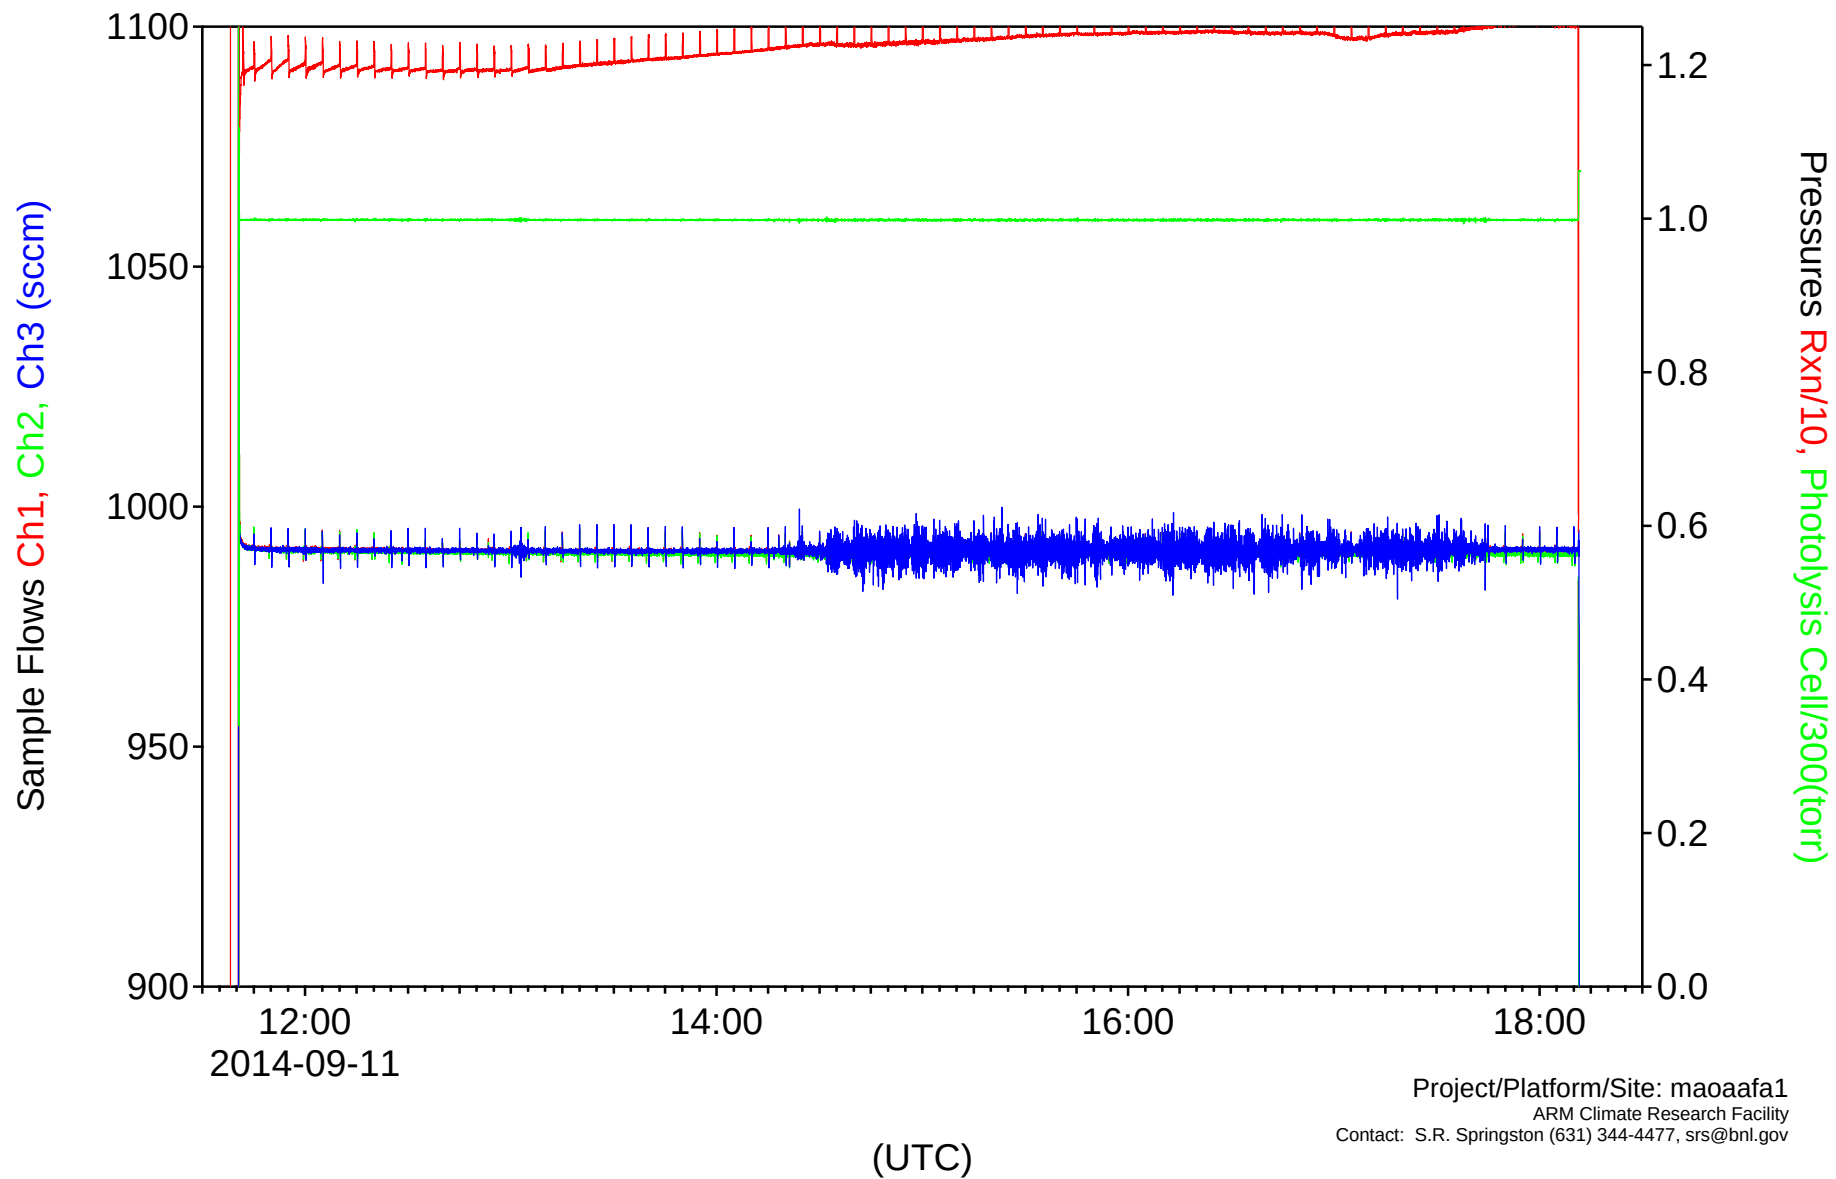
AAF 3-Channel NO<sub>x</sub> Analyzer  
Housekeeping 3  
Pressures

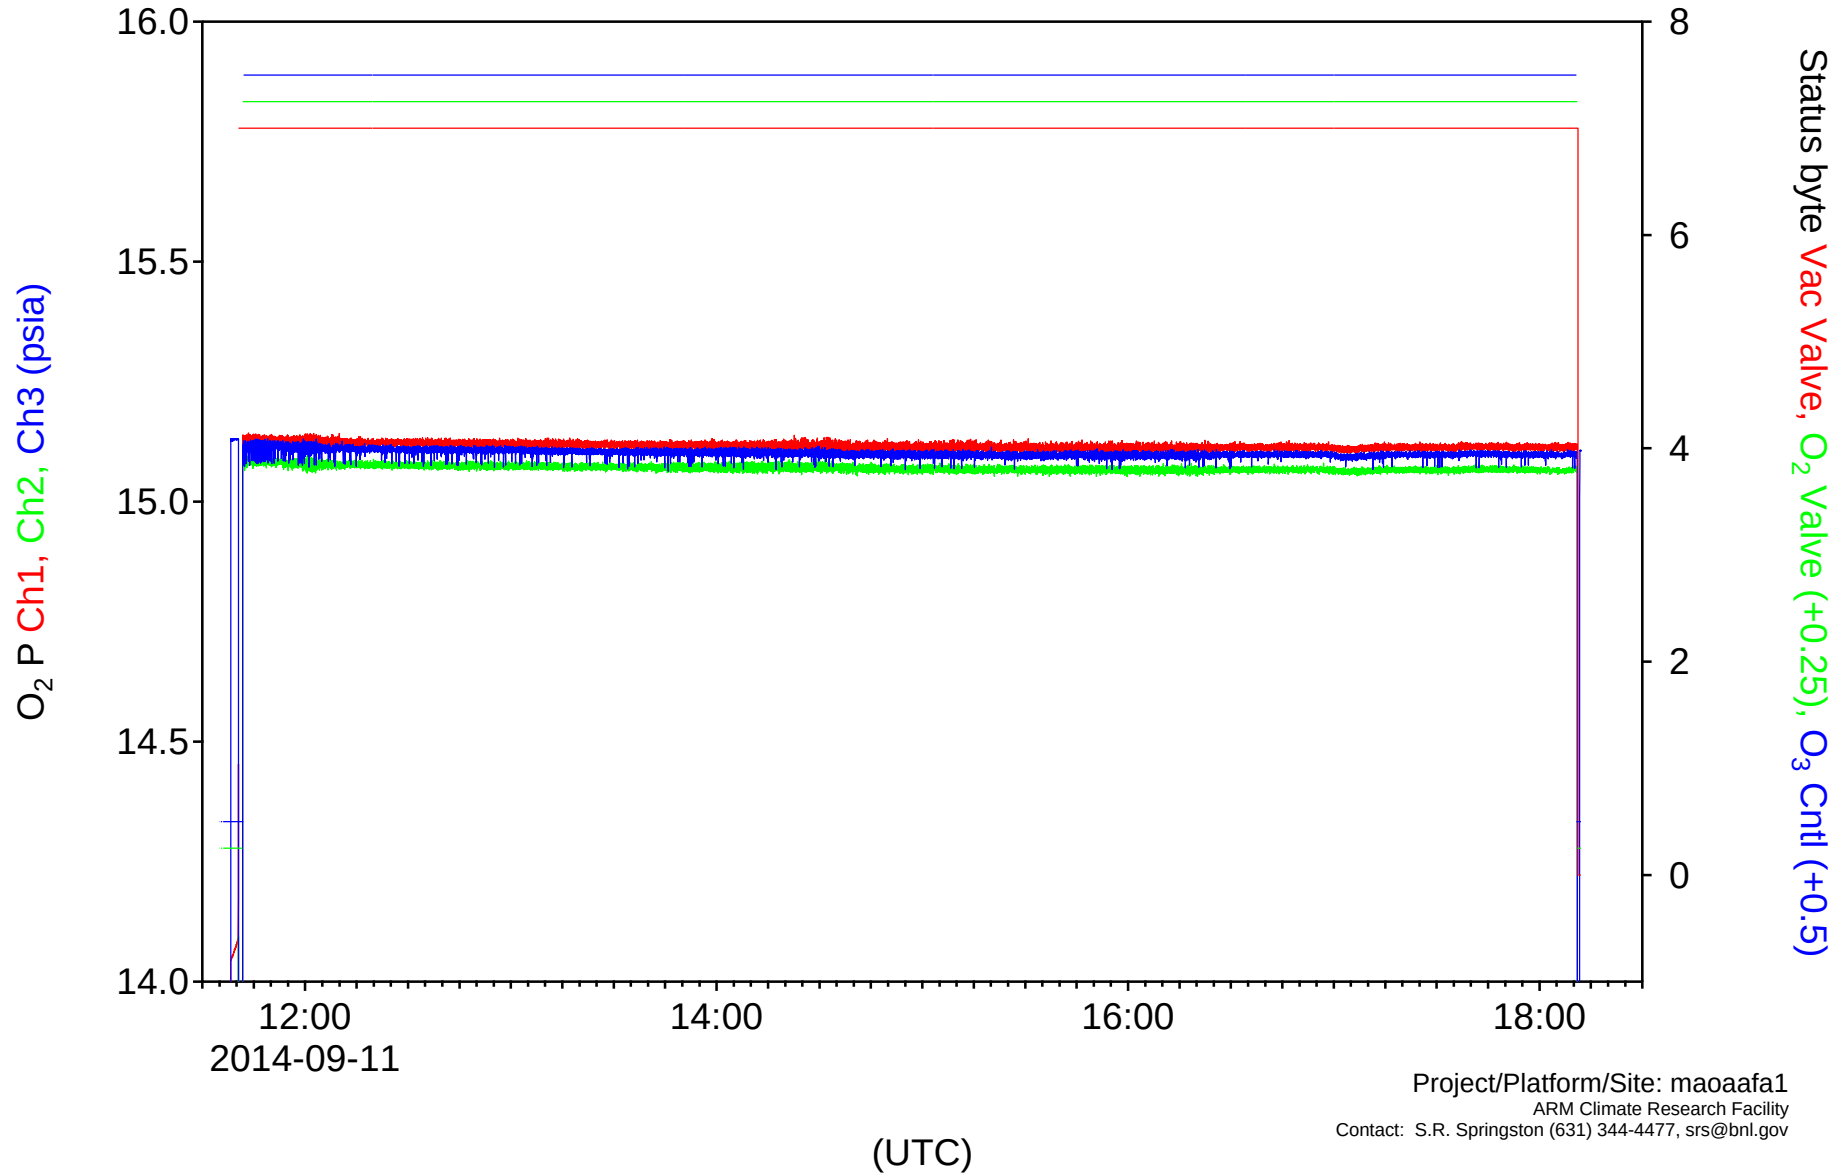
AAF 3-Channel NO<sub>x</sub> Analyzer  
Housekeeping 2  
Ozonizer

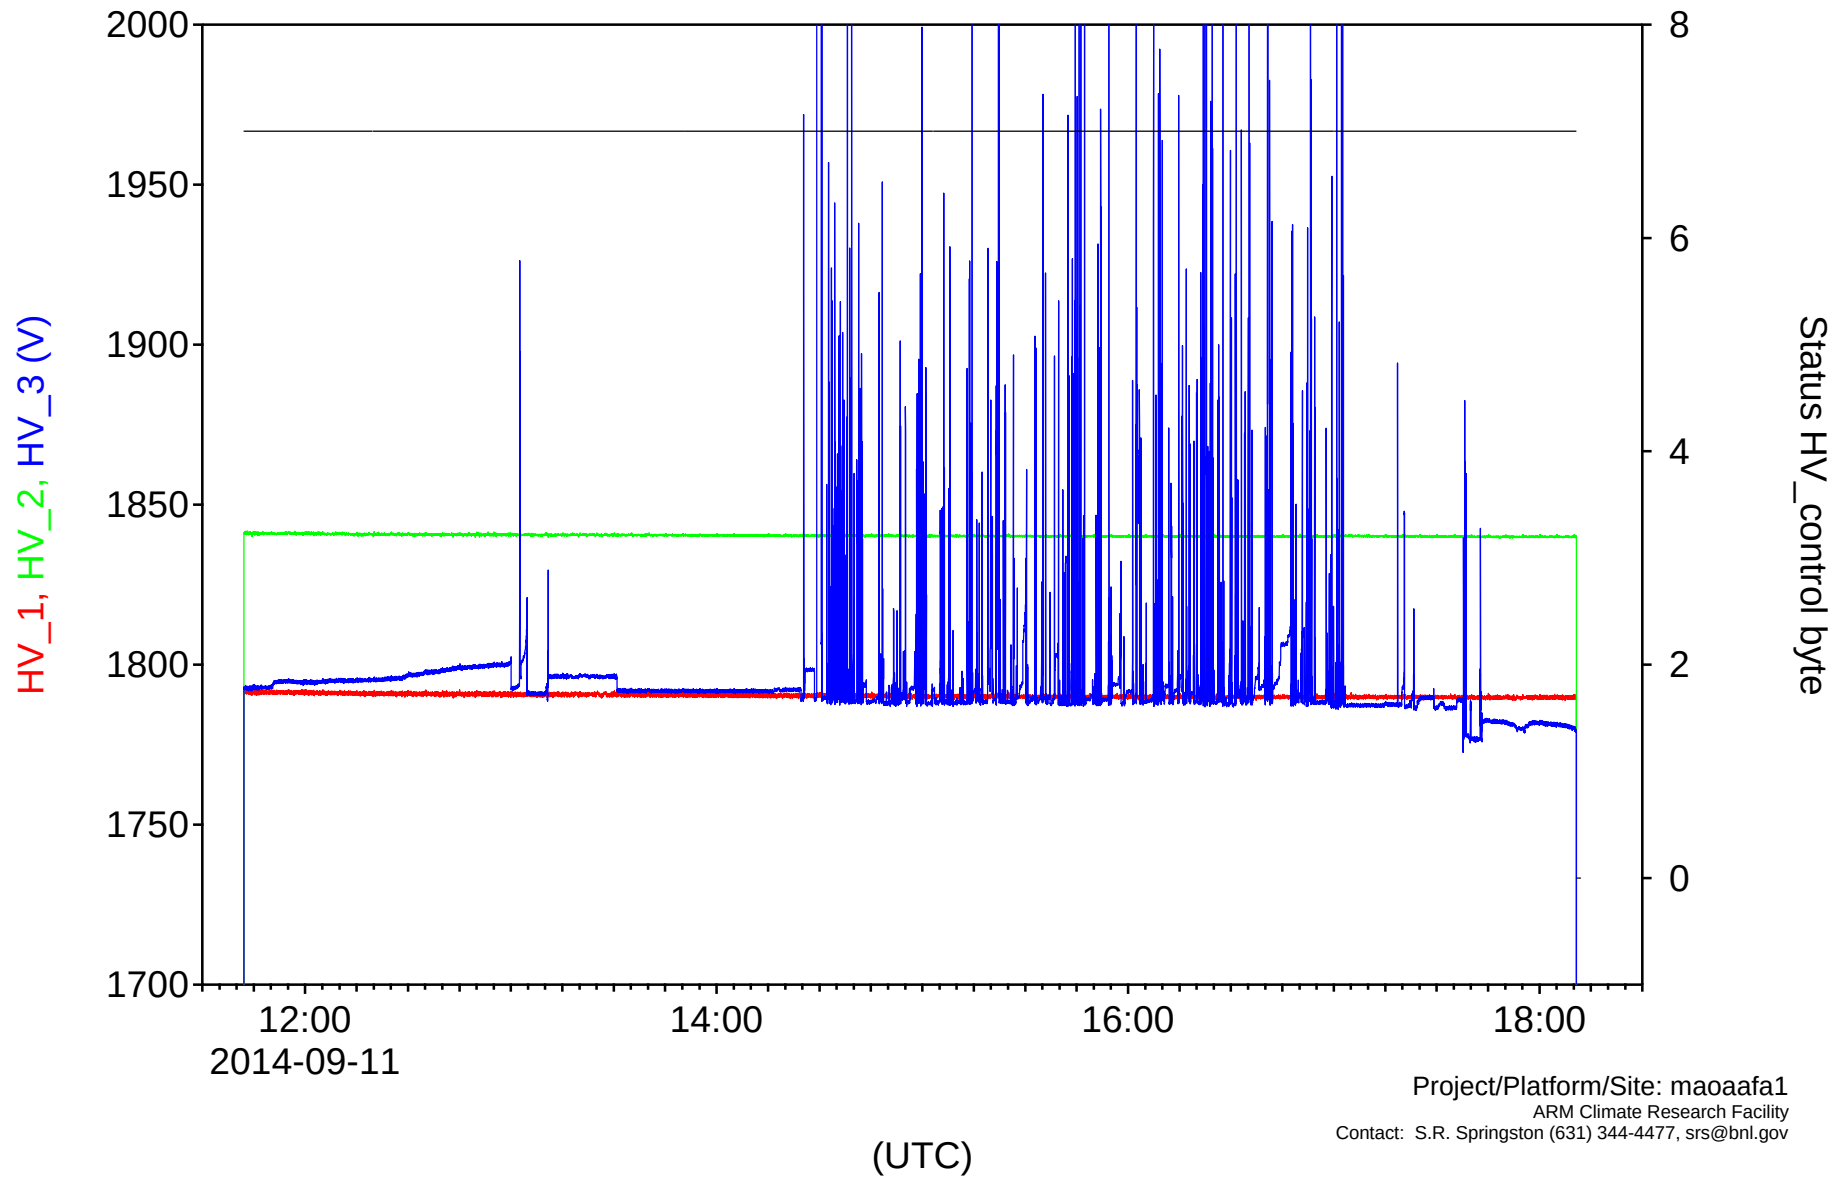
AAF 3-Channel NO<sub>x</sub> Analyzer  
Housekeeping 1  
PMT HV

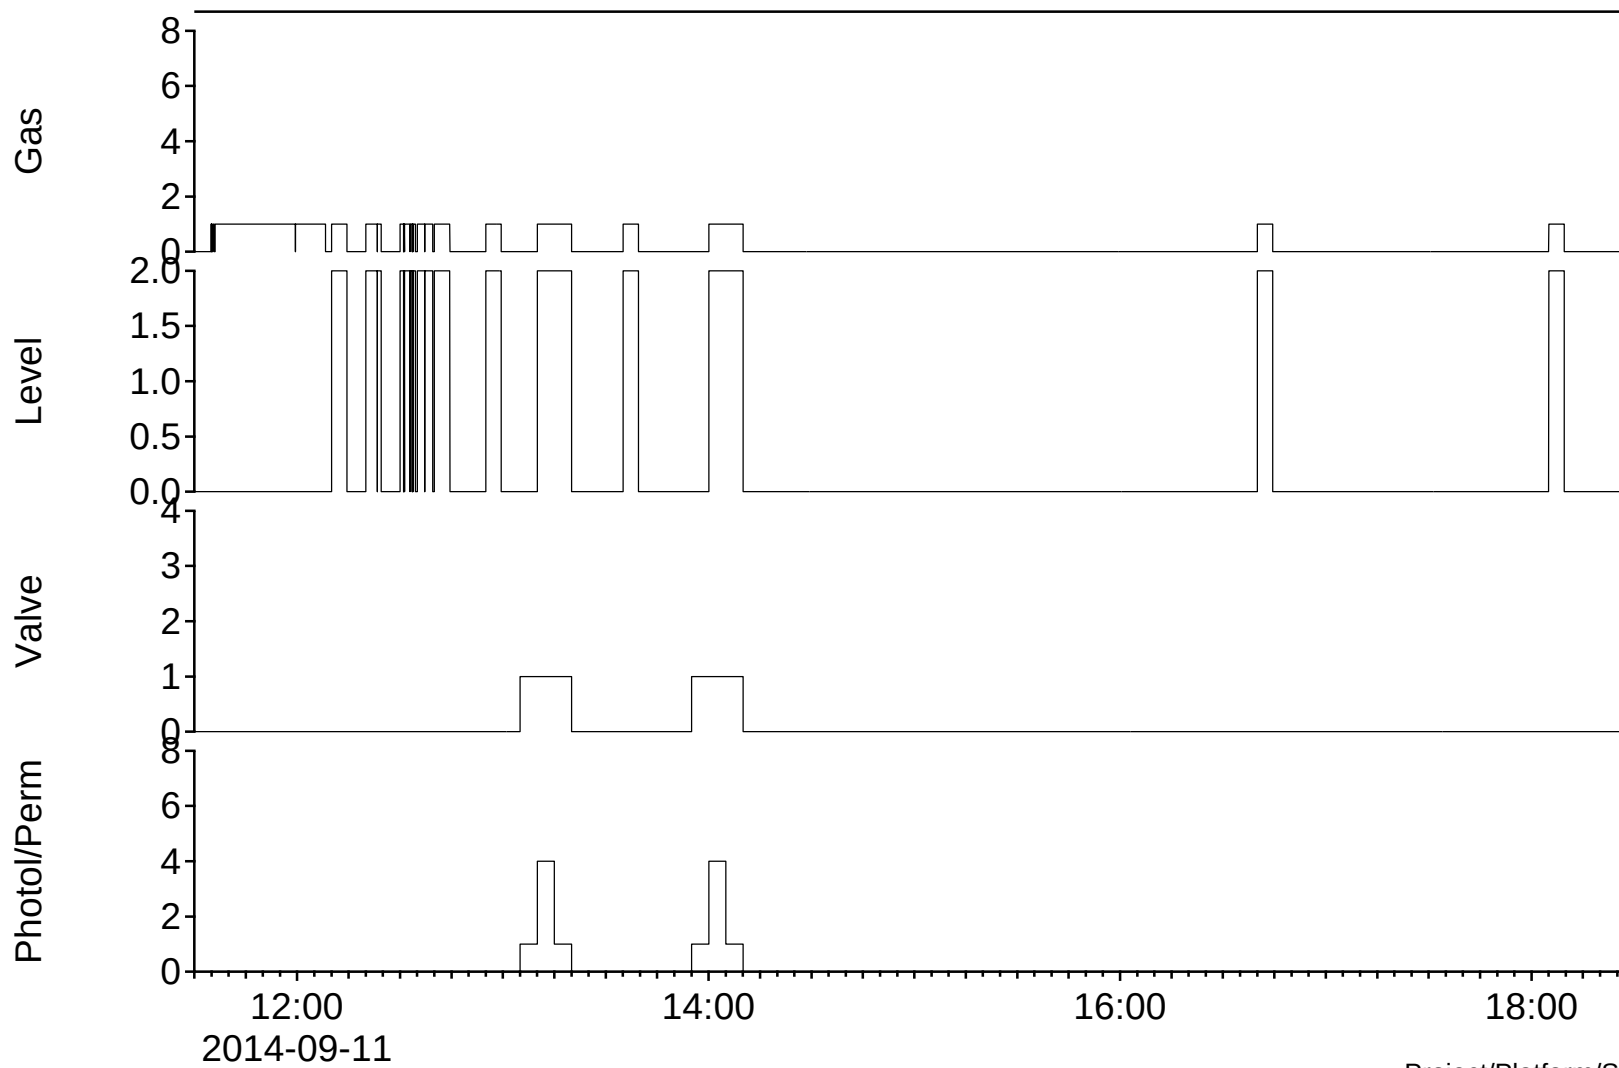
# AAF TEI 146i Calibrator State

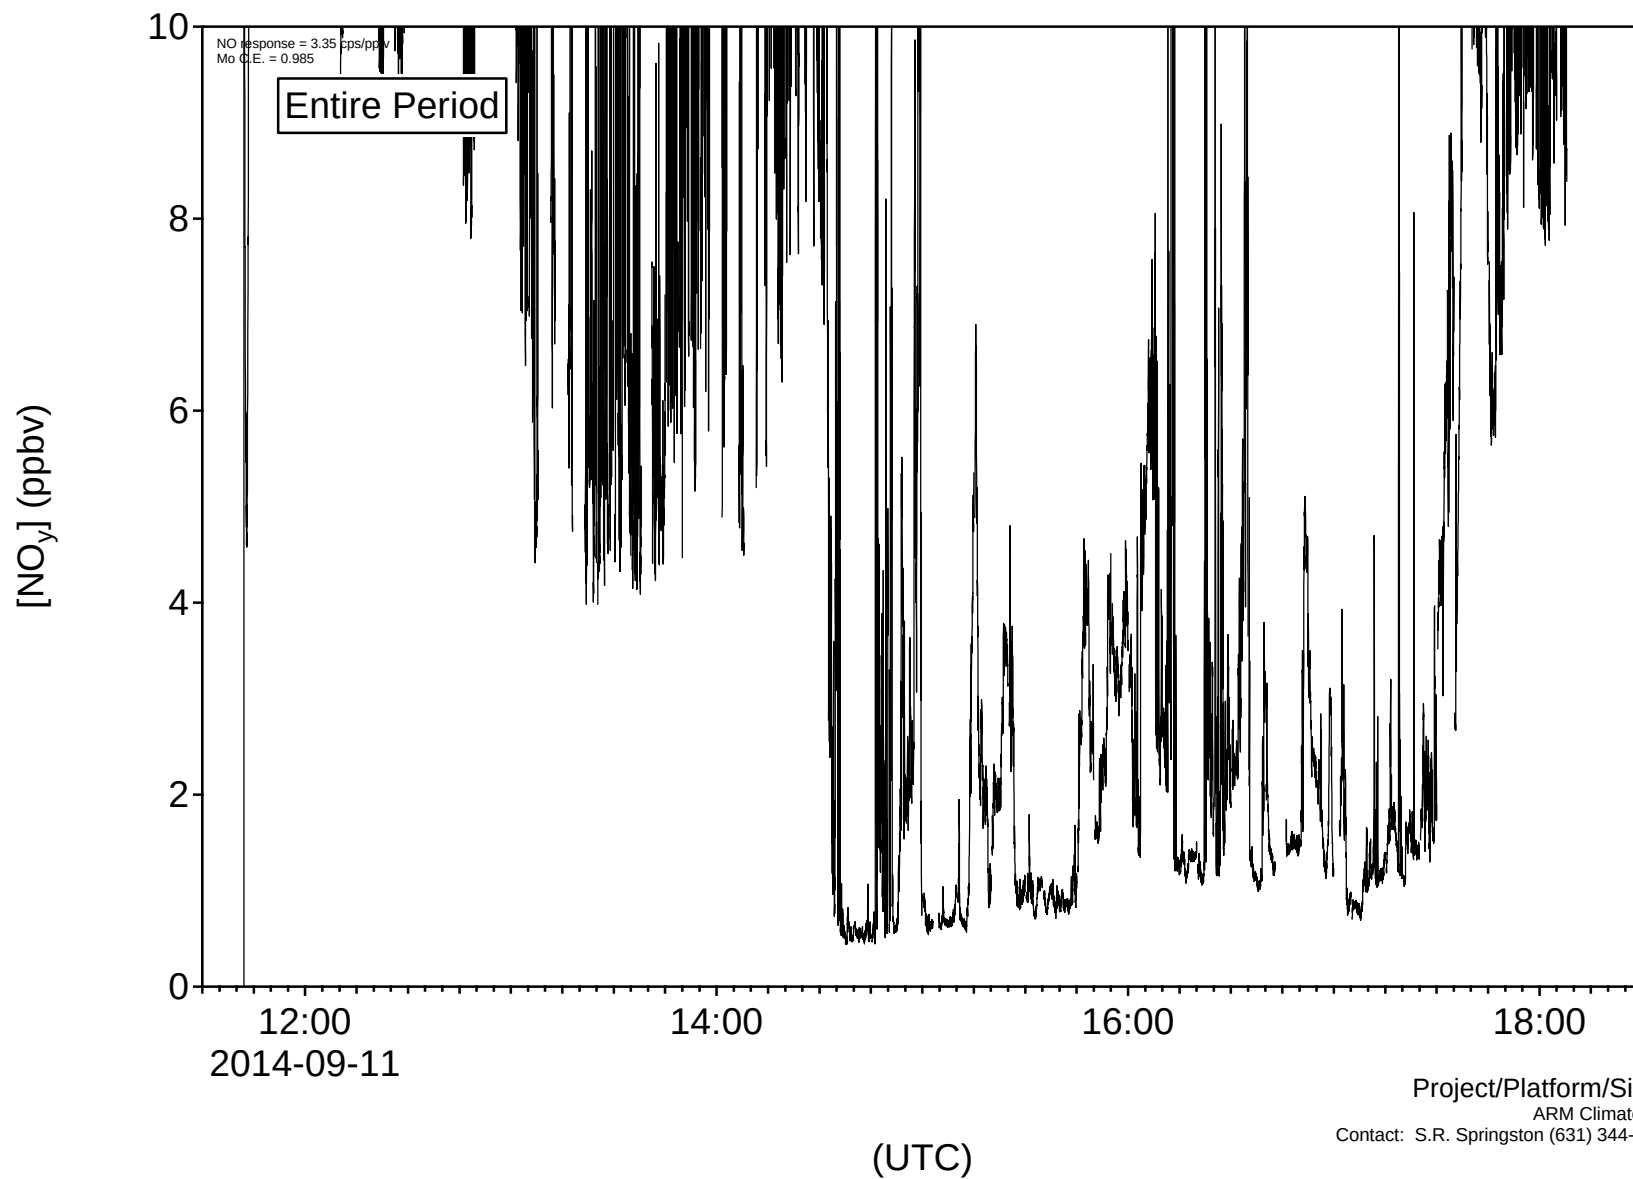
AAF 3-Channel NO<sub>x</sub> Analyzer  
Processed NO<sub>y</sub> Channel Data

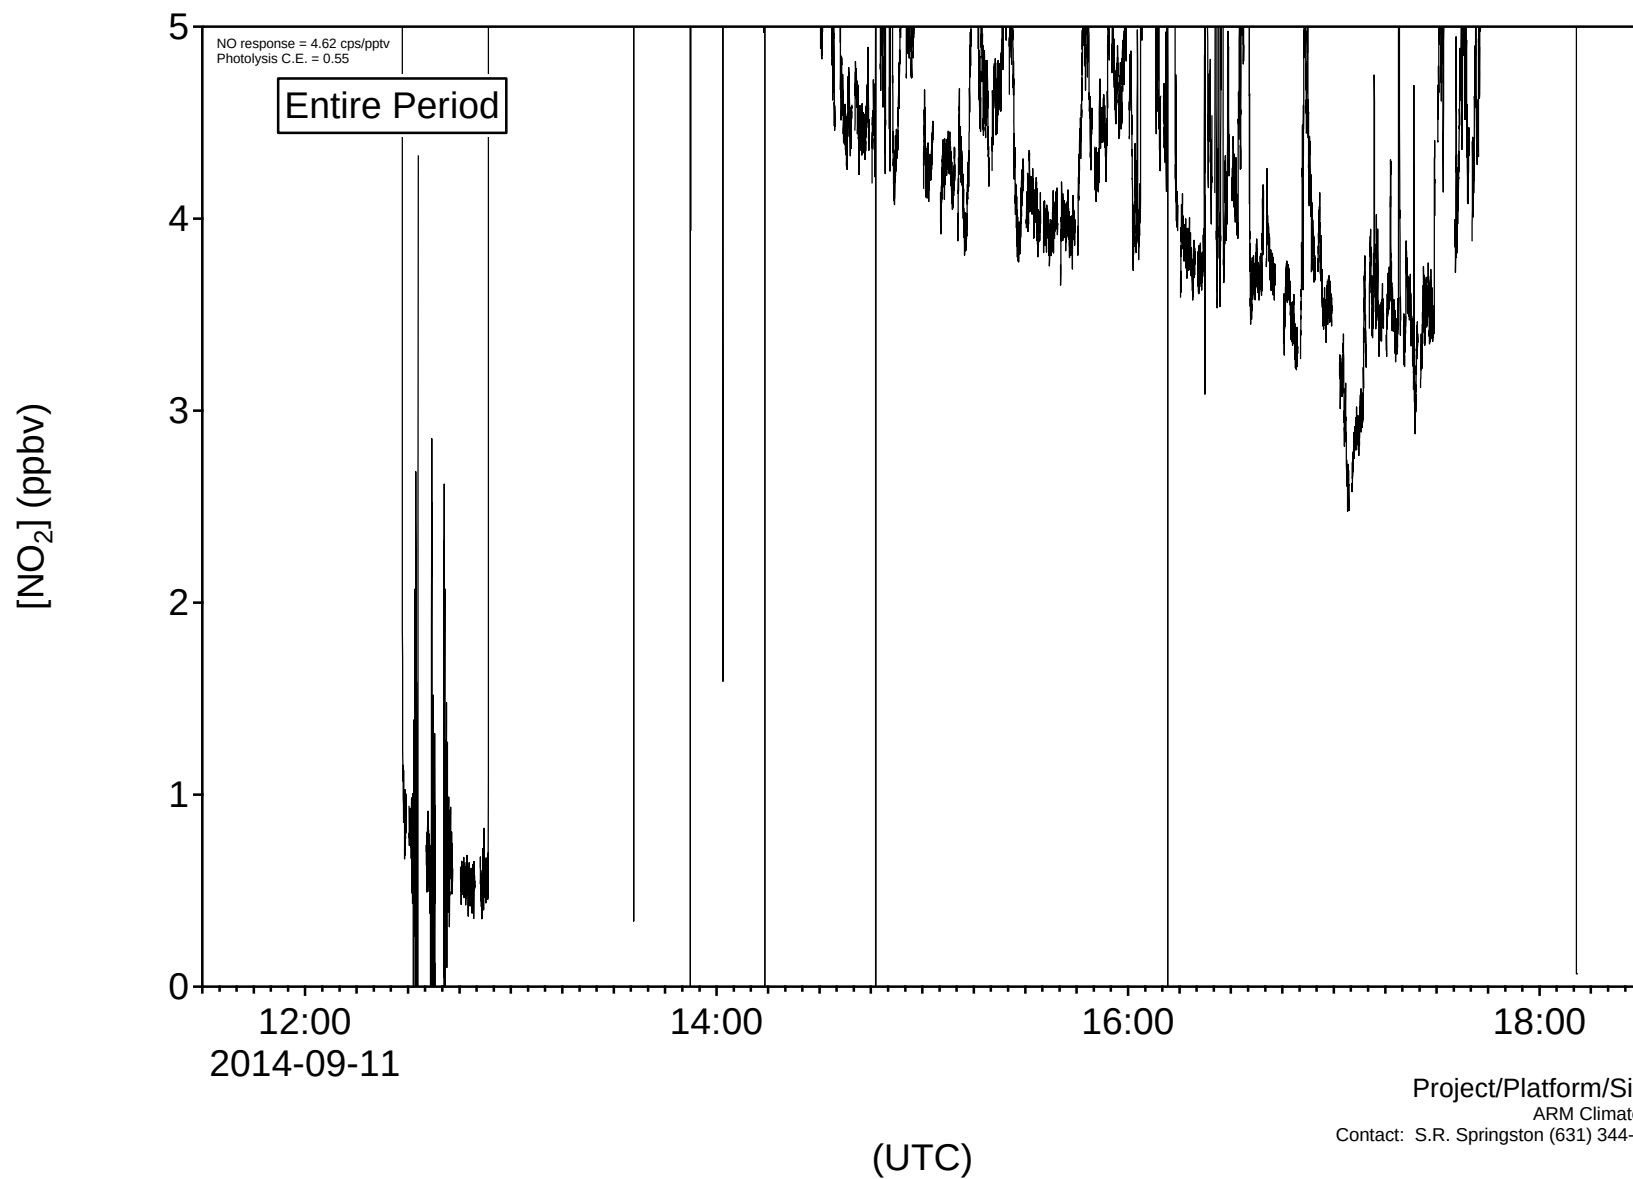
AAF 3-Channel NO<sub>x</sub> Analyzer  
Processed NO<sub>2</sub> Channel Data
