Processing Record for this file:  
(Make notes here unique for this file)

Loading from flight 140911a  
Data taken from NOx CPU c:\data\NOx

AAF 3-Channel NO<sub>x</sub> Analyzer  
Parsed NO<sub>y</sub> Channel Data

Project/Platform/Site: maoaafa1  
ARM Climate Research Facility  
Contact: S.R. Springston (631) 344-4477, srs@bnl.gov

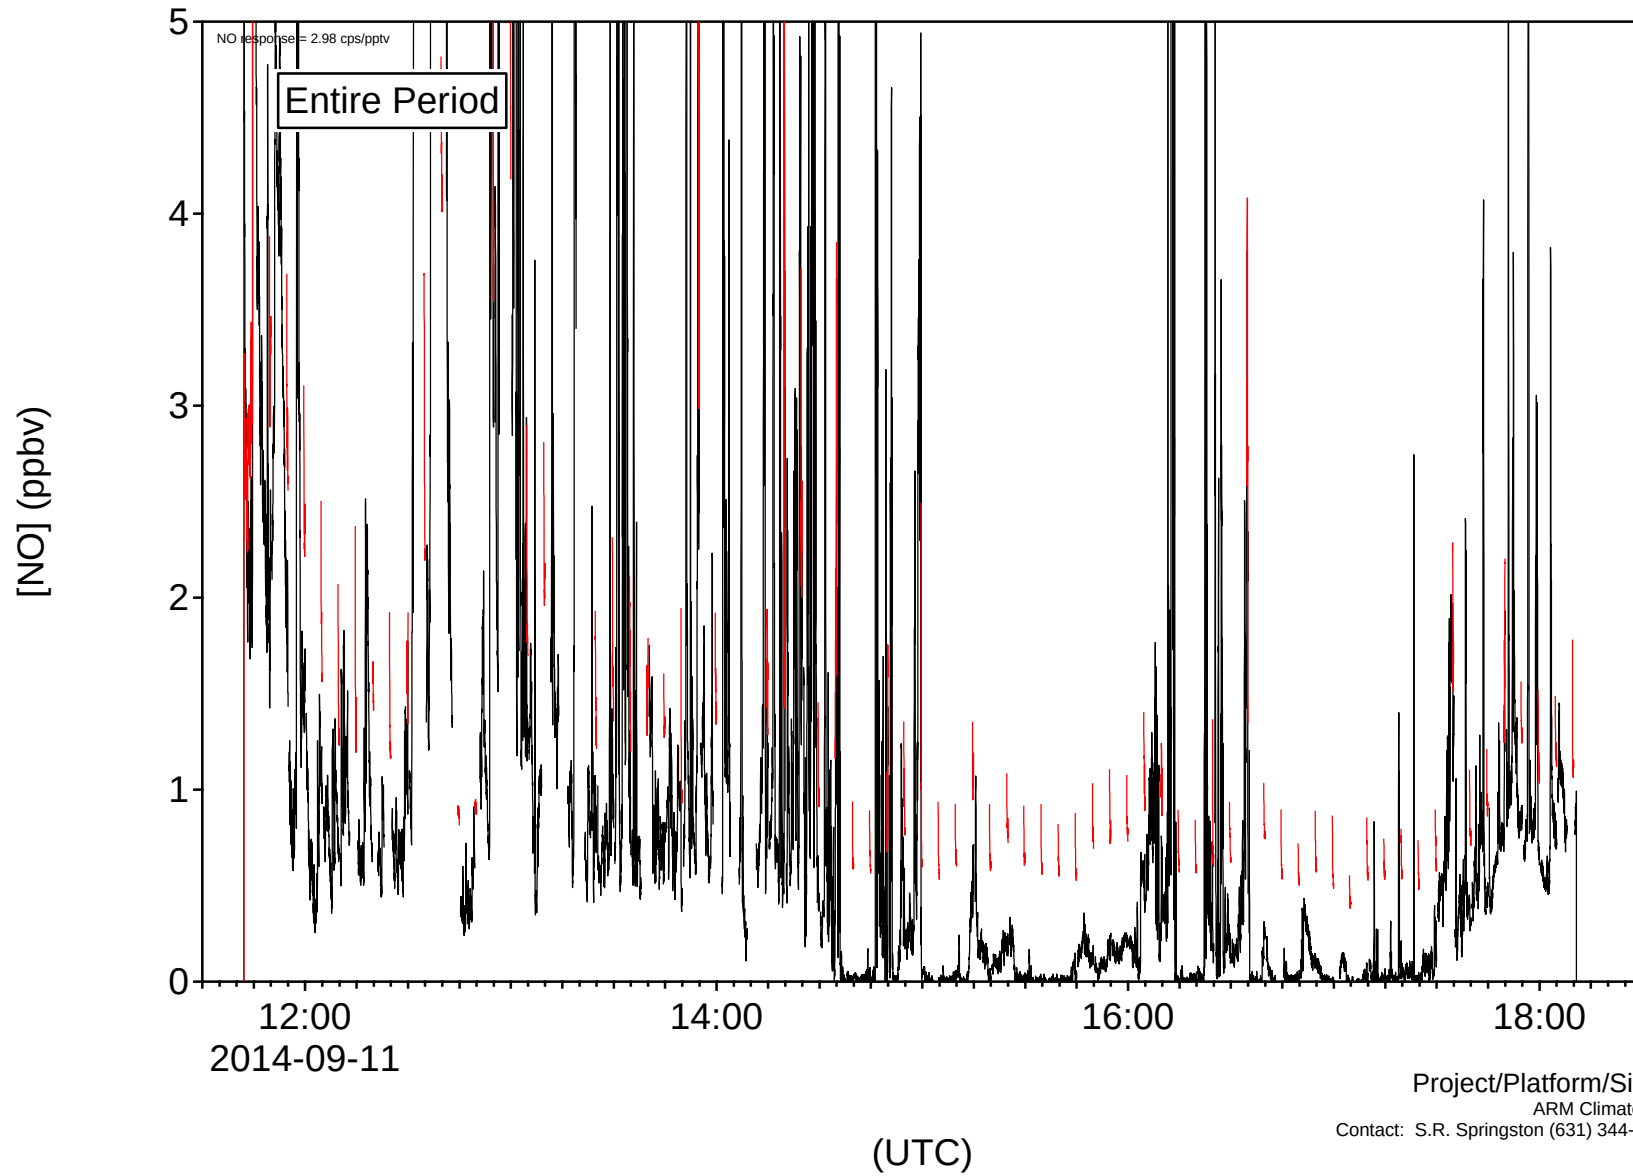
AAF 3-Channel NO<sub>x</sub> Analyzer  
Processed NO Channel Data
